## Suspended access platform collapse: Chicago 2002

Report ID: 5009

#### SCOSS FAILURE DATA SHEET (2006)

#### SUSPENDED ACCESS PLATFORM COLLAPSE: CHICAGO 2002

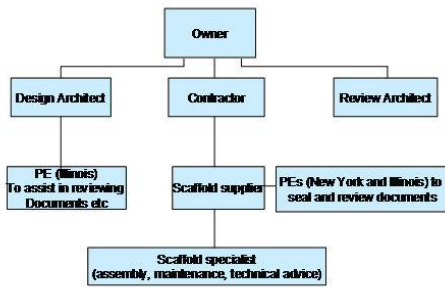
These involved a significant number of parties (Figure 1): See below

PE indicates 'Professional Engineers'. These are state registered.
