SC/08/024

THE FIRE AT THE TORRE WINDSOR OFFICE BUILDING, MADRID 2005

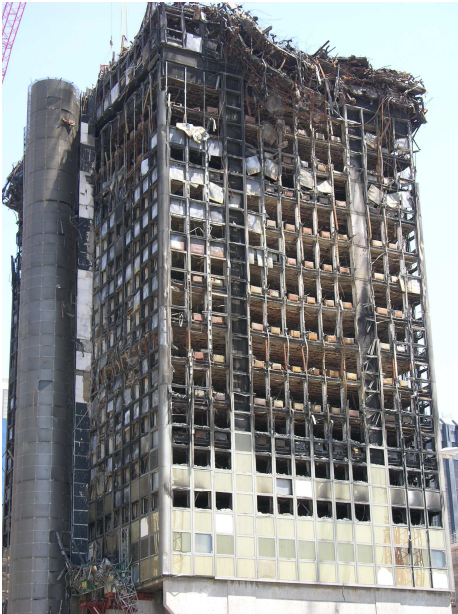
During this refurbishment work a fire broke out on the 21st floor. The fire spread downwards to the 2nd floor, and upwards to the top of the building. It burnt for some 19 hours and engulfed the entire building. Although local progressive collapses occurred a total collapse was narrowly averted. The new staircase performed well (see photo below). However the building was later completely demolished.
