# CROSS

## Confidential Reporting on Structural Safety

### Newsletter No 4, November 2006

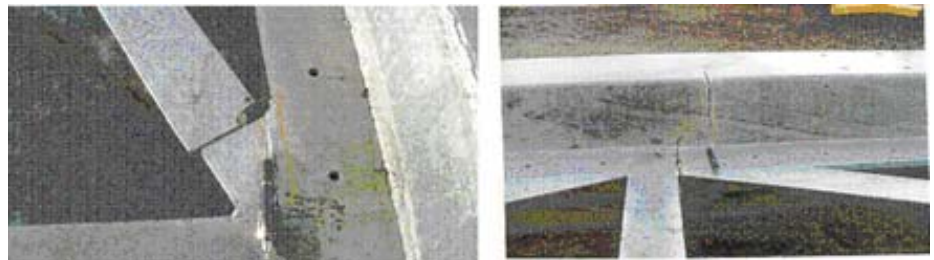
He gives the example of a girder which was fabricated in normal welded steelwork using beam and angle sections where possible and plate fabrication for the remainder. The design and specification were given to the main contractor, who in turn passed it to their own sub-contractor. Minor changes were made to the design and after fabrication the structure was galvanised as a complete unit. It was then found to have suffered severe distortion and there were numerous visible cracks. Some were in materials 20mm thick whilst others were in 6mm thick sections. The level of distortion was considerable and affected both primary and secondary members. All cracks seen were brittle in appearance with no indication of ductile tearing.

The reporter says that repair is not simple as it is possible that cracks in the steel may be obscured by the galvanising. It is not known if the guidance given in the BCSA/GA publication (40/05) was followed.

*Illustrations of Liquid Metal Assisted Cracking*

The reporter's firm took expert advice to establish the cause of cracking and the consensus was that it had occurred in the galvanising bath and that it was Liquid Metal Assisted Cracking. It looked likely that the cracks had been masked by zinc so were not visibly detected until the structure had been erected and tension applied across the crack surface. The nodes were remade with tougher steel and the cracking did not re-occur.

*Comment BCSA document 40/05 emphasises that LMAC is a rare phenomenon. However it can occur if due attention is not paid to the design, fabrication, galvanising and inspection processes of susceptible assemblies. It is apparent that not all designers are yet familiar with the guidance. (Report Nos DI 045 and 049)*
