Confidential Reporting on Structural Safety

Newsletter No 8, October 2007

COLLAPSE OF BRICKWORK CLADDING

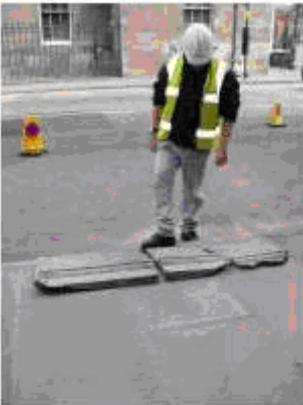
The external leaf of a brickwork pier at first floor level fell down onto the playground of a school adjacent to the main entrance door. Fortunately there were no casualties. The reporter believes that the structure is a concrete encased steel frame. Bricks on end had been used on either side of a column between windows to form a cavity and an external skin built without provision for tying back to the main frame. The school was closed for an initial period of a week whilst investigations were carried out on the rest of the elevation. The brickwork cladding was removed and replaced with an alternative material. The reporter's firm has advised the local authority in case there are other schools of similar construction in the same ownership.

Fallen masonry from SCOTCROSS

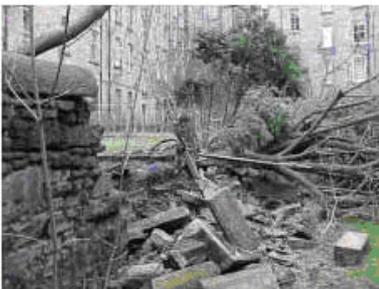
Collapsed freestanding wall from SCOTCROSS

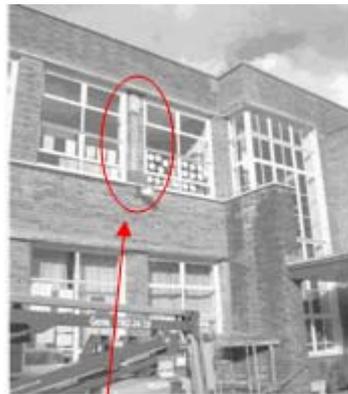
Column from which brickwork fell

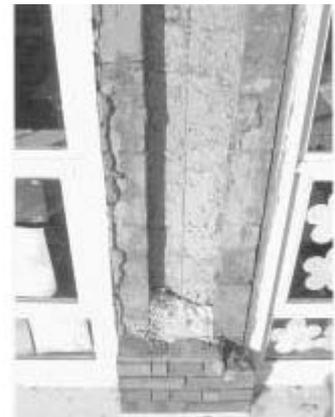
Concrete casing with no ties to brickwork cladding

CROSS comments: As with many other reports of masonry falls from buildings it is fortunate that there was nobody underneath at the time of collapse. The SCOTCROSS project which gathered data over a two year period up to August 2007 had 1,200 reports of material falling, or in danger of falling, from old buildings. In 12 cases passers by were injured. A full report on the project will be published in due course by the Scottish Building Standards Agency. There is a risk to people from falls such as the one given above and they are usually due to combinations of poor construction, poor maintenance, and weathering. Two examples are shown below. The most significant failures are those where there is a pattern and hence further falls can be expected if nothing is done. The Scottish investigation may be extended to other parts of the UK but meanwhile CROSS welcomes reports of falling, or dangerous and about to fall, materials. So far as new construction is concerned this is perhaps a timely reminder that good

building practice requires the ability to see how all items are restrained and retained within buildings, and that construction industry professionals should be proficient at good detailing. It is also a reminder to school authorities and school governors of the importance of regular condition surveys to detect defects before they become dangerous. (Report 078)
