CROSS

Confidential Reporting on Structural Safety

Newsletter No 10, April 2008

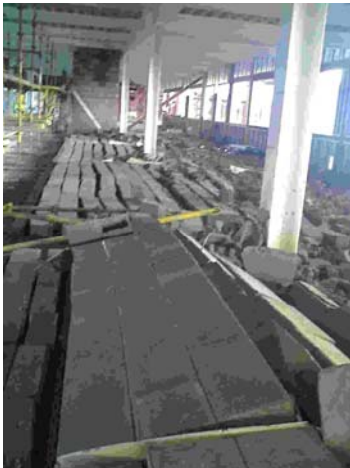
This report concerns the collapse of part of a gable wall to a fairly recently constructed block of flats. The collapsed masonry fell onto a parked car which suffered significant damage. The owner had left it only a minute or two beforehand, heard the crash as she walked around to the front of the building, and was therefore very shocked at how close she had come to severe injury or worse. The subsequent investigation found several reasons for concern. The lateral restraint ties were spaced excessively and had inadequate fixings. Wall ties had been bent up where an adjoining wall should have been tied in but were not connected because the coursing did not match. Similar defects were found on other gables and remedial action had to be taken.

CROSS comments: *Supervision on site is critical for good construction and was clearly lacking here. Are standards for supervision adequate and if not what should be done? Risk based inspections appear to some to be the way forward in Building Control, and this may be the basis for fewer random inspections so such deficiencies may not be picked up in this way. On the other hand if risks are thought to be significant it could lead to more inspections. The failures of inadequate wall ties and lack of lateral restraint emphasise that if mid-construction inspections are not undertaken then there is a risk. The fact that 'similar defects were found on other gables' suggests that the poor construction and supervision throughout the site. (Report No 092)*
