# CROSS

## Confidential Reporting on Structural Safety

### Newsletter No 12, October 2008

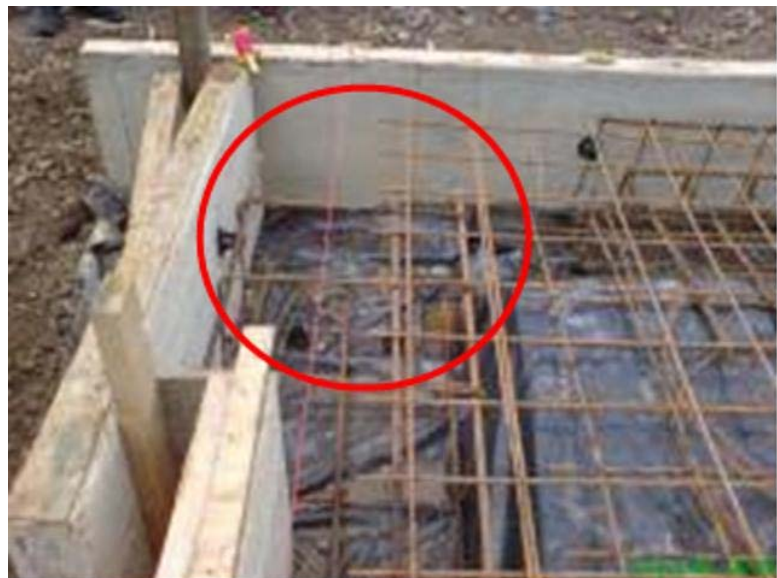
The photograph below is of ground beams for a multi-storey development where the subcontractors carrying out the ground works failed to provide sufficient continuity reinforcement. In an attempt to provide continuity the steelwork was repositioned with the result that all reinforcement from a corner of the building was removed as shown in the highlighted region of the photograph. The local authority building control officer twice advised the sub contractors that this was unsatisfactory but they claimed that the consulting engineer had considered the work acceptable. Regardless of this statement the work was not approved.

*Missing reinforcement*

The reporter advises that this is not an isolated case because on many sites there is little or no involvement of the design engineer to ensure that his details are being followed on site. Traditional checks on construction standards from Clerk of works and site resident engineers are now rare because Clerk of works are not generally employed and the site engineers knowledge usually relates to setting out only. A reputable design team and main contractor were carrying out this development but the lack of basic knowledge of the ground workers would have gone unchecked if it had not been for the local authority inspection. There is, considers the reporter, a concern about the lack of site involvement by design engineers in respect of critical areas of construction. Reliance is placed on sub contractors but their lack of knowledge creates risk of fundamental errors in the construction process.

**CROSS comments:** *Unless adequate supervision is provided on site, problems will eventually result. This separation of design from construction is a potentially dangerous trend. It is common practice in the UK for reinforcement to be detailed by the contractor. In such a situation the design engineer would check that the reinforcement placement drawings met the design intent. It would appear that no such placement drawings were approved or if they were the steel fixing details were not followed. Whilst the*

*involvement of the original designer in site inspections provides the best check of design intent, there appears to have been failures in good practice prior to the start of works on site. Even for relatively trivial details checks should be in place. Design briefs often exclude any site involvement by designers whose activities are restricted to monitoring. However the key lesson here is that there must be competent structural engineers on site either from the design side or from the contractor to prevent failures. (Report 112)*

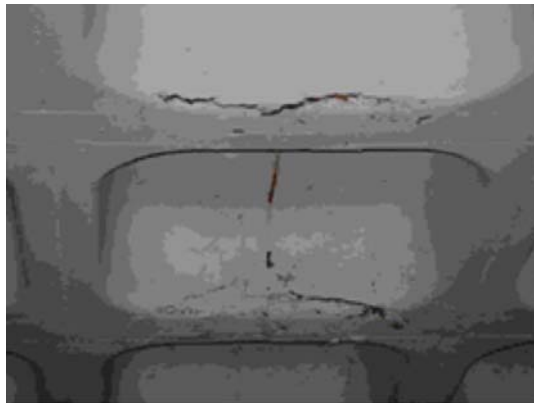
A reporter says it was interesting to see the note on the staircase collapse in a MSCP (multi storey car park) in CROSS Newsletter No 11 and it prompted him to write to express concerns which he has held for some time. He is regularly sent photographs on defects in MSCPs (below is a typical one of a soffit) and has been concerned for some time that there potentially could be another failure similar to Pipers Row in Wolverhampton – see [SCOSS Report](#) number 10 page 18.

*Cracked soffit in multi-storey car park*

**CROSS comments:** *It had been hoped that the publicity following the collapse of Pipers Row car park and the publication of the ICE report would ensure safe regimes in all car park structures. Such structures are subject to harsh environmental conditions, repetitive loading cycles and lack of maintenance. Structural engineers dealing with these buildings must be aware of the need for inspection, monitoring and repair. Owners and Local Authorities should follow the guidance given in the references below. CROSS would welcome further information on this subject in order that a comprehensive picture may be established, and will check with ICE as to whether their guidance will be re-printed.*

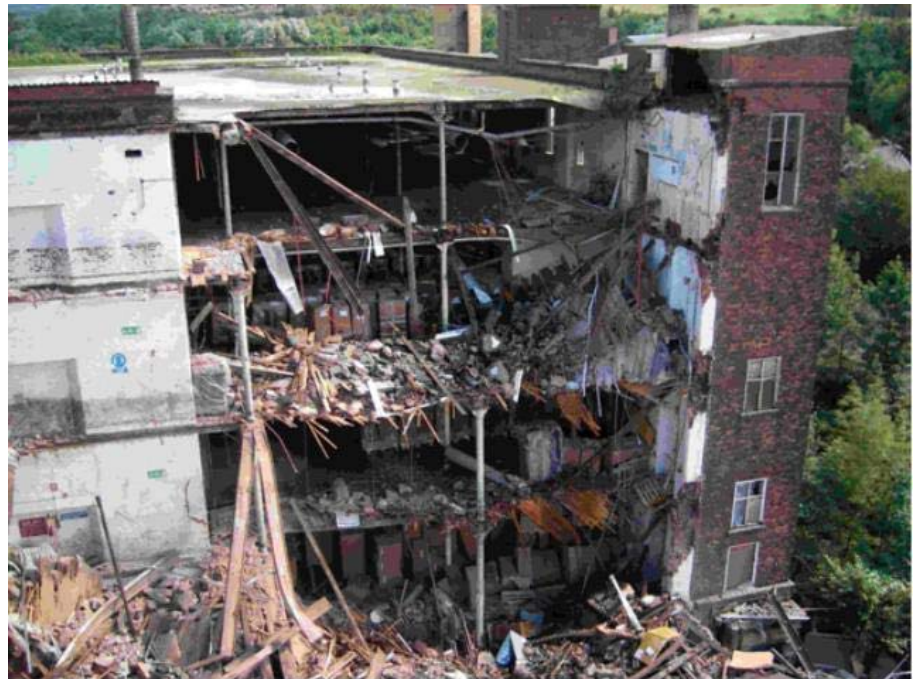
Nearby families were evacuated after part of a four-storey former mill building collapsed adjacent to their homes. Residents reported hearing a sound like a heavy goods train as the building fell. The mill was used for storage and was about to be converted into residential apartments. The reporter said that the construction was typical of 19<sup>th</sup> century mills with brickwork interior walls, cast iron columns and filler joist floors. It is thought that the sudden collapse was initiated by the failure of one of the columns.

**CROSS comments:** *This is a classic example of progressive collapse following the removal of a single element. It happened suddenly and apparently without warning and it was fortunate that nobody was inside and the debris did not hit the nearby houses. See below for more general comments on such buildings. (Report 121)*

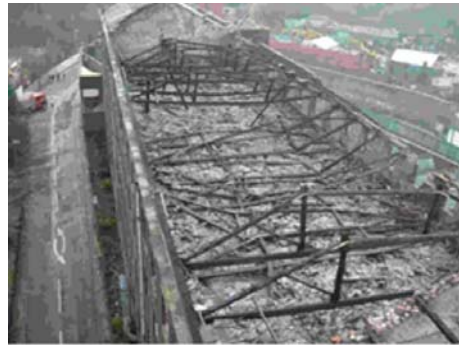
The second report concerns the unexpected collapse following a fire of part of a twenty-five bay, five storey mill dating from around 1830. It had external masonry walls and internal cast iron columns with brick arch floors on cast iron beams. The original part had concrete floors whilst a later addition, abutting the original with straight vertical joints in the walls, had timber floors. The floor beams were tied with rods at the level of the arch soffit. There was a stone clad roof on timber truss roof supports. It is believed that the seat of the fire was at the base of a lift shaft which then travelled up the shaft and took hold of the roof structure. By the time the fire had been controlled the roof had collapsed and sections of the parapet had fallen on the front and rear elevations.

*Roof after fire damage*

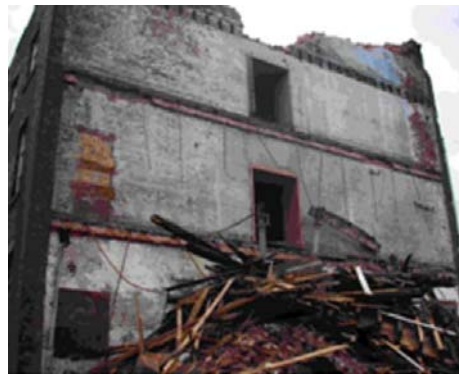
storey section. The straight joint in the masonry walls probably contributed to the sudden collapse. Onlookers, including the reporter, were surprised by the speed and extent of the collapse. Although no one was injured there was considerable damage to neighbouring houses.

*Collapsed section*

**CROSS comments:** *This is a case of progressive failure in which an impact on the top floor of a typical mill structure dating from the 19th century resulted in the cascading collapse of 5 storeys. Whilst the fire caused the initial problems there is no indication that it had weakened the part that fell. Whilst the collapse was initiated by the attempt to reduce the height of the unrestrained gable if this had not been done it could have failed in any event from wind, and the subsequent collapse could have had potentially fatal consequences.*

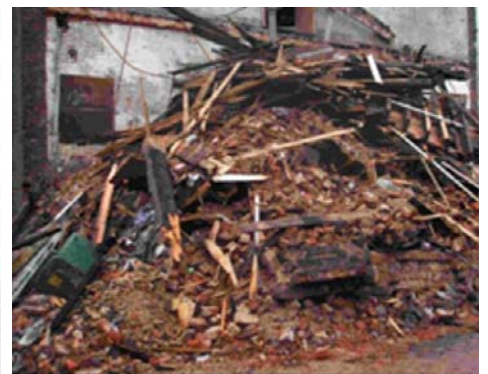
*Resulting debris*

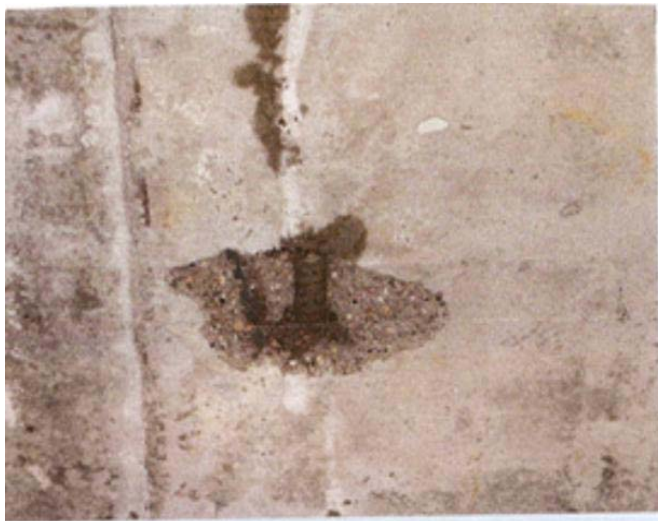
Pre-stressing in concrete has been used in bridges and heavy civil structures for many years and more recently in buildings. A reporter has come across a situation where during grouting of the ducts in a slab, patches of concrete as big as 0.5m x 1m and 30mm thick fell on to the ground creating a safety hazard. Investigation showed that the main reasons for falling patches of concrete were combinations of the following:

- 1) During grout the pressure was not monitored at the delivery end and entry end into the duct and higher pressures than normal were used.
- 2) The grout was expanding very quickly - more than that which was specified.
- 3) The ambient temperature was low during grouting.
- 4) Water found its way into the lowest points of the duct during rain and eventually froze resulting in partial ice expansion.

Soffit of slab showing pre-stressing duct

**CROSS comments:** Grouting of pre-stressing ducts requires careful workmanship and supervision. Recent investigations have revealed the likelihood of a lack of properly grouted ducts in some buildings. One method of minimising the risks is to ensure that post tensioning installation is only carried out by properly trained teams, for example those certified for PT installation through the UK CARES certification Scheme. It should be noted that point 4 above (water ingress and freezing) can occur in completed structures where grouting has not been properly executed. An excellent guide on procedures and techniques is given in the CARES note distributed in June 2008 and now put on their web site: ([www.ukcares.co.uk/PDF/CARES\\_Post-Tension%20Leaflet.pdf](http://www.ukcares.co.uk/PDF/CARES_Post-Tension%20Leaflet.pdf)). Reference is made to the need for project specific reviews and advice is given for new structures. (Report 089)
