Confidential Reporting on Structural Safety

Newsletter No 14, April 2009

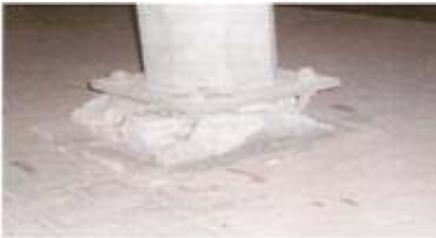
An overseas reporter says that majority of street light poles and advertisement board bases in his location are not constructed to the proper standard of safe practice for structural engineering and this creates a potential source of accidents. Errors include inadequate minimum edge distance between concrete face and bolt centres, no grout between base plate and foundations, and no protection to the bolts and base plates. The reporter believes these could affect the safety of road users.

improperly installed and damaged base

CROSS comments: *Design and construction standards for new street lighting columns have been in use for several years, but older structures still exist and it is probably these which are the subject of UK press reports. In one town more than 500 lamp-posts were deemed to be unsafe and a survey of lamp-posts in another found that they were suffering "structural failure", where more than half have been eroded by rain and dogs. SCOSS drew attention to the problems of aging lighting columns in section 3.6 of their [Report 12](#) in 1999. Ten percent of the 6.5m lighting columns in the UK were estimated to be in urgent need of repair or replacement. Steel columns can suffer from fatigue due to wind oscillation, and by the seaside even galvanised post have a very finite life. Corroded lamp posts in particular pose a big risk if they are hit by a vehicle and potentially unsafe columns should be reported to local authority Highways Departments. (Reports 098 and 114)*

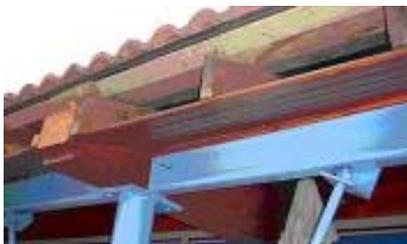
end grain of rafters

inadequate nailing

A section of pressed steel gutter and plywood fascia board at a school collapsed during or after a heavy rainstorm. The reporter believes that it had been in service for 15 to 20 years. He understands that staff and pupils had walked beneath the failed gutter just minutes before its collapse, narrowly avoiding a serious accident. The gutter was about 200 mm wide x 250 mm deep. He believes that the down pipe may have become blocked, allowing the gutter to fill during heavy rain. The method of fixing the gutter and plywood fascia board was simply by nailing into the end grain of the rafters, which are at 600 mm centres. Inspection by the reporter revealed that there was no other support. BS 5268 cl 6.4.4.3 states that 'no withdrawal load should be carried by a nail driven into the end grain of timber'. He therefore regards this fixing detail as inadequate and potentially dangerous and is concerned that the detail might have been used on other institutional buildings.

CROSS comments: *CROSS has previously had reports concerning failures at schools including a brickwork cladding panel collapse (Report No 078 Newsletter No 8, October 2007), and the collapse of internal wall due to wind load during construction (Report No 099 Newsletter No 10, April 2008). This is another example of a collapse that could have had tragic consequences and the question might be raised as to whether the standards at schools differ from those in other buildings. Apparently trivial details may not receive proper engineering attention but are nevertheless vital. All building work needs to be 'robust'. (Report 137)*

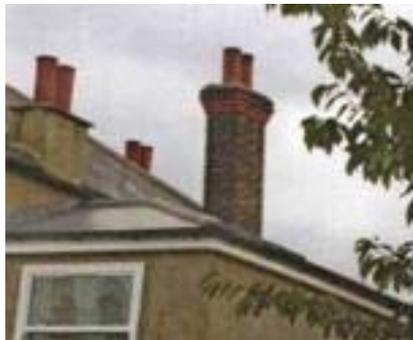
During the refurbishment of an Edwardian single family dwelling a reporter found that the supporting chimney breasts had been removed and replaced with inadequate gallows brackets in the roof space above eaves level. The substantial 2.5m high chimney stack was left almost unsupported and in a potentially dangerous state.

unsupported chimney

CROSS comments: *Many building control officers will be familiar with cases such as this where the structural significance of a masonry component has been ignored and there is a risk of consequential collapse. Deterioration of the exposed mortar over time, high wind loads, or even a very minor seismic shock could topple the chimney and deposit several tonnes of debris into the house. This illustrates the need for competence and supports the view that any structural alteration works should be assessed by a structural engineer. (Report 131)*

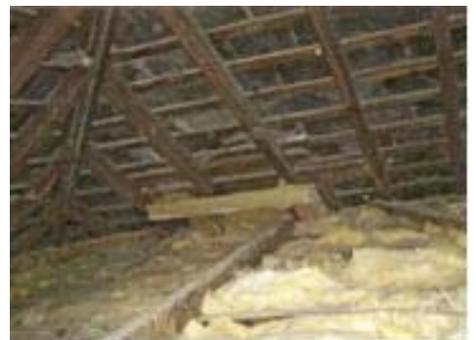
roof space with chimney breast removed
