CROSS

Confidential Reporting on Structural Safety

Newsletter No 15, July 2009

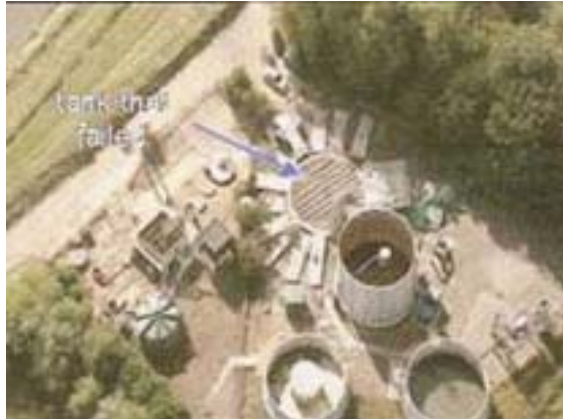
A utility company suffered a sudden and catastrophic failure of a concrete tank at a sewage treatment works. The tank was constructed from pre-cast concrete panels which were pre-stressed with circumferential un-bonded cables in grease filled sheaths. They have a large number of similar tanks. A photograph taken after the

collapse shows the concrete panels lying around the base in a star formation. All parties who have investigated this incident agree that the ultimate failure was caused by stress corrosion cracking, but it is not possible to say exactly what caused it. At some stage there was pressure water testing of the cable ducts which may have had an effect on subsequent performance. The design appears to rely on the grease and the sheathing to provide its corrosion protection, and it would not be expected that grease used for this purpose would emulsify in water. Tanks of this nature, which are built either above ground or partly buried, rely entirely on the tendons for their structural integrity. The utility company who own the facility therefore recommend erring on the side of caution and do not recommend the use of such tanks unless a system of protecting the cables from corrosion is in place and the possible influence of the grease is clarified.

CROSS comments: Failures with unresolved causes are difficult to give advice on and this warning by the utility company should be taken seriously by owners, designers, and suppliers of such tanks. Of particular concern are failures which may be generic but not display signs of distress before collapse. CROSS would be very interested in hearing of similar concerns. (Report 147)
