Confidential Reporting on Structural Safety

Newsletter No 18, April 2010

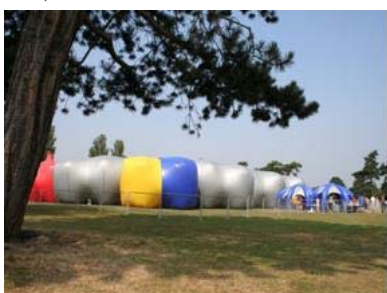
He then instructed staff to add additional ropes and anchors, and to possibly reposition some of the existing ties, to the front and along one side of the structure. Many of the ropes were weakened by knots and the methods used to secure the pods. Later that afternoon a gust of wind from the rear corner caused the structure to break free from the moorings and rise into the air.

The flight of the structure was stopped only by it colliding with a CCTV pole and deflating. Had this not happened with the direction of travel it is very likely the structure would have gone into a nearby river. As a result of the incident, two women were killed and 27 other persons were seriously injured.

The installation pre-collapse

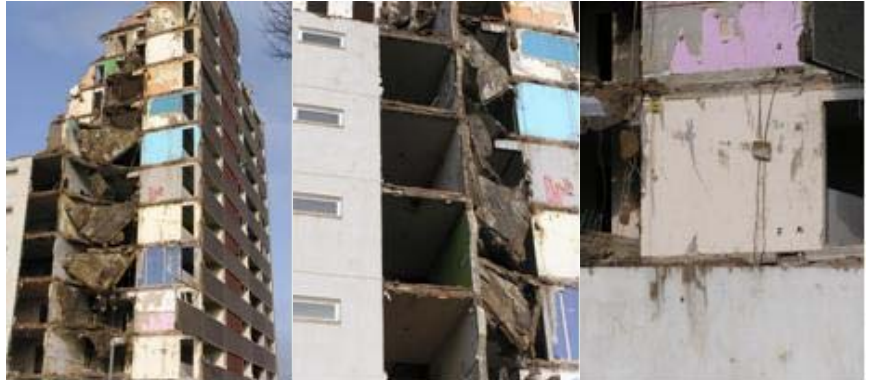
client to determine a methodology and control measures for the demolition of the second block in early 2010. After taking down three or four storeys in one corner there was an uncontrolled collapse affecting the complete corner bay over its remaining height. Of considerable concern was the very clean shear failure across the slab/cross wall panel junction indicating a significant lack of connection (mechanical tying) between floor panels and the cross walls forming the structural cells. At the time of the initial collapse the engineers focused on the method and quality of erection.

However this second collapse, and the nature of the failure experienced on both occasions, led to concerns about the integrity of the system as a whole.

Photographs of the collapse of the second LPS block

The lack of adequate ties between walls and floors and between adjacent floor panels shown in the photographs here means that the buildings would not comply with current Building Regulation A3, but at the time of construction the need for horizontal and vertical tying through mechanical anchorages, or other suitable measures, was not appreciated. SCOSS, along with others, will be further reviewing robustness in large buildings

The reporter says that anyone considering the demolition of this type of structure should take measures to determine their ability to resist demolition forces, and ensure that the safety of those involved, or potentially affected, is protected.

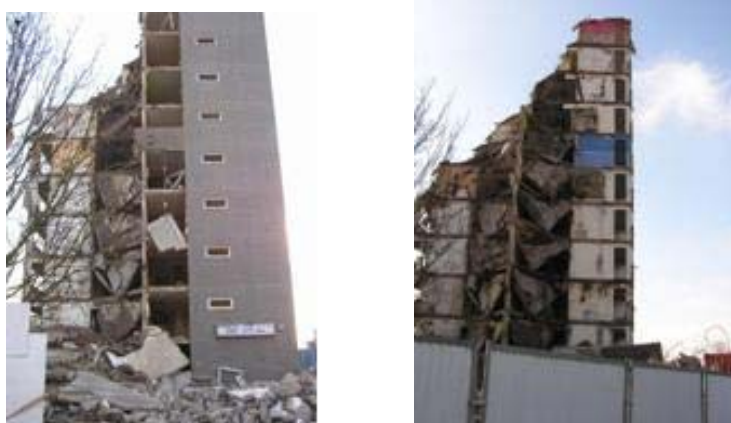
A short time afterwards the reporter sent CROSS an update on the collapse of a third identical block. Since the second collapse safety measures had included bolting angle connectors between the floor to wall connections across two bays of the structure closest to the neighbouring houses. Demolition began at the end of the structure which had been reinforced, and this bay was successfully reduced to ground level. The rig then started on the adjoining unreinforced area at which point nine floors collapsed. On another section of the block there was a further collapse affecting eight storeys. As can be seen from the photographs the collapses have left almost clean shear planes at the wall panel/floor slab connections. There was more evidence here than was present in the previous cases of a lack of continuity between panels. These identically constructed blocks (pre Ronan Point) had been built by the same direct labour organisation at around the same date.

Photographs of the collapse of the third LPS block

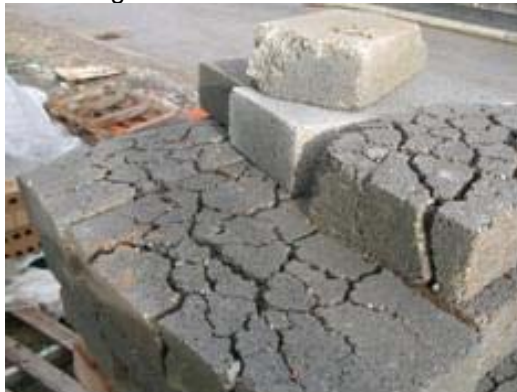
deep foundations to the internal walls of two of the houses. The blocks used in the retaining wall were showing the same problem as seen in the initial job. The image is of one of the remaining pallets on site illustrating blocks that have been soaked after a period of wet weather.

Cracked concrete blocks

CROSS comments: *This looks like a severe case of reactive aggregates where blocks are completely breaking up. This type of progressive cracking can occur when there is a high moisture contents (e.g. blocks get wet on site during storage or in a partially constructed situation). It emphasises the point of procuring blocks (and other materials) that comply with British Standards from a manufacturer who can give a quality assured history of the product and its constituents. Once built in it is very difficult to rectify these situations. The standards which apply depend upon the application for which the blocks are to be used. CROSS is keen to hear of similar examples in order that a broader picture may be established.*
