CROSS

Confidential Reporting on Structural Safety

Newsletter No 19, July 2010

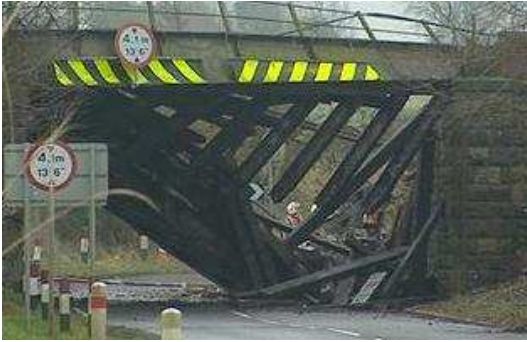
Network Rail bridge collapse (Report 187)

A train carrying kerosene, gas oil and diesel, came off the rails south of Stewarton on 27 January 2009. Six of the 10 wagons came off the rails during the incident and some caught fire. Power lines were also brought down and the nearby A735 was closed. It took the emergency services several hours to bring the fire under control. The resultant leakage of fuel contaminated local waterways, causing harm to wildlife. The Rail Accident Investigation Branch said corrosion in the bridge's girders meant it could not support heavy loads and criticised Network Rail's maintenance regime for the bridge saying corrosion went unidentified.

The report states: "The immediate cause of the derailment was the collapse of the bridge that followed the catastrophic structural failure of its east and centre main girders. Heavy corrosion had so significantly weakened these main girders that they were no longer able to carry the loading from trains that were permitted to run over the bridge." It further states that "no arrangements had been made to inspect the hidden parts of the east and centre main girders" where the heavy corrosion had occurred. Corroded parts of the bridge were "not fully repaired" when the bridge was waterproofed in 1987. The report also states that the bridge superstructure was not re-painted when the waterproofing work was done, or afterwards. The operator of Britain's rail infrastructure is also urged to improve its "methods and processes for the examination of hidden critical parts of structures" and its management of the information used for making decisions about the structural safety of its bridges.

Network Rail said that since the crash it had carried out inspections on 575 bridges of similar design throughout the UK - 129 of which were in Scotland. No bridges have been found in a condition similar to that of the bridge at Stewarton. "As a result of this incident, we have reviewed the way we examine bridges of a similar style." "We have made changes to our inspection procedures so that bridge inspectors are required to expose hidden critical elements of the bridge during examination."

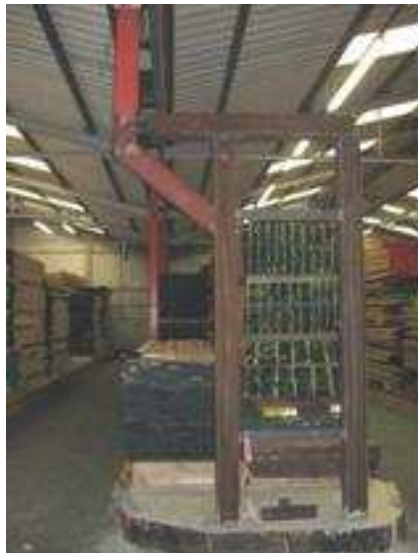
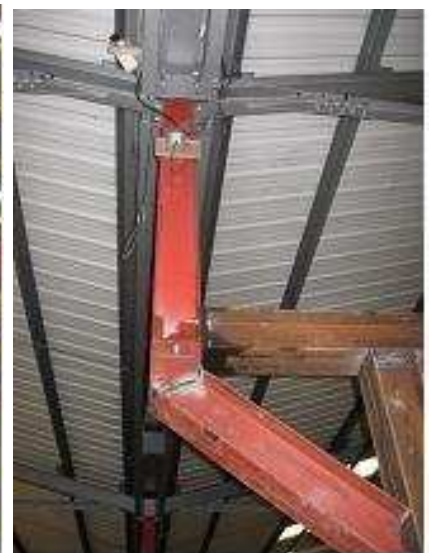
DANGEROUS MODIFICATION TO A COLUMN (Report 169)

A reporter was requested to visit a warehouse to inspect work carried out to a column that was constantly being hit by a fork truck. The Client had commissioned a 'design & build' contractor to remove the lower section of the column and support the higher section out of the path of the forklift with a cantilever. The Client was concerned that the work 'did not look right'. The photographs show the work that was carried out. The reporter spoke to the builder who confirmed that no calculations or detailed drawings had been prepared for the scheme. The new posts were merely resin anchored to the floor slab of the warehouse and covered with 200mm of unreinforced concrete. The bolt holes did not line through and some bolts were at an angle between members. Welds were of varying quality and all work was carried out on site, i.e. no shop fabrication. The most worrying fact was that there was no temporary propping to the column despite the works not being complete according to the builder. It was also learnt that Building Control were not informed of the proposed column removal. The reporter advised the Client to have temporary props installed immediately.

CROSS comments: *Building owners must be mindful of their responsibilities in ensuring that the work they are commissioning is undertaken by competent persons and that the necessary approvals are in place. It appears here that the Client has not appointed a competent contractor and/or designer who complied with CDM regulations. However a lay client cannot be expected to know this, which is why contractors are obligated to inform them, and some "design and build" contractors appear to be reluctant to use engineers except when a building control officer asks for calculations. Unauthorised work can be reported to a local authorities building control section and the authority may be able to prosecute the builder for failure to give notice particularly if the builder is known to them as a repeat offender.*

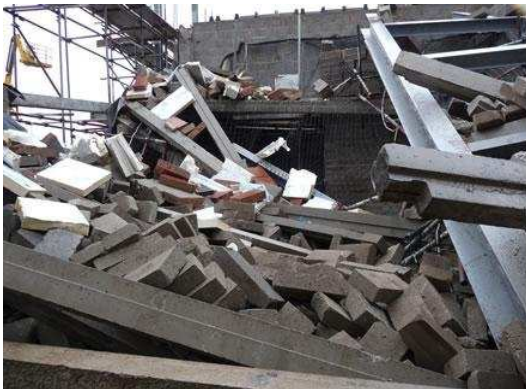
Fines totalling £7,000 have been issued after part of an office block that was under construction collapsed, seriously injuring a worker. The Health and Safety Executive (HSE) prosecuted the building's designer and the principal contractor. A Magistrates' Court heard that emergency services, including a county Fire and Rescue Service's major incident unit, were called to the scene in 2008. The HSE investigation found that a concrete block pillar, used to support the first and second floors, had been resting on the ground floor instead of going down into the foundations.

Part of the collapsed office block

“One of the workers' legs was badly broken after the rubble fell on him, but the consequences could have been much worse. This was a basic error which should have been spotted by both the building's designer and the principal contractor. It is common sense that the pillar supporting the floors should have gone into the foundations, and not just rested on the floor below. It is vital that companies learn lessons from this to prevent similar incidents happening in the future.”

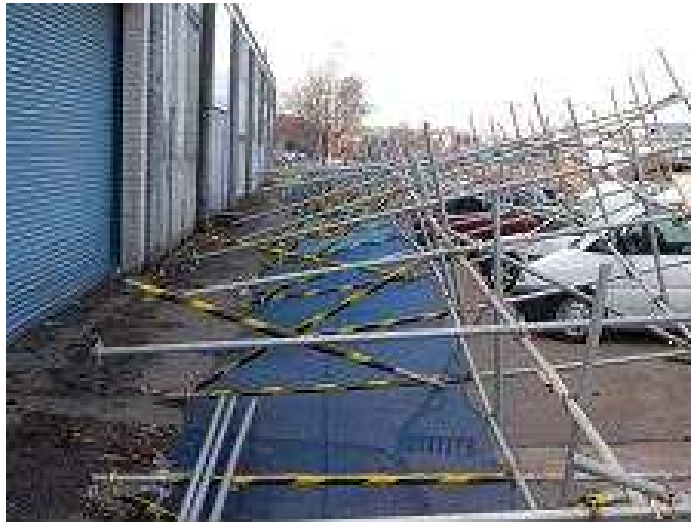
SCAFFOLD COLLAPSE AND SLIPPING CLIPS (Report 152)

This photograph has been sent in by a reporter and shows a scaffold that collapsed onto a parking area. Luckily, he says, only 11 vehicles were damaged, and no people were injured. The scaffolder's sign board apparently vanished fairly quickly thereafter. The reporter notes that front to back diagonals and horizontals are offset by half a bay and that the horizontal members are held with putlog clips only. The diagonals and some verticals were wrapped in polythene before the clips were put in place which then appear to have slipped.

CROSS comments: *In a similar case a scaffolding company failed to take sufficient care to protect public when working in a city centre after a pole fell and gashed the leg of a pedestrian. The company was fined a total of £4,000 and ordered to pay costs after pleading guilty to breaches of the Work at Height Regulations 2005 and the Management of Health and Safety at Work Regulations 1999. The scaffolding had been erected on a pavement that had not been closed or restricted, allowing pedestrians to pass by it. Scaffolding should comply with BS EN12811-1, by following the National Access & Scaffolding Confederation, Technical Guidance, TG20:08, Volumes 1 and 2. This case is a reminder of the need to:*

- Appoint competent scaffolders
- Ensure that scaffolds are designed and built to industry standards, for example TG20
- Inspect scaffolds properly
- Plan and supervise their use
