# CROSS

## Confidential Reporting on Structural Safety

Newsletter No 22, April 2011

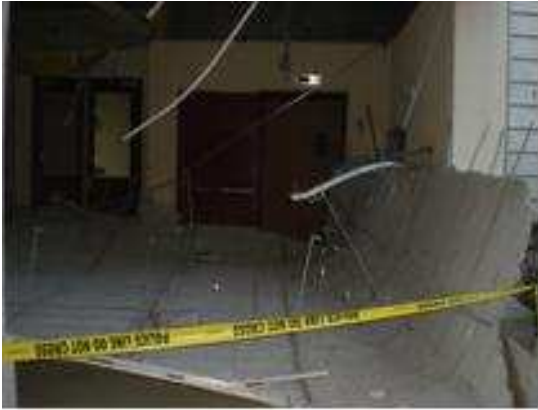
Investigators have determined what caused a 4,000-pound ceiling to collapse in an accident at a university campus in the USA. Engineers concluded that ceiling suspension anchors were not sufficiently embedded in the concrete structure, and suspension wires were not uniformly tensioned. The flaws caused an unequal load in the ceiling, which led to progressive failure of the suspension system. No one was injured when the 500-square-foot ceiling, one of several steel-supported plaster-and-concrete structures covering open-air lobby areas at the building, crashed to the ground. The full report of the investigation into the cause of the collapse can be found at:

The collapsed ceiling

**CROSS Comments:** CROSS Newsletters published a series of reports on ceiling failures including one very similar to this where a cascade failure had taken place initiated by pull out of a single ceiling anchor. As both reports highlight, ceilings are not necessarily flimsy items and proper precautions against all failures are required. Looking at the generic nature of the collapses it would suggest a) that all ceiling designs should include a check for a progressive collapse mode b) all design should account for potential uneven loading onto ties c) site installation should include QA/QC of the anchor fixings to assure that as-installed, capacity matches design assumptions. To access similar reports enter "ceiling" in the [Quick Search](#) box on the web site.
