CROSS

Confidential Reporting on Structural Safety

NEWSLETTER No 25, JANUARY 2012

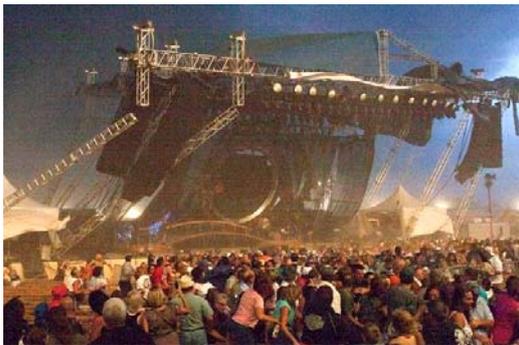
Collapse at Indiana State Fair August 2011
(Joey Foley/Getty Images)

- *Sugarland Concert Indiana August 2011 – main stage roof collapse with 6 fatalities and 44 injured*
- *Flaming Lips Concert Oklahoma August 2011 – large video screen collapse*

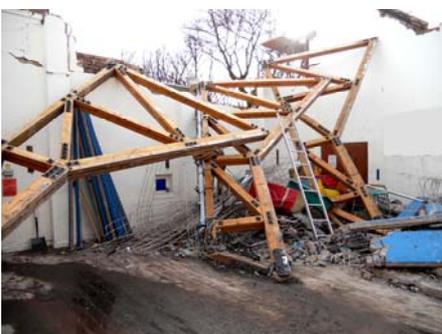
A gym/assembly hall roof to a school collapsed suddenly and without warning overnight when, fortunately the building was unoccupied. The building dates from the early 1960's and, in the view of the reporter, the collapse was due to a failure of the mid-span splice connections in the top and bottom chords of the bolted timber trusses which span the length of the hall (approximately 12m). The roof is flat over two thirds of its length but slopes upwards at 45 degrees at one end. A subsequent analysis of the trusses confirmed that the design complies with the Codes of Practice around at the time of construction, namely CP 112 (1952) and CP 3 (1952). However CP3 did not require the designer to consider the effects of snow drift loading. When snow drift loading is considered in the analysis, the mid-span splice connections to the top and bottom chord members are overstressed and this appears to be the reason for the failure. There was no snow on the roof at the time of the collapse. However during the previous winter the region where the building was located had experienced what is considered to be the heaviest and most prolonged period of snow fall for many decades. It is the reporter's opinion that this caused damage to the timber, causing it to split at the mid-span splice connections. High winds during the winter may have exacerbated the problem. There is significant damage to both top and bottom chord splice connections. The

School roof collapse

reporter believes that the bottom chord splice failed first. The damage to the top chord appears more dispersed and 'collateral' in nature. The reporter's concern is that any roofs of a similar period supported by bolted timber trusses and designed using the imposed load criteria of CP3 could be vulnerable if the shape of the roof is such that significant snow drift loading can occur.

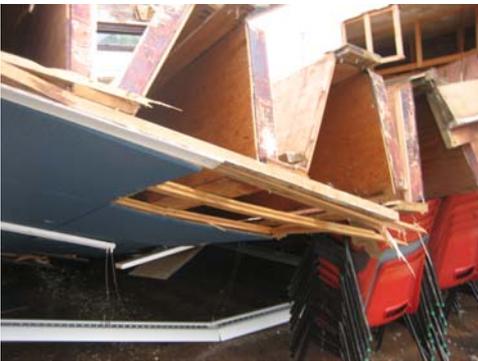
Collapse of Timber Roof

We were called, says a reporter, to investigate the collapse of a roof spanning 8m over a hall which was fortunately unoccupied and no one was hurt. The roof was constructed in 1959, and formed from a ply-web beam system, with hardboard ceiling and ply deck and asphalt covering. The asphalt had been felted, and then a further layer of insulation and felt applied. The roof had a parapet wall running around it, 100 to 150mm high, with internal rainwater outlets. There was evidence of ponding at one of the outlets and a lot of water was on the roof at the time of the collapse. Apart from creaking of the roof 15 minutes before the collapse, there was no warning. The roof was a proprietary system, which relied for support on end bearers glued and nailed to end stiffeners in the webs. The bearers sat on narrow ledges. This requires highly accurate construction of the supports; however, the failure mechanism in this case appears to be complete debonding of the end stiffeners and ply deck at one end, resulting in sudden shear failure. The end detail was a standard arrangement, as an alternative to sitting the beams directly on the supports. The system seems to have been used from 1953 or 1954 onwards and continued for at least 5 years (when the hall was built). The system is noted as a patented design in the 1976 version of the timber designers manual so may have been used for considerably longer. The system was used for walls, floors and roofs in a wide variety of buildings. The manufacturer however went out of business some years ago. Spans varied from 15ft to 42ft (4.57m to 12.80m). Decks at particular risk of this type of failure, believes the reporter, (until the end supports are verified) will include floor beams, decks with trimmed openings and roofs up to 9.1m span, (longer decks are less likely to have the end board detail but may still be subject to other types of failure, particularly in warm, humid environments). The only mechanical fastenings between the stiffeners and the web were small diameter nails, effectively panel pins, 3 or 4 each side, which he believes were only intended to provide gluing pressure for the joint. All such units with an end bearer detail should be regarded as dangerous and there may be hundreds in use. To identify these components a small hole and inspection with a boroscope would hopefully

be enough as the members are quite distinctive, with their inclined webs, but these of course may be hidden by ceilings. Figures show the aftermath of the collapse, an exploded view of the form of construction, and a side view drawing of the bearing.

This report raises a number of issues: water ponding as a result of blocked outlets which cannot be seen from ground level, deterioration of timber (and glued components) arising from wetting conditions through water ingress, and possibly details associated with the bearing such as the bearing length. At the time of construction such plywood box beams were either structurally glued or structurally nailed. If structurally glued then tacking nails were used to hold the assembly together while the glue cured. After curing the nails were redundant and not considered in the design. In structurally nailed assemblies there was a designed dense nailing pattern along flanges and down stiffeners and 11 gauge galvanised nails were commonly used. The glues that were typically used are water resistant if applied correctly and plywood web beams were good structural elements provided that manufacture and construction practice was controlled. It may be that the design and construction were satisfactory but that a lack of maintenance allowed rainwater ingress to occur. This could have affected the timber at the glueline, or the failure may have been related to support conditions, or it could have been a combination of the two. Whatever the cause this is a potentially serious issue and possibly there ought to be a requirement in building management to periodically check long span roofs. As suggested by the reporter the use of a boroscope could be helpful when assessing conditions at bearings. In the section on robustness in Approved Document A there is a clear indication of higher risk when the consequences of failure are multiple injuries. In this case, and that of report 242 (above in Newsletter No 25) there were long span roofs over school halls where the risk of injury could be very high. There have been previous examples of roof failures in schools which prompted large scale investigations. In 1973 at Camden School the beams made from concrete containing high alumina collapsed and many similar structures were checked and some strengthened: see [Question on high alumina cement](#). In 1976 the timber roof over the gymnasium at Rock Ferry School collapsed again resulting in widespread checks of such structures. For example see [The Structural Engineer volume 78, Issue 1, A Century of Innovation: Structural Engineering 1900 - 2000](#).
