CROSS

Confidential Reporting on Structural Safety

NEWSLETTER No 26, APRIL 2012

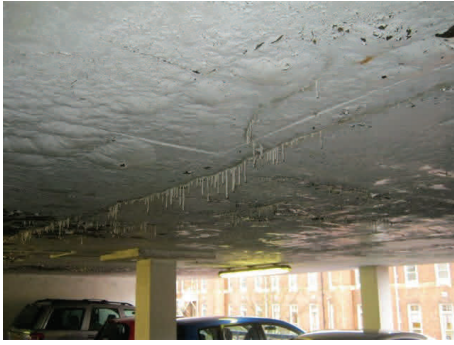
Soffit deterioration

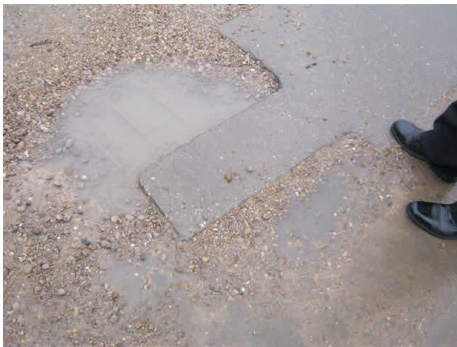
Surface break up

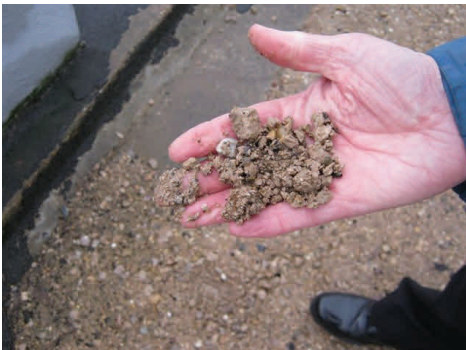
Loose aggregate on surface

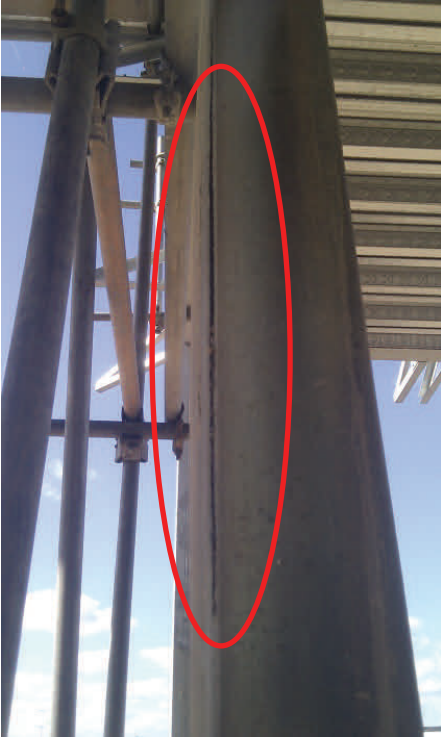
At a construction site a number of ground floor RHS columns had split vertically. The columns were 120 x 120 x 5.0 Hot-Rolled Square Hollow Sections and part of a single-storey section of a new complex. The construction was only partially complete and included the profiled metal deck roof and in situ concrete slab only, and possibly some nominal construction live loading. The design was checked and found to be

Report 253: Split RHS due to freezing

satisfactory and the failure mode did not follow the expected Euler buckling shape for compressive forces. The sections are galvanised and holes had been left in the cap plates for drainage as part of the galvanising process. These had been left exposed to the elements prior to concreting. The reporter suspected that water had come in through the holes and filled the hollow sections, and that this had then frozen to exert a significant bursting pressure sufficient to split the steel along one corner, (not at the weld position). Holes were drilled through the columns near to the base and proved this theory as water jetted out under pressure (see photo). This could have gone undetected if the weather had not been sufficiently cold to freeze the water within the columns, but could have occurred at a later date following completion of the building with greater consequences.

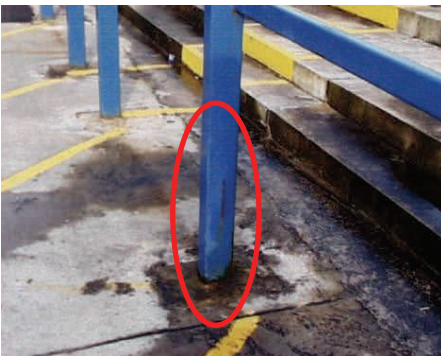
SCOSS Biennial report 2001:
Split RHS due to freezing

The [SCOSS biennial report](#) for 2001 included a case where barrier posts had filled with water that had caused the damage on freezing in winter. The barrier structures were only 4-5 years old and made of RHS sections with fully welded joints and end plates. Visual inspection of the barriers showed no sign of any openings that would allow ingress of water (see photo). It appears that water can be drawn into tubular steel structures of this type by capillary action. The phenomenon has been experienced in other structures; such as roof trusses made from hollow steel sections, and welded box girders. Although the structural elements are manufactured as 'sealed units', continuous welding does not necessarily produce a complete seal and water may accumulate inside where the units are exposed to the weather. Research into the phenomenon in Canada has shown that a partial vacuum caused when a relatively warm, imperfectly sealed steel tube is rapidly cooled by rainwater, can draw in water through very small cracks and holes. Over a period of time this can result in a considerable build-up of water trapped inside. Where such a steel tube forms a structural element that is exposed to the weather, the trapped water may freeze in winter. The element may thus be damaged as it fails to restrain the expansive action of ice formation. The resulting bulging and/or splitting may reduce the load-carrying capacity of the element substantially, thereby undermining the safety of the structure. SCOSS draws attention to this reported experience because tubular or other 'sealed' steel elements in crush barriers; bridge parapets and other structures may be similarly affected. The phenomenon may exist elsewhere even though it has not yet progressed to the point where bulging and/or splitting has become visible. The presence of water cannot be detected merely by an external visual inspection until damage occurs. Inspecting engineers should be aware of this possibility and, where appropriate, consider specific investigation. For the damaged crush barriers, the reported remedy was to repair and replace damaged posts and to make drain holes just above ground level to allow water to scape. A boroscope inspection through the drain holes enabled the internal condition of the posts to be checked for corrosion. More generally for tubular steel structures exposed to the weather and in unheated buildings, the report on the Canadian research advised either complete weld seals free from porosity or, the provision of some form of drainage with periodic inspection of drain holes to ensure they do not become blocked. Provision of holes also prevents the development of partial vacuum in the units and can also enable beneficial ventilation of the internal voids. Similar problems have been found on highway structures with water ingress into 'so called' sealed steel sections used as gantry legs when there were freeze/thaw splits, and relieving holes had to be drilled and repairs carried out.
