Confidential Reporting on Structural Safety

NEWSLETTER No 32, OCTOBER 2013

395 PARTIAL ROOF COLLAPSE AT SHOPPING CENTRE

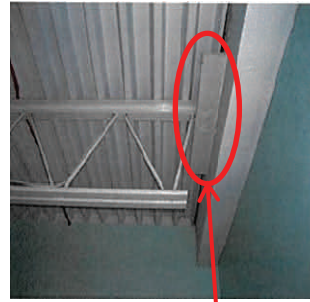
Typical connection: cleat bolted to beam and top flange of truss rests on cleat

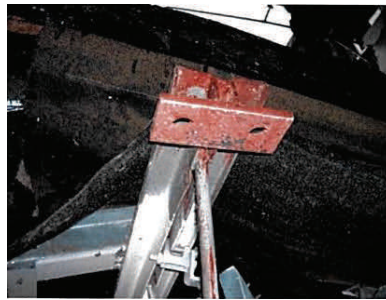
End fixing of truss to cleat

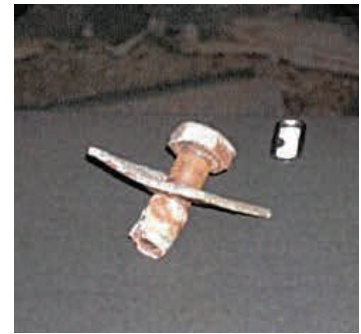
Failed bolt with part of shield still in place

The building is of reinforced concrete construction, with columns supporting a grid of beams at roof level, which support the flat roof construction over shop units and a mall. The flat roof had a mineral felt weathering, on insulation board, on profiled metal decking. The metal decking spanned between steel lattice trusses, which themselves spanned between the reinforced concrete beams at roof level. The lattice girders were connected to the high level RC beams via a top flange bearing plate which was bolted to an angle cleat (bolts 'B') which was in turn bolted to the RC beams by bolts 'A'. The arrangement is shown in the photographs and the diagrammatic section. It was clear that some of the bolts used to secure the angle cleats to the RC beams (bolts 'A') had failed in tension. They appeared to have been pulled out of the concrete. A closer inspection of some bolts which were found in the debris showed that the bolts which had failed ("Drop-In Wedge Anchors" — manufacturer unknown) had done so

within the shield of the anchor, within the embedded depth of the bolts. The threaded steel shields were later found to be no more than 1.6mm in thickness. The reporter did not see any evidence of corrosion, but was surprised at how thin the walls of the shells were. It appeared that it is most likely that the failure occurred as a chain reaction when a single bolt, or group of bolts at a connection failed (4 No bolts 'A' per connection). It was clear to see that the failure started in one corner, where the bolt shells had failed in tension. But further along, where the support cleats were still in position on the RC beam, the fixing bolts 'B' between the lattice girders and the cleats had failed in shear as the roof collapsed. The collapse followed a significant period of heavy rainfall. The fall of the roof towards rainwater outlets (which would dictate the "deep end" for any ponding water) should have accumulated more loading and possibly cause failure at that end if the outlets were blocked or flow restricted. However this was not the case and failure occurred at the "shallow end", the opposite end to the outlets. Remedial works to enhance the loading capacity of all of these connections were necessary.

From the limited information available it is difficult to identify the cause of this failure which apparently originated at one fixing point and resulted in a progressive collapse. What was the force that caused them to fail? The bolts pulling out may be a symptom rather than the cause and the following comments are not an explanation of what happened here but reminders of the issues that can affect a fixing such as this. The bolts attach the angle to the concrete so carry shear but also tension due to the eccentricity of the truss bearing on the angle. If the roof had ponding water and the beam was deflecting the point of bearing would move towards the edge of the angle increasing the tension significantly, failure could then have been by combined shear and tension. Normally it is assumed that bolts 'A' are in shear only but if shimmed out too much they move into shear + bending and that makes a big difference. Bolts 'A' could also be levered out to some degree depending on whether the cleat is 'stiff' enough. Given there is only one line of bolts at B, there will be moment due to the eccentricity of load between B and the concrete face. These are secondary forces that may need to be considered. Another possible cause could be corrosion of the 1.6mm steel shield although the reporter did not notice any evidence of this. Sequential temperature changes over the years or a sudden change in temperature might have had an effect. It would be helpful if anyone else has experienced similar failures and has an explanation as to why the fixings have lasted for 30 years without obvious problems.
