# CROSS

## Confidential Reporting on Structural Safety

### NEWSLETTER No 33, JANUARY 2014

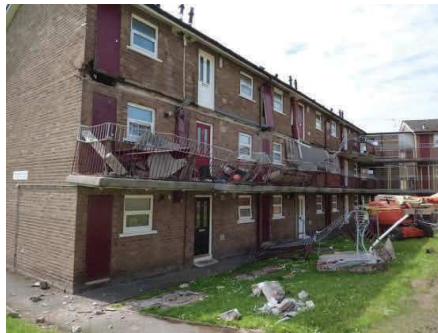
A reinforced concrete balcony collapsed at a block of flats which are believed to have been built in 1966. Fortunately no-one was injured. An HSE Construction Specialist Inspector found that the external balcony appeared to be a continuation of the floor slab and served as the residents' only access to their individual flats. It was approximately 150mm thick and cantilevered by approximately 1.3m. A majority of the reinforcement, just over 1/4in or 8mm approximately in diameter, was located in the bottom half of the slab (compression zone) and some of the reinforcement had next to no cover. The closest the reinforcement appeared to get to the tension zone was around the neutral axis. It would seem that the most likely reason for the collapse was the lack of reinforcement in the tension zone. However, the balcony had clearly managed to remain in place for the last 40 years or so, relying only on what little tension capacity was afforded by the unreinforced concrete. HSE have been advised that there are a number of other similar balconies in the area. These have now been propped and work is underway to assess whether they too are susceptible to a similar type of failure. Work is in hand to repair the balconies in a risk based priority order.

Fall of 2<sup>nd</sup> floor balcony onto 1<sup>st</sup> floor (reproduced with permission)

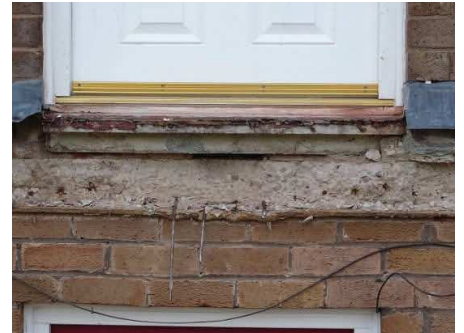
Rebar in the bottom of cantilever slab (reproduced with permission)

*It is not known why the bars were in the wrong face although they may have been placed correctly but without adequate support, and site operatives have walked on the bars and displaced them whilst placing concrete. Or perhaps there was a continuous shutter under the slab for the interior of the building and the balcony and no recognition that the last section was a cantilever. The bottom rebar for the interior span was simply carried on into the cantilever. In any event there was poor control on site and for reasons of quality and safety there has to be competent and resourced supervision. Since this case was brought to the attention of HSE there have been reports to them of other cases so the problem may be systemic.*

*Structural safety relies not just on adequate strength but also on controlling modes of failure such that they are ductile, benign and give warning of impending collapse. Rapid brittle failures of any kind are to be feared. No doubt this slab was mostly relying on tensile capacity of the concrete to survive, but even if that had been adequate, the slab would have been 'unsafe'. Great care is also required if percentages of rebar are small such that members have less bending capacity than they would have based on the tensile strength of the concrete. The danger is that under increasing load, the member fails at the higher moment and load transfer to rebar is so rapid it just snaps rendering it useless. The incident once again shows the importance of an experienced person just walking around sites and seeing that gross mistakes are avoided.*

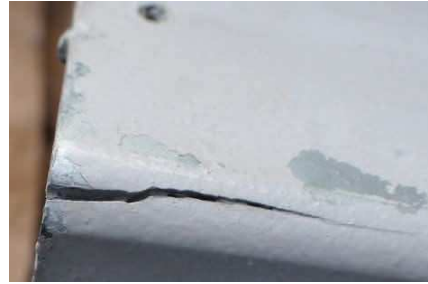
In CROSS Newsletter 26 there was an article (report 253) on *Freezing splits galvanised steel columns*. A reporter says that in the course of his work for a Warranty provider he was involved in correcting a cold formed galvanised SHS (120 X 120 X 5) 4 storey balcony structure which had longitudinal splits formed in at least two of 4 columns that supported these balconies. The issue was that SHS balcony support posts filled with water and then split on a cold night. This echoes very well the issue reported in 253. Sections of the SHS were assessed by an expert who indicated that some SHS, CHS and RHS members are susceptible to splitting under freezing water conditions dependent on thickness of tube and shape. Water entered the tubes through what appeared to be poorly designed or detailed spigot and socket joints which were not adequately sealed. The steelwork designers / fabricators / erectors and Contractor's staff had not realised the hazard and possibility of it causing a failure. The reporter and other Engineers involved had not seen the phenomenon before and initially there was unjustified concern over steel quality. The four columns were replaced and care was given to sealing the tubes to prevent water ingress in the future.

Longitudinal split (reproduced with permission)

*It is an eternal truth that water will get in anywhere and one solution is that it should be permitted to drain away. There have also been instances of similar problems on fairly small section motorway gantry legs where small holes and unsealed joints can lead to a differential pressure sucking moisture into the internal voids in steelwork. This was then frozen and thawed leading eventually to splitting. A positive venting system (a modest sized hole) low down has been successful in avoided this happening again. A paper entitled "Internal resistance to corrosion in steel hollow sections" by Michel Tourney, 2002, gives information about moisture in tubes with a number of examples of corrosion over time. Similar issues have been reported previously:*

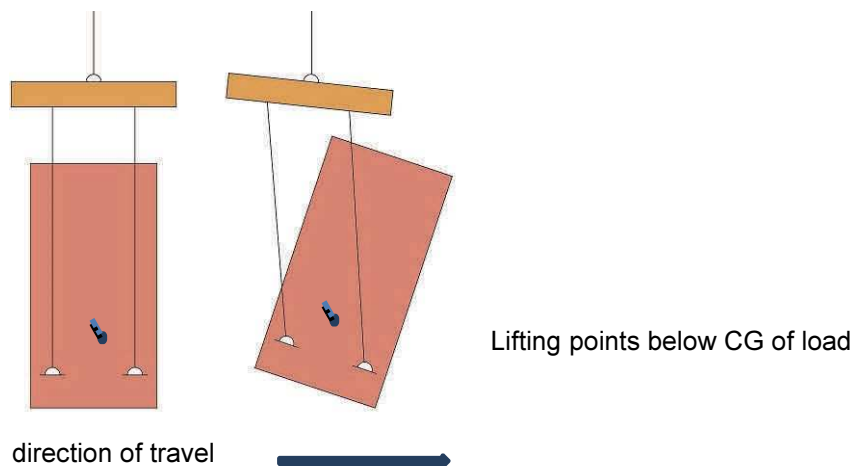
This relates to the lifting of an item of plant by a tower crane during which the load toppled from the slings causing considerable damage and delay. By chance serious injury was avoided. A lifting frame was positioned above the load with chains at each corner which were connected to the bottom of the load. The centre of gravity was above the base of the item of equipment and, as it was lifted, the item swayed sideways and fell through the chains until it was almost upside down. Whilst the capacity of the crane, the lifting frame, and the chains were entirely adequate for the load, the arrangement whereby the chains were attached below the centre of gravity of the item of plant was flawed. The point of application of the lift should have been above the centre of gravity of the item being lifted.

*A fundamental point is that the depicted lifting system is actually a mechanism. If the test of applying a horizontal load had been applied, and consideration given to displacement it would have been seen that the system was unstable. In all issues of robustness, if there is no obvious horizontal load (like wind) a notional load related to self-weight should be used and this will act through the centre of mass. As the reporter says, this system is then unstable. With temporary works a minimum horizontal load of 2.5% is used (BS5975). However designers might want to consider a higher load in the case of handling due to greater uncertainty of acceleration-induced loads (jerking), and probable uncertainty of the exact location of the centre of gravity.*
