SCOSS TOPIC PAPER

December 2014

Elliot Mall Inquiry

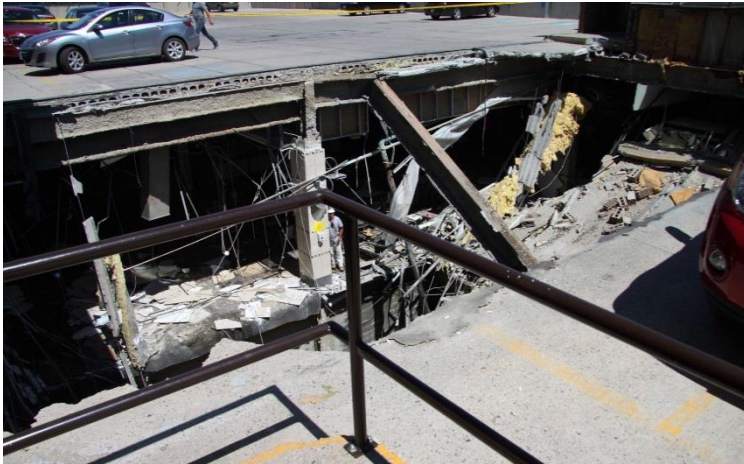
The collapsed roof structure

The Commission found that from day one the roof leaked and numerous attempts were made to fix it throughout the life of the building. Water found its way through joints, in between the slabs and the topping, onto the supporting steelwork, and into the retail units below. In winter the water contained de-icing salts. Over time the topping debonded in parts and there was significant corrosion of the structural steelwork.

Eventually there was a sudden collapse as a steel frame connection between a beam and a column failed and debris fell into the mall.

The lack of continuity and tying of planks to supports meant that when failure did occur there was no alternative mechanism. This issue is now covered in the *Practical guide to structural robustness and disproportionate collapse in buildings (2010)*⁽²⁾.
