CROSS

Confidential Reporting on Structural Safety

NEWSLETTER No 37, JANUARY 2015

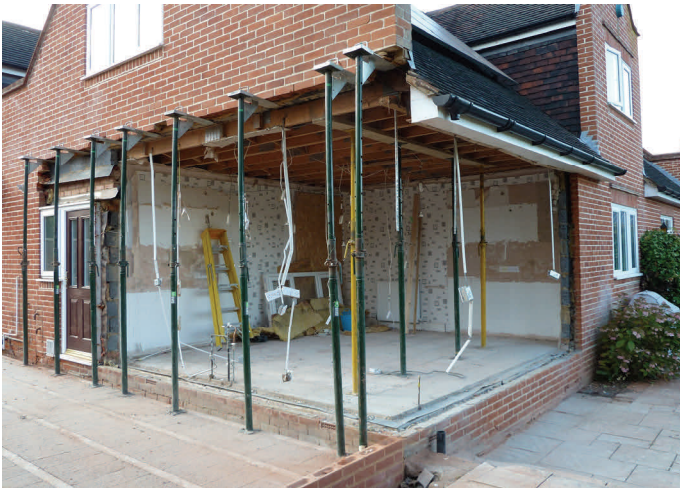
An alarming photograph has been sent by a contributor.

Many years ago BRE Good Building Guides contained an almost identical photograph as shown below. Clearly any disturbance of the props could result in collapse. If these props were erected by a householder, the individual was putting his own family’s lives at risk. If they were erected by a builder, the individual was at risk of a manslaughter charge and custodial sentence, should they have failed and caused death.

2014 photograph from a reporter

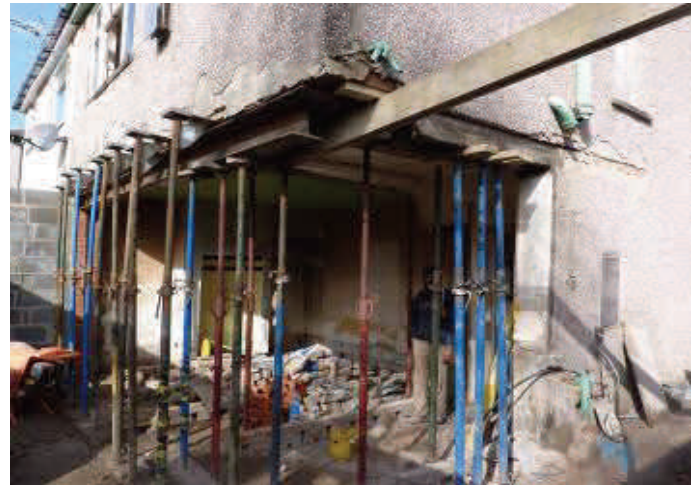
BRE Good building guide illustration
