CROSS

Confidential Reporting on Structural Safety

NEWSLETTER No 39, JULY 2015

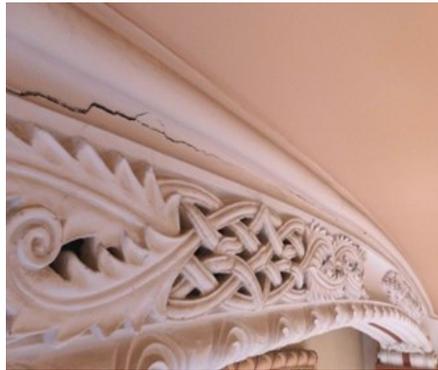
This recent report of a serious concern about an old fibrous plaster ceiling has similarities to the Apollo Theatre ceiling collapse in London in December 2013. In retrieving a helium party balloon, says the reporter, a crack was discovered in a down-standing feature arch in a local authority hall built circa 1926. On closer inspection this was a non-structural plaster trough section with ornate scroll features. The crack 6mm wide was present over 2/3rds of the span and occurred on both sides. Inspection from the roof space revealed a system of small timber battens (30x18mm) tied together with hessian “wadding” type rope with “balls” of plaster around the joints – no mechanical fixings. The assembly was suspended from timber joists by similar wadding rope wrapped around the joist. Many of the wadding ropes were snapped at various places around the loop. Sometimes this was hidden below the joist, at the side or on top, particularly if there were signs of past crawl boards having been placed upon the rope

or dragged over them. Where ties were intact, they could be snapped by finger pressure. Closer examination of the wadding rope showed a high volume of plaster in the cross section and upon crushing, the fibres were found to be interwoven confirming the origin of rolled cloth impregnated with plaster rather than preformed rope dipped in plaster. The hessian strings had fully degraded and could be pulled apart with light finger pressure. It is thought that complete collapse was averted by the arched shape of the trough section and that if the ceiling was flat, prior collapse would have occurred. The estimated dead load of the trough is 1.51kN/m (154kg/m) and it is 11m to the crown. Two other halls (with flat ceilings) were inspected and found to have down-stand architectural features with similar wadding ropes. Past reports have highlighted "Theatres" and there has been recent issue of the ABTT Guidance Note 20, by the Association of British Theatre Technicians (*see below*) but there must be many similar Public buildings including Council Chambers/meeting rooms, Town/Concert/Assembly Halls, School/University Buildings, and Stately Homes that are not specifically designated as a "Theatre" that may have circa 90 year old fibrous plaster ceilings. Clearly fully inspection of these ties is extremely difficult and in this case it was considered all ties were suspect (as all examined were) and alternative means of support were installed. The reporter hopes that his photos will help to pass on the message that these may be hazardous.

First crack to be spotted

This is an issue of real and immediate concern and duplicates the findings following the Apollo Theatre Collapse when 88 patrons were injured as plasterwork fell during a performance. Advice issued after this by Westminster City Council is given in [CROSS report 442](#). When hessian ties are holding up heavy ceilings in places of public assembly there is a risk of failure as described above, when the ties deteriorate.

There may also be loading changes if lights or other items have been added over the years and there may be dynamic effects which exacerbate the situation. In February 2014 Westminster City Council said: "As a result (of the Apollo Theatre incident), we recommend that in addition to what was stated in the interim guidance the wadding ties of all suspended ornate ceilings are thoroughly inspected from above as a matter of urgency by a competent historic plaster specialist and a structural engineer." In response to the Apollo incident The Association of British Theatre Technicians published [Guidance Note 20 – Suspended Fibrous Plaster Ceilings](#) in May 2015. This has been compiled by specialists in the field and provides excellent guidance. More publicity is needed about the potential risks to other buildings and local and national government agencies and others are asked to draw attention to these.

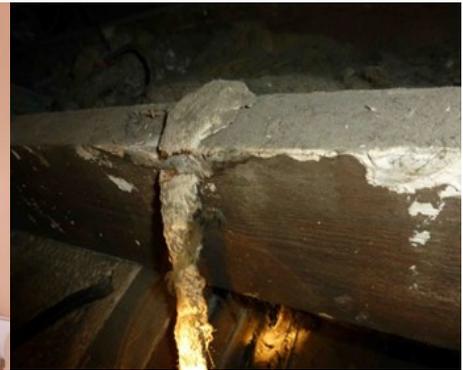
Broken tie

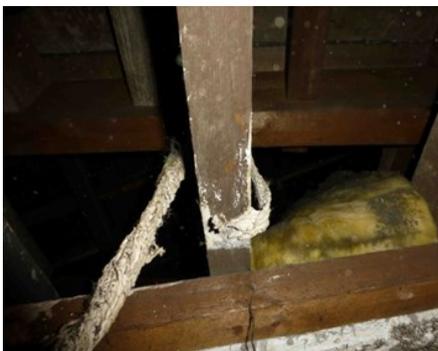
Snapped tie

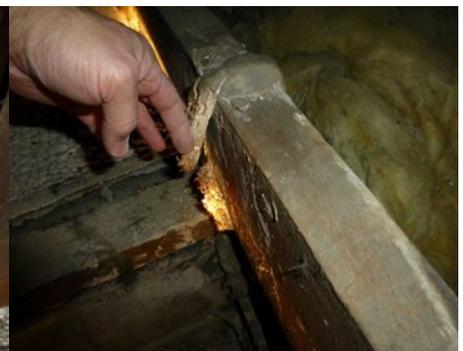
Another rotted connection
