# CROSS

## Confidential Reporting on Structural Safety

### NEWSLETTER No 40, OCTOBER 2015

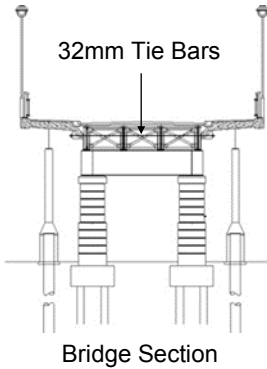
Fractured Tie Bar

The tie bars were however exposed to chlorides from sea spray and the marine atmosphere. They were sheltered from the rain and would not be naturally cleaned with fresh water so there has been a build-up of chlorides and rust staining. Examination of samples showed that there was a consistent pattern of red rust along the length of the bars and in the area of fracture there was a particularly large patch of corrosion on the 'bottom' surface with deep pitting. The small size of the final fracture region indicated that the load at the time of failure, the 225kN pre-stress, was not excessive. The coupler showed a red rust patch on the outside 'bottom' with some minor pitting evident. Several branch cracks were noted. Micro examination of the failed components showed the steel to be free from any manufacturing or processing defects and that failure had initiated at pitting of the surface of the components. Branched cracks and corrosion products indicate that stress corrosion cracking was the most likely mode of failure.

- It is essential that the correct grade of stainless steel is used for marine environments.
- Just because a steel is stainless doesn't mean that it doesn't corrode, further protection measures may be required against stress corrosion cracking and other failure modes.
- It is difficult to identify Stress Corrosion Cracking from in-situ visual inspection.
- Sudden failures can occur in tensioned elements.
- The surface finish and regular washing of stainless steel components has a major effect on their durability and can be critical to their successful application in a marine environment.

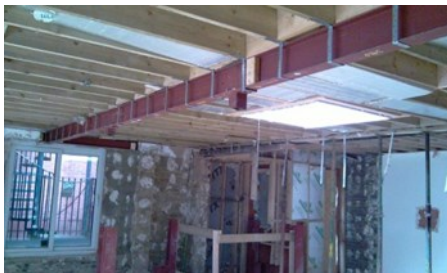
Three Span Beam with Columns Removed

An existing building was being converted to another use, says a reporter. The structure is being replaced, but the facade retained. The construction method was to create a new frame within the existing, with columns punching through the existing slab. The facade was then to be tied into the new frame and the old structure removed. The local authority building control officer went to site and witnessed on an upper floor that the columns had been removed out of sequence, before the new frame had been constructed. The existing beam over had been left simply supported, with no continuity over the columns. Upon removal of the columns, the beam tripled in length and with load reversal at the column points, the compression flange had no positive connection. It seemed that the floor over was spanning through membrane action, as there was luckily very good tying between members. The building control officer asked for the beams to be propped immediately and no damage occurred. The reporter says that this highlights poor site control, an inadequate construction plan and a lack of understanding of the structure by the site operatives. Furthermore, he says, the structural engineer did not make any visits to the site.

*Judging by the number of failures that are reported to CROSS, the skills of assessing temporary stability during construction or alteration seemed to be lacking. In any alteration there is no substitute for breaking down the planned changes into discrete steps and for then assessing strength and stability at each stage. The CDM Regulations make clear that both phases be adequately planned, managed and monitored by the designers. It is good practice to refer the contractor to the HSE page [Temporary Works \(TW\) FAQs](#) which advises the appointment of a TWC who then needs to direct the design and sequencing of the temporary works. It also requires that those involved have the right skills, knowledge, training and experience to carry out the tasks required of them. Site monitoring is often neglected in terms of risk management, but it is a question that would arise in any formal proceedings in the event of failure. Insurers sometimes advise engineers to limit site visits unless specifically included in agreements and temporary works are generally additional services. CIRIA is currently (2015) undertaking a review of structural stability during alteration work and a series of recommendations will be published in due course.*
