Confidential Reporting on Structural Safety

NEWSLETTER No 41, JANUARY 2016

529 RISKS FROM OFF-SITE MANUFACTURE AND HYBRID CONSTRUCTION

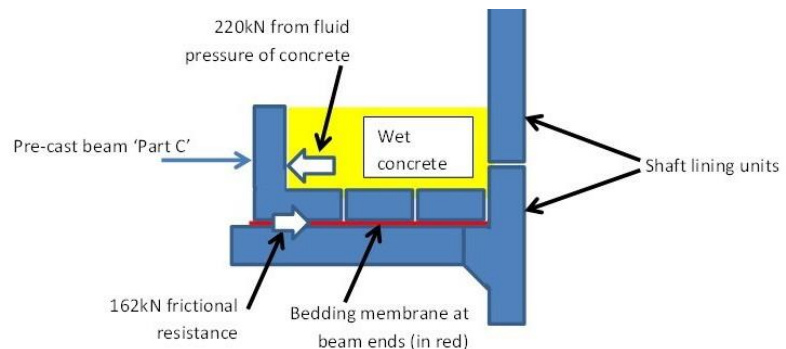
Figure 2 Diagrammatic cross section

balcony (the in-flow pipe being larger in diameter than the outflow pipe) until it weirs over the upstand into the shaft, which serves as a storage tank. In-situ concrete was used to provide headwalls for the in-flow and out-flow pipes. The headwalls are in fact large blocks of concrete, each approximately 2,500mm long and 1,650mm high. They were built using the balcony upstand to contain the concrete. During concreting, the upstand of the L-shaped pre-cast beam therefore acted as a 'shutter' and, owing to the geometry, had on it

the same horizontal force as would a shutter giving a force of around 220kN. It had been assumed that the weight of the L-shaped pre-cast unit, 460kN, plus the weight of the in-situ concrete itself (around 190kN) was sufficient to ensure enough friction between the beam ends and the corbel to allow the in-situ concrete to be contained without any need for the beam to be fixed in place. This proved not to be the case and the edge-most unit slid towards the corbel's edge, but did not quite fall off. As the pre-cast units are parts of the permanent works, the

temporary state was not identified as Temporary Works and so the management procedures of BS5975 were not applied. In fact, no calculations at all were made in relation to the temporary condition of the permanent works. The reporter asks the industry to be mindful on the following points. While they are drawn from this case specifically, they often apply in all cases where off-site manufacture or hybrid construction is used.

- In developing the design, be clear about who is responsible for what aspects of the design and for what phase of the asset's lifecycle.
- Aspects of the design and pre-cast erection methodology were sub-let to the pre-cast supplier. While responsibility for the detailing of the elements was clear enough, the responsibility for ensuring that the elements were able to fulfil temporary works, temporary condition and permanent works roles needed to be clearer.

- This being an industrial structure, it was not tied, as would be the case for a residential or building structure. Tying would (i) probably have given the restraint needed in the temporary condition and (ii) is good practice for the permanent works in any case. Designers are asked to give thought to robustness of all structures.
