Confidential Reporting on Structural Safety

NEWSLETTER No 42, APRIL 2016

REPORTS IN THIS ISSUE:

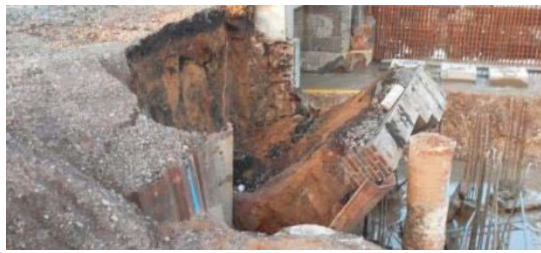
The masonry wing wall of a bridge fell as a single section and came to rest against an adjacent pile. Staff had been in the immediate area prior to the collapse but left following some observed movement in the previous 30 minutes. The wall collapsed because adjacent excavations had undermined the supporting ground.

Displaced wall resting on pile

Although the roles and responsibilities placed on individuals on site was clear, there was a lack of direction on who held ultimate responsibility for identifying the need for temporary works. This action relied on the recognition of the requirement by the site

team, the Temporary Works Coordinator and/or the designers. A requirement for temporary works was identified by the designers but this became diluted and was not picked up on site. A management issue was that some responsibilities, which might have been better if handled separately, were allocated to one individual. Ultimately it was decided that the event was a caused by a lapse due to lack of foresight.

When working on congested sites adjacent to existing infrastructure, the risk of the works affecting the stability of old structures, with low confidence on as-built condition, is high. Designers should be alert to this and draw attention to the risks, with a default position in favour of temporary works to remove or reduce uncertainty. Contractors should be aware and devise appropriate methods that recognise the uncertainties and associated risks. Communication between contractor and designer is essential, preferably at many levels to raise confidence that risks are sufficiently understood.

It was recommended that:

- Designers review their risk registers and highlight temporary works issues.
- No one individual should be expected to prepare, review, and authorise either works control documents or design certificates. Reviews are to be independent.
- Formal documented handover meetings are undertaken between the design organisation and the project team.
- Prior to the commencement of major work or high risk activities a joint risk review is carried out by designers, contractors, and others as appropriate at a suitably high level across all disciplines and organisations.

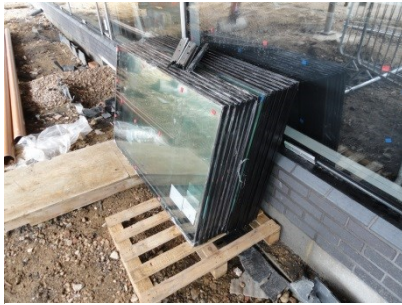
Stacked glazing panels

A reporter has been undertaking facade inspections for insurers across many buildings in the UK and the same issue keeps appearing on every site; glazing is not individually tied back to storage frames or to a secure place when being stored. Some of the panels seen have been 3m by 5m. When a panel is moved from temporary storage to be installed, a suction force can be induced onto the panel behind, which could cause the panels to fall onto workers. This is not something that the managers on site take seriously as the storage of the panels appears to be done in a safe way. However, there are hidden dangers.

The provision of safe storage is the responsibility of the relevant sub-contractor and the Principal Contractor. A simple lack of care can lead to devastating consequences which have included death from toppling panels. Heavy glazing units, mirrors, and cement based sheets that have toppled have led to fatalities.
