CROSS

Confidential Reporting on Structural Safety

NEWSLETTER No 43, JULY 2016

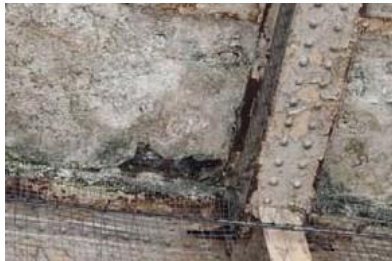
549 A member of the public reported that he was hit by falling concrete from an underbridge. Responsibility for the bridge was in a "grey" area between two owners and the organisation concerned recommended that clear and transparent demarcation is required for all assets where maintenance liability is shared. Where defects are identified on grey assets then liaison between liable parties should be carried out to ensure risks are managed appropriately.

549 Spalling concrete

Joint ownership (Report 549) has caused many problems – often one party assumes that the other party is maintaining the asset and/or is responsible for parts of it. There have been cases where one shared-owner modified a structure, not realising the changes were unsafe. In another case an owner carried out no inspections or maintenance, so it was fortunate that the operator of the infrastructure underneath, who did not know it was not their structure, inspected and maintained it. In a similar case no inspections were carried out due to misunderstanding about ownership. This was a newer

structure such that significant deterioration would be obvious but, nonetheless it was of concern. It should be stressed that the owners of structures over and under roads and railways have an obligation to inspect and maintain these structures in accordance with the procedures set out by the operator of that infrastructure. Engineers advising on these structures should ensure that their clients are aware of this obligation. With new structures this is hopefully covered by the O&M documentation. There is need for a robust asset ownership matrix, both within separate divisions of one entity, but also where asset ownership may be shared between separate entities. Such a matrix, shared between asset owners and agreed by all. It is also important that there is adequate quality control of structurally significant change such as alterations and renewals, and of inspections.

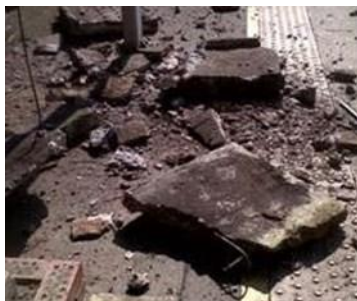
560 A 4.5m length of concrete encasement was detached from a bridge soffit and fell onto a public area. Fortunately, no one was injured, but clearly the incident could have caused a fatality. The root cause was corrosion of the reinforcement after cracking of the concrete, but differential temperature between the metal beam and concrete had a part to play in the final failure – around that time a temperature of 34°C was recorded.

560 Fallen concrete encasement

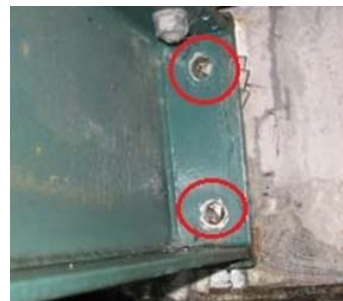
561 Missing bolts

561 A report was received from a Local Authority about a fracture in a footway attached to the side of a main bridge structure. The footway was supported on cantilevered members and it was found that of the 8 bolts holding these in place 4 bolts had fallen out.

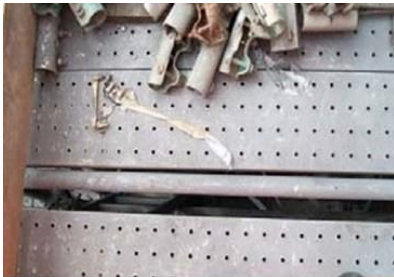
571 Tube fell through this gap

It was reported that work was taking place to refurbish the roof of a large publically accessible area. Two scaffolds had been erected to enable this to happen: a high level working platform that gave access to the roof, and a lower level scaffold to support a protective deck. Whilst operatives were in the process of installing roof sheeting above part of the area a 2.4m long standard tube that had been stored on the walkway on the high level scaffold moved. It fell through a gap in the scaffold planks then struck and penetrated the protective decking below. Two children on the concourse received slight injuries.

The upper scaffolding was a proprietary system and the user manual recommended that the covering sheets be connected together to prevent gaps from forming but this was not done at the area in question. The lower scaffolding was to give protection from weather and against small items that might fall such as pieces of glass or hand tools. The designer's risk assessment, says the reporter, did not reference falling scaffold tubes. Although there was a general requirement that the lower decking should provide protection from falling objects, there was insufficient recognition of the need to withstand the impact from potential missiles falling from height.

Anything falling from height has the potential to cause serious damage, even small tools. Experience shows that items are commonly dropped or roll off platforms, or on tall buildings may simply be blown off under temporary exposed conditions. Consequently, the hazard should be a standard one for consideration particularly when working over areas used by the public. As this report shows there is also no substitute for walking the surface area with an informed 'eye' looking for potential consequences. Temporary works may or may not be designed to store materials. Where they are it is essential that the requirements and limitations are defined on drawings. Installations must be adequately inspected and the materials are stored in a secure manner which will not let them move under the influence of external forces such as wind. It is also vital that design requirements are picked up in scaffold inspections.

Falling Objects is specifically covered within the HSE [Work at Height Regulations 2005](#) and specifically Regulation 10 (1) "Every employer shall, where necessary to prevent injury to any person, take suitable and sufficient steps to prevent, so far as is reasonably practicable, the fall of any material or object."
