CROSS

Confidential Reporting on Structural-Safety

NEWSLETTER No 44, OCTOBER 2016

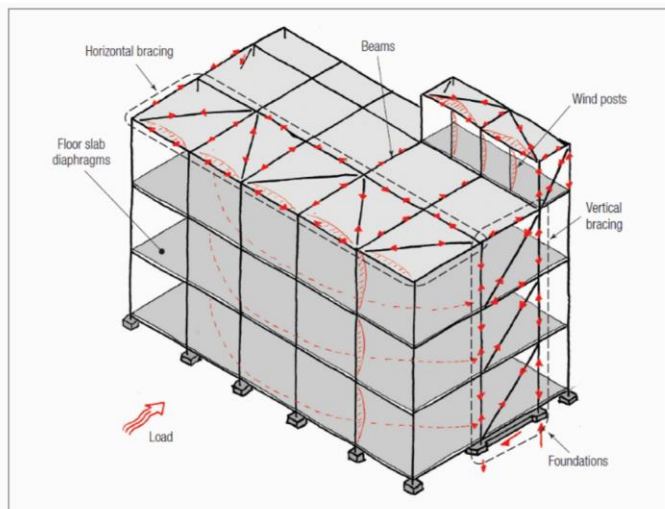
Figure 4.1 Load paths from façade to ground (shown for horizontal loads in the single axis only)

A reporter was appointed by a Contractor to undertake specific temporary works design for an extension to an existing primary school. The extension included a teaching block and an enlarged hall. As part of this process he received the original Engineer's design drawings and calculations. On review the reporter noted several major issues including an almost total lack of vertical bracing throughout the extension, and a total lack of roof bracing in the hall. The design was carried out internally by the local authority who was responsible for the school yet it appeared to the reporter to have been carried out by inexperienced engineers with lack of adequate or competent checking.

This is about the importance of a structural design being carried out, and thoroughly checked, by competent Engineers. It was fortunate that due to the diligence and experience of the temporary works designer the issue of unsafe design was picked up and corrected. Indeed, when a professional engineer notices defective design or workmanship there is a moral obligation to advise the building owner/operator. The apparent lack of basic understanding of overall building stability in reports such as this is alarming and raises once again potential deficiencies in training of engineers and competent checking processes within design/drawing offices. The IStructE guidance on structural stability of buildings <http://shop.istructe.org/stability-of-buildings-package.html> contains valuable information, such as this diagram on how horizontal load is carried from façade to ground by way of bracing.

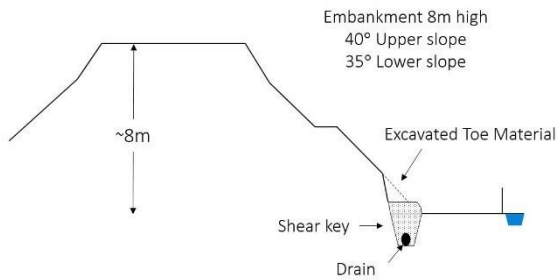
Cross section through embankment

Vertical movement was observed on the safety critical surface at the top of an 8m high embankment. This occurred over a distance of some 25m directly above a length of rockfill shear key being installed at the embankment toe. Had there been a failure of the embankment the consequences could have been severe. The design intention had been to perform the construction in short bays. However, a continuous 130m length of toe of the embankment had been excavated during the previous week and cut back with a face of 1-2m high at an angle of approximately 70 degrees. After investigation it was concluded that the surface deformation above this section was as a result of movement within the embankment caused by the method of excavation. The excavation was later stabilised and strengthened by the installation of a rock fill berm with a shear key and the slope was re-profiled

Whatever procedures were in place it might have been obvious to those on site that an excavation face 1-2m high at a slope of 70° was inherently unstable. Also a design team has to consider how its design will be implemented on site having regard to potential risks; in this case a clear risk of instability both by length and height of excavation. Put more formally it is a statutory requirement for pre-construction information, which should contain details of significant residual risks, to be passed via the Principal Designer, to the Contractor. Even though the parties may be from the same organisation, this should be done through nominated individuals who have authority for design and construction issues. If temporary works are to be involved then a Temporary Works Co-ordinator (TWC) should be engaged in the process to give advice as to the practicality of the design proposals, and secondly, when on site to ensure control as envisaged by [BS5975:2008+A1:2011 Code of Practice for Temporary Works Procedures](#).

- The Principal Contractor should clearly document the scope of enabling works and clarify the authorisation process to allow these to commence on site.
- Include a requirement for the contractor to document, prior to completion of the design, the findings of buildability reviews for similar works that have been categorised as higher risk.
- Ensure that the requirements of CDM for site specific hazards (such as earthwork instability during excavation works) have been clearly communicated to the Principal Contractor during the project planning stage.
- Review arrangements for the storage and retrieval of findings of meetings or investigation reports that contains risk information and lessons that can be learned.

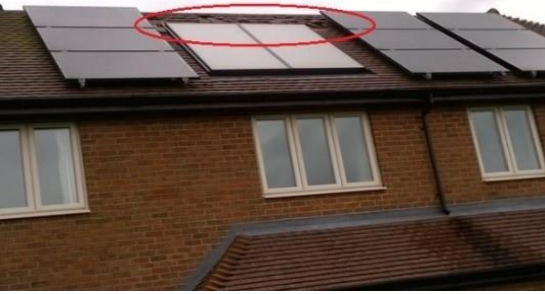
Outline shows area of damage

A reporter has a house which was built in 2011 and had solar panels installed on the roof flush with the tiling. Later the same year she had external PV panels fitted. During the heavy storm a big area of roof tiles blew down. A neighbour who has an identical house, but did not have the solar panels installed, had no damage to their roof during the storm. The reporter therefore suspects that it is the solar panels that have caused local wind turbulence and caused loads in excess of the roof design load. She does not think this was taken into consideration when the solar panels were installed but has no knowledge of either the design or construction. An insurance company report says that the wind speed on the night in question was around 52m/s.
