CROSS

Confidential Reporting on Structural-Safety

NEWSLETTER No 46, April 2017

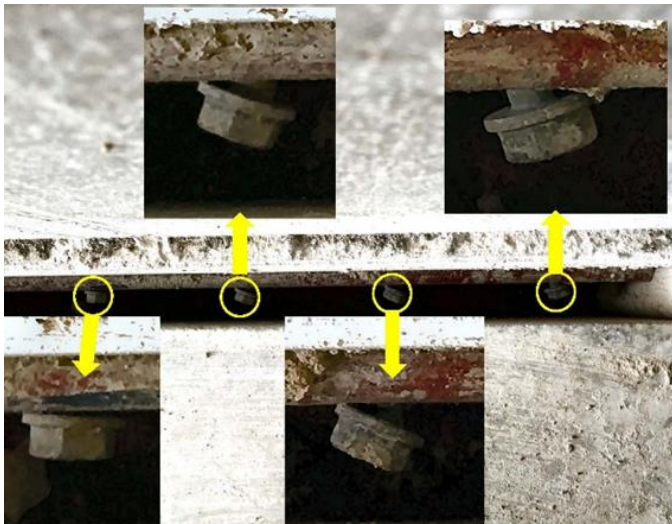
When precast concrete stairs are installed, the landings are normally supported using either proprietary telescopic connectors (AKA 'invisible connections'), or by means of an RSA bolted to the wall. When an RSA is used, the wall is drilled to fix the bolts, whether they be expanding fixings or chemical fixings, and frequently the drilling may hit reinforcement. In such cases the hole should be moved, and re-drilled to miss the reinforcement.

This may also entail re-drilling the RSA so there is a temptation not to move the hole, but to drill in a direction that misses the reinforcement. Doing this has two dangers: firstly, the hole will no longer be circular thus reducing the contact area for an expansion fixing, secondly the bolt head will not sit squarely against the RSA thus reducing the clamping effect onto the RSA. Most fixings require tightening to a specific torque, and this is not happening. The photograph shows clearly that virtually all the bolts in this example are incorrectly installed. It is likely that the capacity of such fixings is far below the specified value, especially as the pull-out 'cone' effect has been very disrupted by the skewed direction of the installed fixings. These operations fall into a very grey area of responsibility. The RSA is probably shown on the drawings produced by the pre-caster, but has to be designed by 'the Engineer'. The erection team will expect the RSA to be ready for them when they arrive to fix the stairs, so it may fall to the main contractor to source and fix it.

The person fixing the RSA will have no knowledge of the loads to be catered for, and may not appreciate the need to install a structurally efficient fixing. The Engineer who originally specified the fixings will rarely have the time or inclination to visit site to check the installation. When the erection team arrives to install the stairs, they will assume that the RSAs are suitable, and land heavy, precast landings and stairs on them. It is far from clear just who is responsible for providing a support that is fit for purpose. RSA fixings for stair landings should be subject to a stringent quality regime, covering design, installation, and checking, before any loads are installed.

They are very much safety critical, but seem to be treated almost as an afterthought, where nobody takes responsibility.

It would be thought that the Lead Designer must either design and detail such supports or formally delegate the task to another party. Almost all connections are safety critical and, as has been mentioned before, fixings make up the largest category of concerns reported to CROSS. There must be a responsible designer for fixings, and adequate design of these must take account of the practicalities of installation including potential clashes with rebar. The Designer must consider how loads are supported. If the retention of all rebar is necessary within a supporting RC structure, the fixing design will need to accommodate this and cast in supports should be considered. In any event, the fixing design will need to accommodate construction tolerances without imposing additional forces on the fixings. Proprietary fixings must be installed in accordance with the design and manufacturer's installation instructions. Guidance is provided in CFA (Construction Fixings Association) publications.

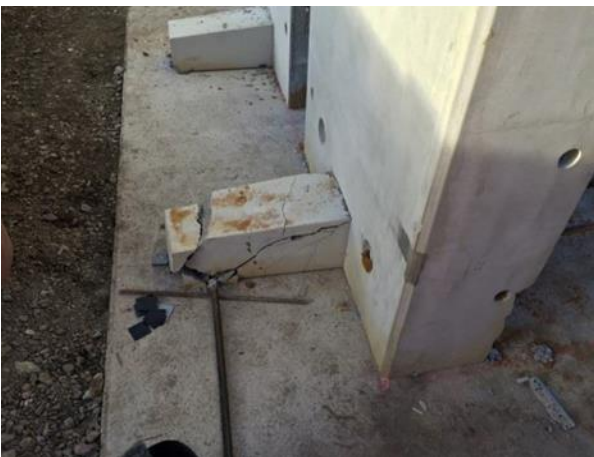
The use of precast concrete units to construct water retaining structures is becoming more common. Their safe installation however, says a reporter, is not as straightforward as may be suggested. During construction of such a tank, one of the precast units' integral stabilising feet failed as the unit was being installed. The tank comprised units up to 8m high which were placed on an insitu base slab. The foot failure was attributed to the use of shims and a steel wrecking bar used when attempting to plumb the unit. Prior to the incident, 8 units had been placed without damage. A unit was then lifted into place and with the load still on the crane, it was plumbed by placing shims under RC stabilising feet. A steel bar was used as a pry to help placing the shims. As the load from the crane was released, one of the feet failed, making the unit unstable.

The use of shims, particularly under the body of the unit (as well as the feet) raised concerns regarding the temporary stability of the units prior to their incorporation into the parent structure. After an investigation, the following measures were taken:

- 1: Where shims were required under the main body of the unit temporary props were provided to stabilise units.
- 2: Construction supervision was increased to ensure even distribution of shims under the units and the addition of grout where necessary. Many of the issues might have been negated by the provision of a flatter base slab making excessive shimming unnecessary. That said, the provision of a suitably 'super flat' slab and the residual requirement to place shims under the unit's feet would negate many of the advantages otherwise attributable to precast concrete construction of tanks.

This shows the need to consider the practicalities of installation when developing an overall design. All construction has tolerances and all items (whether in precast concrete or other material) will require adjustment to achieve alignment so the fittings need to be 'robust'. A robust design ought also to ensure there is no gross change in state consequent on minor damage. In this case, there should have been no overturning risk if any of the items attached to aid stability had been damaged. Combinations of adverse tolerances need to be considered as part of component design.

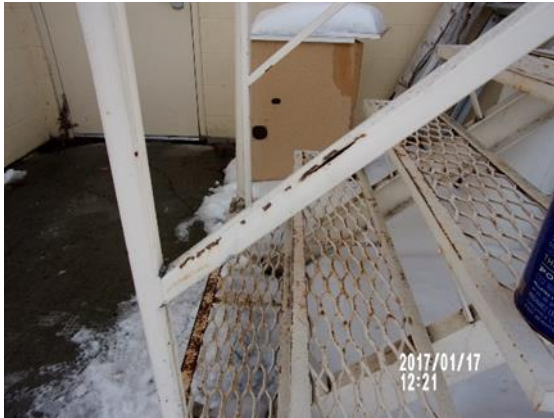
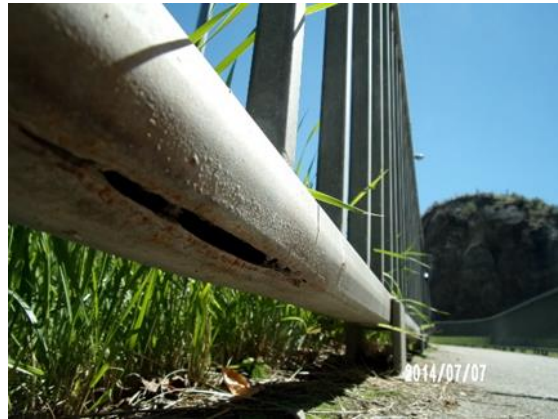
Further to [report 579 in CROSS Newsletter No 45](#), a reporter from Canada has come across a similar problem in a few locations in British Columbia (temp range -30°C to +40°C). Two examples are shown in attached photos, one was a painted 2" (50mm) Square HSS on a sloped Pedestrian Railing, and the other is an Epoxy Paint coated 1" (25mm) Square HSS on a Stair Handrail also on a slope. In neither case were drain holes provided yet both hollow sections split as a result of frost action. The reporter typically specifies drain holes in all areas of HSS members where moisture can collect and checks are made to see that such holes are present before approving work, and this repeatedly finds its way into the internal space of the HSS where it collects over time (perhaps over several years). In the opinion of the reporter, although this is a dryer region of the Province, there is still a moderate amount of moisture at night (condensation).

Thereafter, moisture accumulates faster than it can escape and builds up in non-draining areas, possibly over several cold weather periods/years. The HSS member finally cracks and releases the moisture. Also, corrosion build-up is taking place inside the HSS contributing to strength loss. Corrosion filled moisture may react differently when frozen than straight water in a clean test sample, suggests the reporter. Heat (direct sun exposure up to 70°C) may also affect the area in some way.

This phenomenon may well pose a bigger risk in climates with very cold nights and relatively warm days or where bright sunlight is enough to raise steel temperatures above zero thereby generating repeated freeze thaw cycles CROSS has had a number of reports of hollow sections cracking, usually related to water inadvertently trapped inside the tubes. In some cases tubes have had drainage holes. Sections which are detailed with drain holes will allow a path for moist air to enter and hence for corrosion to take place which can cause damage. In other cases, it is water expansion as water undergoes significant expansion during the phase change to ice and this causes splitting. Fully sealed hollow sections are likely to be more resistant both to corrosion and to freeze/thaw damage. The more cycles there are, the more likely it is that cracking or splitting will occur. Freeze/thaw damage has also been reported in temporary pockets cast into concrete structures to take handrails.
