# CROSS

## Confidential Reporting on Structural-Safety

### NEWSLETTER No 47, July 2017

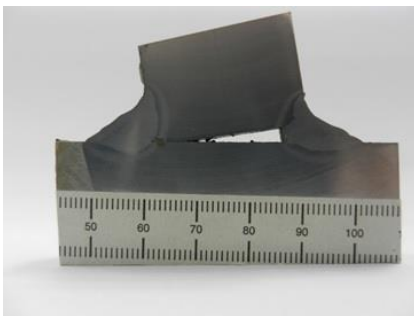
During the construction of a major new school facility, a 57m single span structural steel truss failed, resulting in the catastrophic collapse of a steel framed canopy supported by the truss. At the time of failure five workers were on the top of the canopy, some 15 m above ground level. All received significant injuries but survived. The immediate cause of the failure was associated with the fracture of a number of sub-size fillet welds joining paired load bearing tie bars at nodal points. The design of the 'T' shaped joint required the end of some connection plates to be cut with a bevel angle of 80.7°. However, to simplify production the plates were cut at 90° on the contact edge. This resulted in a gap of approximately 4.5 mm to one side of the joint (see photo of intact cross section recovered from the collapse). This gap resulted in a reduction in the effective weld leg length and throat dimension. What should have been a 10.6mm throat dimension was found to be between 6.9mm and as low as 3.7mm. Failure had occurred through the weld

Gap at end of shaped plate on intact cross-section

material at numerous nodes and assessment showed that failure of one connection at one node would have been sufficient to unzip the truss. In other words, a single inadequate connection would make collapse highly likely - meaning that the design was overly sensitive. There were additional issues with the design that made installation difficult and led to installers cutting and rewelding connections to the building. Such site alterations are often implicated in collapse incidents albeit that, in this case, the root cause lay elsewhere. Legal requirements and published guidance and standards are based on ensuring that the designer provides a structural design that is sound and straightforward to build. More complex situations need sequence and assembly instructions to be provided. This is to ensure that:

*This is a classic example of the intimate relationship between design / workmanship and safety. The failure also illustrates a theme that has repeated in a number of recent reports which is of poor workmanship leading to disaster. It appears that this event occurred through inadequate workmanship and inadequate quality control. As with the failures in Edinburgh schools ([Inquiry into the construction of Edinburgh Schools - February 2017](#)) one aspect is that the poor workmanship in this case could not be detected by post fabrication inspection. Rather, to assure quality, inspection 'before covering up' should have been carried out. Over the years, CROSS has received reports of failure involving tie rods of various types. A fundamental cause has been that tie rods have no effective ductility unless special attention is paid to their end connections. In this failure, with such weak end welds, it is apparent that no reliance at all could be placed on tie rod ductility to assist in re-distributing overload.*

- The fabricator can understand which connections are safety critical
- Components are correctly cut and prepared to achieve the specified fit
- Fit-up tolerances can be achieved both during welding and during site installation
- Difficult fabrication can be carried out under controlled shop-floor conditions and not on site
- Quality assurance checks can see what is being achieved to minimize opportunity for hidden defects

Welding standards for structural steelwork specify that 100 % visual inspection be carried out before, during and on completion of welding to ensure that production quality is being maintained. They also specify that weld size should be checked by a welding inspector and an additional visual inspection should be carried out by a qualified non-destructive testing (NDT) technician. Concern at any stage should be referred back to the designer. Since 2014 it has been a legal requirement under the Construction Products Regulations 2013 that the fabrication of building permanent works in structural steel and/or aluminium is carried out in accordance with an accredited quality scheme based on the specification given in BS EN 1090. Projects that use sensible quality assurance practices including early and regular discussion and cooperation between designers, fabricators and installers will avoid the pitfalls outlined above.

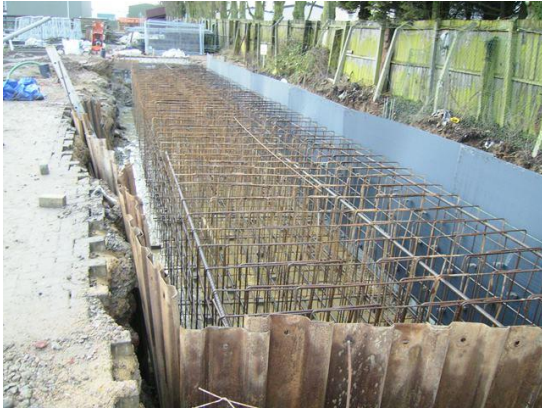
Two companies have been fined a total of £700,000 and a director has received a suspended prison sentence following the fatal crushing of four workers at a site in 2011. The workmen were constructing a large reinforcing cage in an excavation some 23m long, 3m wide and 2m deep. The cage would have weighed about 32 tonnes when completed. See [here](#) for further details.

The rebar cage prior to collapse

The Temporary Works Forum (TWf) has published a safety bulletin aimed at those specifying, managing, designing, detailing and installing reinforcement cages concerning key issues to ensure stability and safety. This TWf guidance, [Stability of reinforcement cages prior to concreting](#) is being updated presently. Research work is also on-going at City, University of London and Swansea University into the strength and stability of steel reinforcement cages in their temporary state.

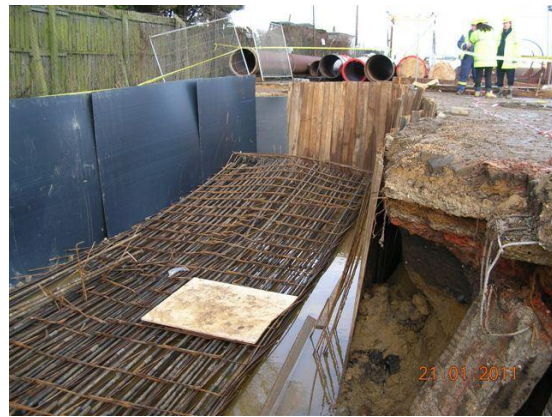
After collapse
