Confidential Reporting on Structural-Safety

NEWSLETTER No. 50, April 2018

REPORTS IN THIS ISSUE:

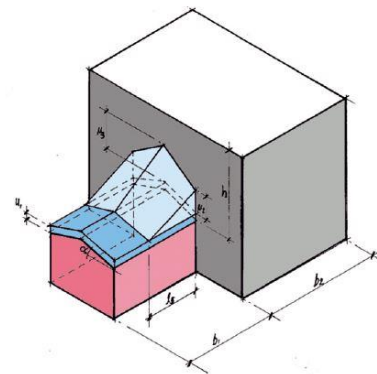
- The extension is some 3m higher than the original thus creating an abrupt change in height.
- The structural engineer failed to realise that this creates the potential for drift snow accumulation in the end bays of the existing building.
- No check in accordance with BS6399:Part3:1988 is therefore carried out.
- Consequently, no localised strengthening of the end bays of the existing building is implemented.
- Building Control's independent checker, a Chartered Structural Engineer, also failed to identify the issue and allowed Building Control to approve the submission (alarming!).
- Heavy snow combined with gales caused significant snow build-up to occur at the interface.
- The roof elements in the end bay collapsed and damaged the penultimate bay.
- Both bays had to be stripped and replaced together with additional secondary members.

A significant cause of failures is simply overlooking a potential hazard. A second general cause of failures is poor change control and there are many classic cases of this. Failure to consider drifting snow is a common problem and not always limited to extensions. If the build-up of a drift does not cause collapse or excessive deflection, it can cause water ingress through the walls and windows at the back of the drift. It is an alarming statistic that so many engineers overlook what seems an obvious consideration and that it takes a good fall of snow to remind them. In general terms, this type of problem is associated with inadequate professional training. The recent “Beast from the East” storm in the UK (March 2018) resulted in heavy snow falls and significant drifting across large parts of the country. Structures may also be designed for snow drift loading to Eurocode 1 - Actions on structures - Part 1-3: General actions - Snow loads.

Figure 1: Snow drift loading (Ref. IStructE Technical Guidance Note - Level 1 - Note 5 - Derivation of snow load)

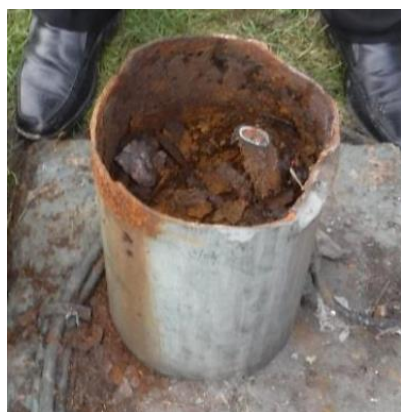
Figure 1: Bottom of mast after removal Figure 2: Upper part of door opening (note the crack at the top right of the opening)

Investigations have highlighted the following factors which contributed to the collapse:

- Moisture was able to enter the inside of the mast through corroded and unsealed brackets supporting the floodlight lamps.
- Moisture was able to enter the inside of the mast through gaps between the detachable cover and the tubular section.

- Drainage holes at the bottom of the mast had become blocked allowing water to gather in the bottom of the mast.
- In addition to losing water by evaporation, water is likely to have been able to escape when it reached the level of the opening. This led to the internal face of the column corroding below the level of the opening leading to a significant reduction in the thickness of the steel tube.
- A horizontal crack had developed in a corner at the top of the opening and it is possible that a similar crack had developed at the bottom of the opening.
- Strengthening plates around the opening appear not to have been long enough to transfer load back into the body of the mast.

An inspection of other columns after their removal also revealed extensive corrosion below the level of the door openings. Advice from the reporter to other clubs is as follows:

- Your maintenance regime for floodlighting masts at your ground should include a risk assessment for internal corrosion of steel tubes.
- A check for internal corrosion should be carried out by a suitably qualified person where internal corrosion has been assessed as a significant risk.
- Your maintenance regime should include a check for cracking around any openings in tubular steel masts.
- Your assessment of the structural adequacy of the floodlighting masts at your ground should include an assessment of the adequacy of any strengthening around openings in tubular masts.

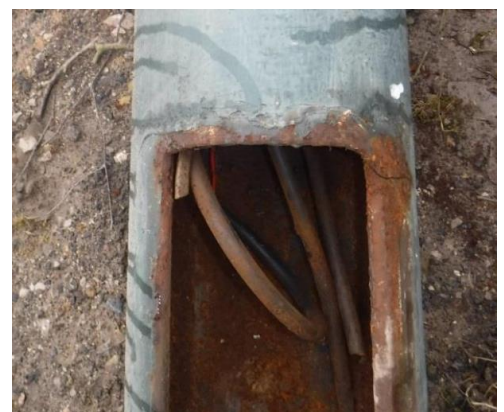
- *In this case, the crack and its location are suspicious. Lighting columns have been known to oscillate and thence fail by fatigue. The risk of fatigue is enhanced by higher stress ranges consequent on thinning sections; by corrosion (giving stress concentrations) and at corners (again for stress concentrations). This crack is in a corner. Hence the advice to look for cracks in corners is very sound, not least as in this location, crack propagation rate is likely to accelerate with increasing crack length.*

There have also been experiences of failures of tubes just below ground level, so there should be means to inspect the internal face when designing for the future. Also, steel will not corrode without oxygen so maintenance should include effective sealing of holes provided for fixings and the original drain holes provided for in galvanising processes.
