NEWSLETTER No. 51, July 2018

REPORTS IN THIS ISSUE:

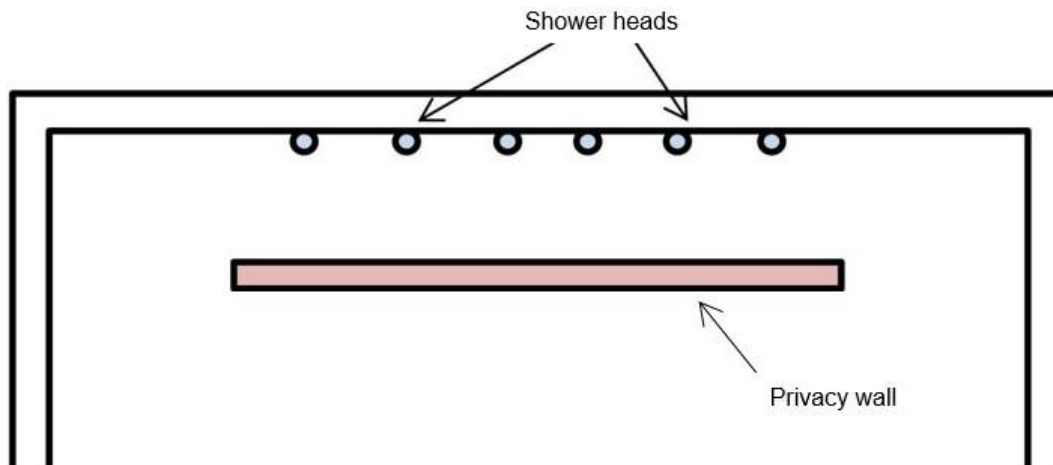
Figure 1: Part plan of changing room

The changing room contained a disused shower area which was routinely used as an additional area for the pupils to change. The shower area had originally had a row of shower heads along the back wall forming a communal shower. This 'wet' area was separated from the rest of the shower area by a freestanding 'privacy' wall. The width of the area between the privacy wall and the back wall with the showerheads was approximately 900mm. The privacy wall was 3.6m long by 2.1m high, it was formed of a single layer of unreinforced clay bricks laid in stretcher bond and faced all round with a terrazzo finish to the full height of the wall. The finished wall was therefore 140mm thick. Such a slender unreinforced wall did not comply with any historical (or current) design code. When the changing room was originally designed in the early 1950s there were no relevant Building Regulations in force in Edinburgh.

On the morning of the incident, a group of 11-year-old pupils were using the area in front of and behind the privacy wall to get changed. At least one, and probably two pupils, who were standing in the gap between the privacy wall and the back wall, decided to support themselves off the floor by bracing their backs against one wall and both feet against the other wall. It is also possible that using this technique they were trying to climb up the gap between the parallel walls. The privacy wall then toppled outwards, striking and fatally injuring one of the 11-year-old pupils.

With the pupils braced against one wall and pushing with their legs against a parallel wall, the amount of force with which they can push is not limited by friction as it would have been if they were standing on the floor. Ergonomic analysis confirmed that in this position it is possible for a small number of individuals to exert a force that exceeds the horizontal design loads given in the UK National Annex to BS EN 1991-1-1, Table NA.8. This braced position also allows individuals to climb up the gap, and consequently the force can easily be applied above the 1.2m max height given in BS EN 1991-1-1 paragraph 6.4(1).

Practitioners undertaking surveys should carefully assess the stability of ANY freestanding walls; whether they are internal or external and irrespective of whether they show any signs of distress.

It is important that the designer/assessor of walls such as those in the report consider what reasonably foreseeable loads could be applied beyond the code minimum values. Additional loading may arise due to the location, type of use or thoughtless or potentially malicious actions. When reviewing risks for any structure, what would be the potential consequences of failure?

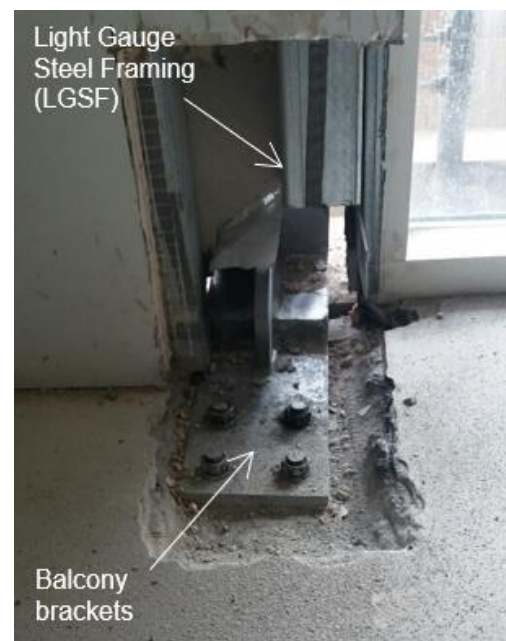
After the installation, additional balcony elements were fitted to the primary frame located at the first and second storey. Balcony brackets were required at a number of opening jambs, but no prior arrangements were made within the concrete frame to connect the balcony, nor was it coordinated with the LGSF sub-contractor or designer. In order to connect balcony brackets to the primary frame, the LGSF jambs were trimmed short at both head and base connections.

The glazing to the structural openings had already been installed and due to the removal of the LGSF jamb connections, it was now the plasterboard which both suspended the LGSF locally and restrained the glazing against wind and other loading applied. Fortunately, the LGSF sub-contractor was made aware of the occurrence, raised the issue with the supplier, and a remedial design was produced to bridge the brackets and reconnect the LGSF jambs back to the primary frame.

Figure 2: LGSF trimmed to allow for balcony brackets

If left unnoticed, this structural fault could easily have been covered and neglected, where under much lower loading than designed for, may have resulted in failure of the envelope and glazed openings. This could have led to the LGSF, glazing or other finishes failing and falling from their installed position.

It is important to remember that LGSF is a structural steel system and it is of vital importance that notching and material removal not confirmed within the design does not take place. Examples such as the above, where future elements of the site program require space not previously provided, must be coordinated during the LGSF design and ahead of installation to mitigate scenarios like this.

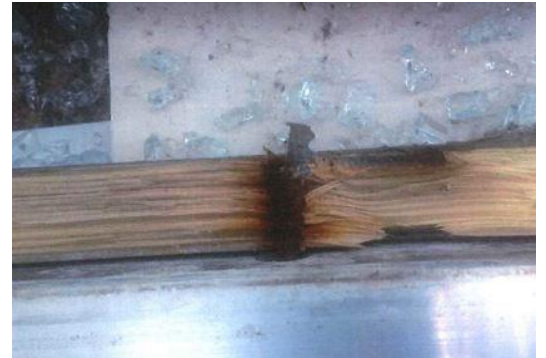
A firm was asked to provide professional advice regarding the replacement of a glass balustrade which had collapsed. The balustrade was at second floor level, free standing in a prefabricated metal channel section which was inadequately fixed down to softwood decking boards. It is a single occupancy domestic property and all glass and debris fell within the grounds of the property. No one was injured. The reporter asks if the firm have an obligation to report the incident to the HSE or any other organisation?

Figure 3: Rusted screws used to fix the balustrade support rail

The cause of collapse was probably down to inadequacies at the time of construction. The question is whether there is a need to report such an event. RIDDOR (Reporting of Injuries, Diseases and Dangerous Occurrences Regulations 2013) puts duties on employers, the self-employed and people in control of work premises (the Responsible Person) to report certain serious workplace accidents, occupational diseases and specified dangerous occurrences (near misses) to HSE. It is unclear from the report whether RIDDOR applies here and whether the reporter or their firm falls into one of the above categories. If unsure readers can contact [HSE Concerns and Advice team](#) who will be able to advise.
