CROSS

Confidential Reporting on Structural Safety

Newsletter No.52 | October 2018

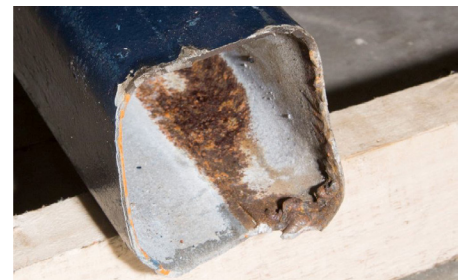
A metallurgical examination was carried out on the support post which had fractured approximately 2,600mm above ground level at one of the transverse weld sections. The transverse butt weld at the fracture location exhibited regions of incomplete

Figure 1
Failed support post

weld penetration through the post wall and internal corrosion.

A fatigue crack was present in the full-length U-channel adjacent to the butt weld and had initiated at the unfused edge of the transversely welded channel. The unfused areas would have raised the local stresses in the post, reducing resistance to fatigue crack initiation, propagation and an increased susceptibility to failure.

Whilst the larger sign would have increased the forces acting upon the post and were a contributory factor in the post failure, calculations indicate that the support post would not have structurally failed had it been free from defects.

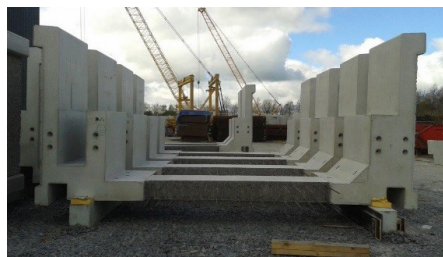
The solution, as shown in the photograph, was to design and cast a 'U-kerb' using a section of the in-situ cross ramp stitch as part of the precast connecting the original single standalone kerbs. The permanent works designers were responsible for re-designing the U-kerbs, however it was the Principal Contractor and the Temporary Works Coordinator (TWC) who were tasked with designing the lifting points.

● **Figure 2**
U-shaped precast kerbs

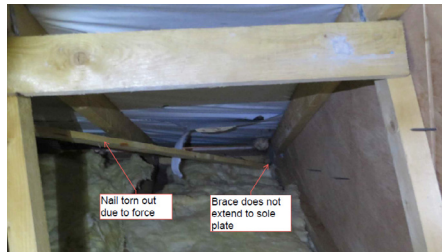
There was no access, so a hole was made for inspection. Inside the reporter found the bracing to the trusses fixed with a single nail and there was discontinuity in the bracing. The main issue however was that as the truss didn't support the ceiling (as the module came with a roof), there was no diaphragm under the trusses and all the force in the bracing went to the gable end through the final brace.

The photo shows there is a nail pull out failure on the penultimate truss and it appears the brace wasn't even connected to the wall/sole plate. Following the inspection, bracing was added along with noggins at the areas of highest deformation and additional fixings were made. The reporter says that designers need to be careful putting trusses over an existing flat roof.

● **Figure 3**
Bracing deficiencies in the timber roof
