# CROSS

Confidential Reporting on Structural Safety

## Newsletter 54 | April 2019

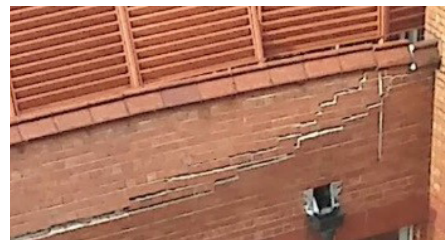
In 2018, there were exceptionally strong South-Easterly winds with gusts of approximately 50+mph (80 km/hr). Under these conditions the wall collapsed, and inspection revealed that the parapet and affixed screening had been pushed over. The masonry had failed on the bed joint across almost the whole of its length. The left side of the parapet was a free edge with the right side bonded to a chimney. It is assumed that the action of the strong winds on the screening allowed sufficient pressure

● **Figure 2**  
Failure of masonry wall with fencing above

to cause the screen and fence to be overloaded and, as the wall has little tensile strength, the failure resulted along the bed joint closest to the roof level. At the base of the lightwell was a rooflight into an occupied space. Had the parapet slipped and fallen into the lightwell there could have been substantial damage and possibly fatalities.
