# SCOSS

SCOSS Alert | May 2019

## FAILURE OF REINFORCED AUTOCLAVED AERATED CONCRETE (RAAC) PLANKS

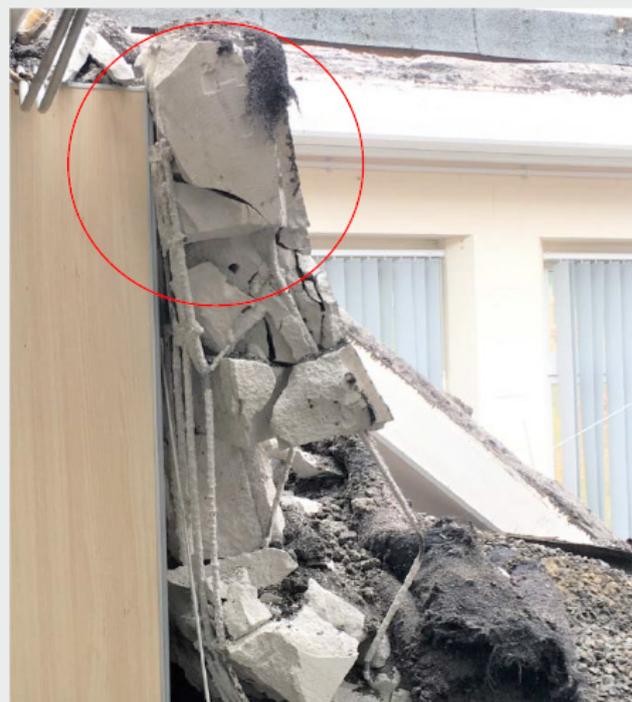
● Figure 1  
The 2018 roof slab collapse

In the case of the 2018 failure, there was evidence of shear cracking adjacent to a support and possible indications of tension reinforcement stopping short of the support. It was noted during investigation that the roof had been recently resurfaced. Also, the failure was at a time of hot weather, so there may have been a thermal influence.

Sight must not be lost of the fact that the 2018 collapse was sudden with very little noticeable warning. This is indicative of shear failure in cementitious materials and can only be protected against by knowing that there is sufficient shear resistance in the material, the reinforcement, or both.

There is therefore a risk, although its extent is uncertain. The risk must be identified by locating buildings where RAAC planks are present and assessing their condition and structural adequacy. If there is doubt about the structural adequacy of the planks, then it is recommended that consideration is given to their replacement.
