Confidential Reporting on Structural Safety

Newsletter 56 | October 2019

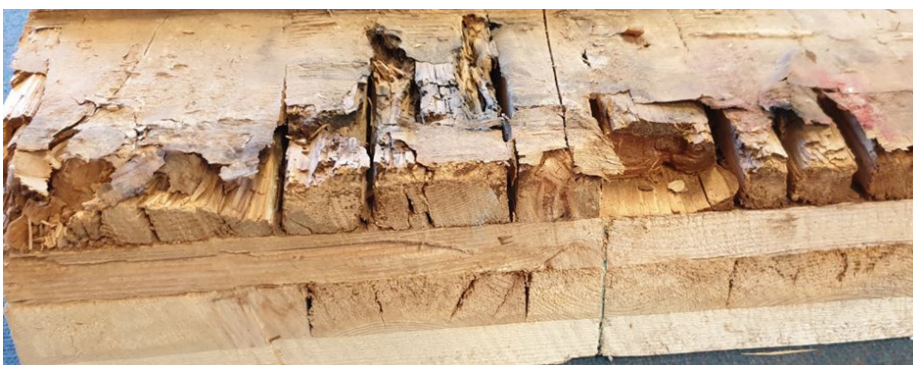
As part of their investigation, CLT panels on the roof, parapets and terrace were exposed. Inspection found that not only was the ply under the membrane rotten, but areas of CLT had also severely rotted. The reporter was shocked to see that in some areas, three of the typical five plies in the CLT panels had rotted through both on parapets and roof panels. Sloping sections of roof with the membrane on top of insulation seemed fine.

The reporter speculates that the issue is due to hidden water entrapped between an impervious roof membrane and the effectively impervious CLT panels. They were told that the roof had been allowed to become wet during construction, but it is not clear if the water which caused the rotting developed during construction or was allowed in following construction due to incorrect design and detailing.

CLT, like timber in general, will rot when excess moisture is present over long periods of time. It is worth considering how the CLT became exposed to water in the first place. The reporter speculates that the water could have developed during construction. It could also be due to condensation, or leaks in the waterproof membrane, or both.

● Figure 1
Rotting of a CLT panel

The remedial works for the heavily damaged areas resulted in replacement of much of the flat roof areas using parallel chord timber trusses with metal webs for the longer spans, with more traditional joists used elsewhere. Less damaged areas were repaired by replacing the ply under the membrane, and in other areas, steel beams were connected to the CLT wall panels with shear rings cut into the panels.

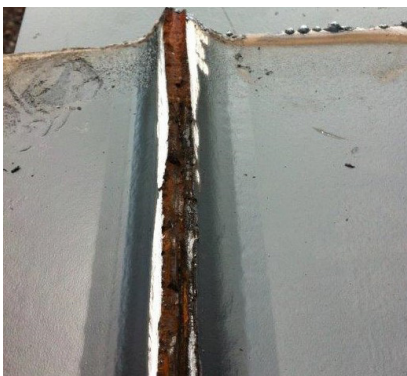
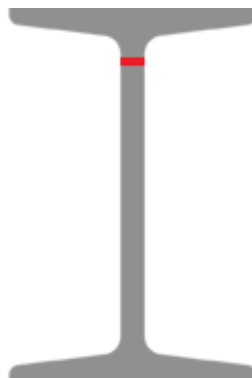
When loading fabricated members for a steel truss to be installed as part of a roof in a large industrial building on to a delivery lorry, a slight but unusual ridge was noticed by a reporter in the paint longitudinally along the interface between the flange and web for a hot rolled steel I section chord member. The beam, which was painted, was not deep and the web thickness was thin.

The paint was subsequently removed and revealed a crack. A section of the flange was then cut out to investigate the crack with a view to carrying out a local welded repair if possible. When the flange was cut across its width, well beyond both ends of the visible crack, the flange fell away revealing rusting at the connection of the flange to the web, extending further than originally thought. A crack through the web appears to have existed undetected and there was no significant connection between the flange and the web, says the reporter.

This is an unusual case which the CROSS Panel have not come across before, demonstrating that new safety issues continue to come to light. The fact that the crack surface was rusty as shown in the picture, suggests that it must have been there for a considerable period of time.

The crack cannot be due to lamellar tearing as this only occurs where there is welding, and this beam was a hot rolled I section. The beam was painted, not galvanized, so Liquid Metal Assisted Cracking (LMAC) can also be ruled out. It is possible for steel to have laminations, but this crack is across the thickness of the web.

The most likely conclusion is that the manufacturing of the hot rolled I section did not comply with the required standard. The advice is to be alert, conduct visual inspections and only purchase steel from organisations who meet the appropriate manufacturing standard. For steelwork, BCSA/TATA Steel publication **Steel Construction - CE Marking** is a useful document and states that in order for steelwork contractors to demonstrate their right to CE Mark their products, they must provide the following three documents:

● **Figure 2**
Flange/web splitting on steel beam (approximate crack location shown in red on sketch to the right)
