Confidential Reporting on Structural Safety

Newsletter 59 | July 2020

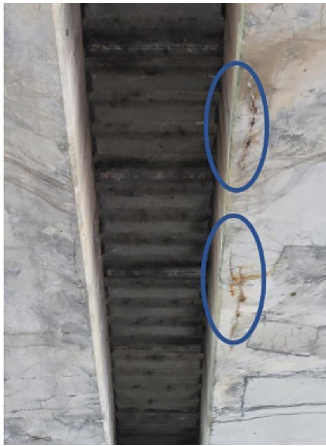
The incident involved an unplanned emergency lane closure of a bridge carrying a motorway. This was required to mitigate the risk of overload of the bridge after excessive concrete removal to the soffit during repair works. The bridge consisted of 3 spans with half joints for a central suspended span. Leaking road surface water through the half joint and longitudinal central reserve joint had contributed to extensive concrete repairs being required to mitigate the risk from falling spalled concrete and further reducing structural capacity (Figures 1 and 2).

● **Figure 1**
Initial damage

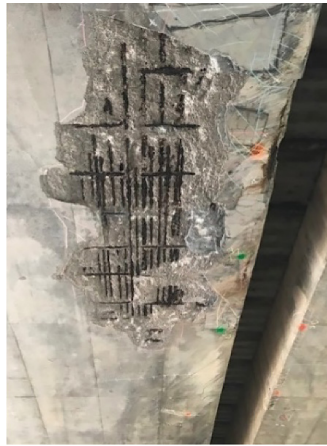
● **Figure 2**
Loose concrete removed

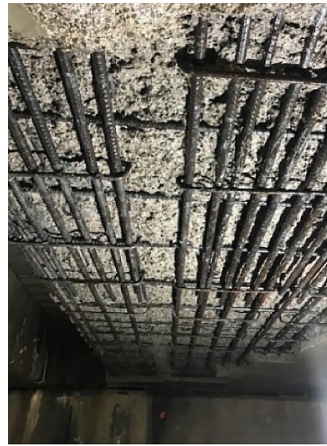
A sequence of misunderstandings led to a larger area of removal, which exceeded the specified constraints. The extensive areas of spalling on the central span near the half joint led the site team to believe, incorrectly, that the constraints were only applicable to this area, not the side spans. The hydro-demolition team cut out a much larger area of concrete than had been planned (Figure 3).

● **Figure 3**
Hydro-demolition

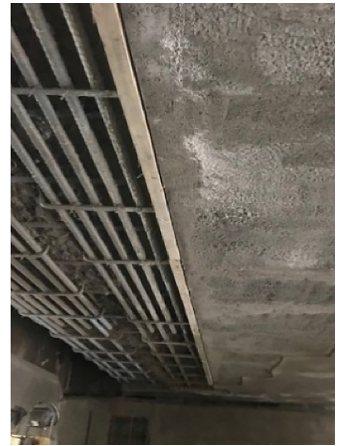
An assessment was then carried out by the designers which found that the structure did not now have enough capacity for the required live loading. Poor deck reinforcement detailing, combined with the extensive concrete removal, meant that permanent, significant deformation and damage could have occurred. This led to an instruction to immediately close the lane above the repair area and to repair the soffit the following nights (Figure 4).

● **Figure 4**
Repaired section

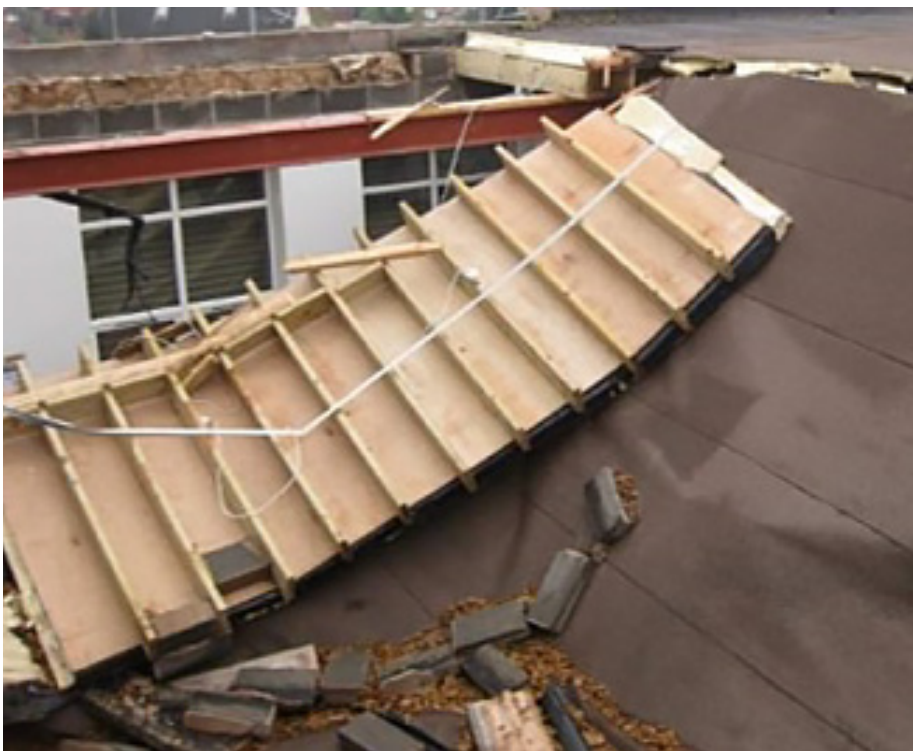
The joists to the main roof had fractured at their midspan, damaging the end supports as they did so. At the time, substantial quantities of water were seen pouring out from the ground floor.

The section of roof in question was surrounded by a parapet with a hidden gutter at one end. This had leaves within it and there was debris and vegetation in the gutters and outlets to other roofs to the school. It is likely that the outlet had become blocked and water had gradually filled the roof area without being noticed.

Current codes say that roofs with access for maintenance only are to be designed for an imposed loading of 0.6 kN/m². It is considered that the dead load from both old and new coverings was within this allowance. However, if the area above the roof did fill with water, say to a depth of 250mm (the height of the upstand), there would be a sustained uniform loading of 2.5 kN/m².

● Figure 5
Collapsed section of roof
