## Newsletter No. 2 | September 2020

## US-15: Failure of existing long-span wood roof truss following installation of new roof-top HVAC units, Report ID: 949

Failure of an existing long-span wood roof truss following installation of new roof-top HVAC units offers lessons in the special challenges of renovations to existing buildings.

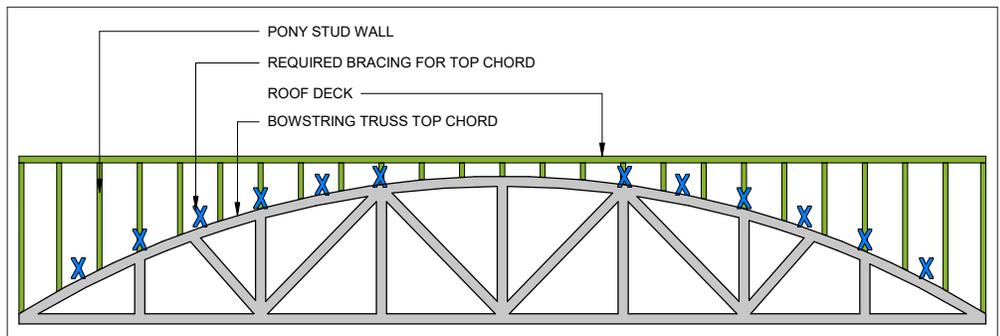
Figure US-15-1: Figure drawn by REM Arch LLC.

An existing wood roof truss failed after several new HVAC (Heating, Ventilating, and Air Conditioning) units and associated piping and ductwork were added on the roof of an existing building during a renovation project.

Several months later, the SE received a phone call indicating that the trusses were failing, and the roof was collapsing. The SE went immediately to the site and noted two important facts. First, several lateral braces of the pony wall above the trusses near the truss ends had been removed during the recent construction and had not been reinstalled. No notification of the removal of these braces was ever provided to the structural engineer. These lateral braces were required because near the ends of the trusses, the top chords were not directly connected to the roof diaphragm and therefore the top chords were not laterally braced without the extra lateral brace members (Figure US-15-1). Second, although the SE had asked and been told that the ceiling would not be supported by the roof structure, it had, in fact, been hung directly from the roof. The amount of ductwork and piping was significantly more than was expected by the SE during the evaluation and design.

The contractor made debilitating changes to structural conditions without SE's knowledge, most significantly removal of studs from the pony wall and removal of truss chord bracing. It is, unfortunately, not uncommon that contractors take liberties with structure during MEP work. To prevent this for wood construction the International Building Code<sup>15</sup> states: 2303.4.5 Alterations to trusses.

were required. The SE provided a sketch to remediate the pony walls.
