CROSS

Confidential Reporting on Structural Safety

Newsletter 60 | October 2020

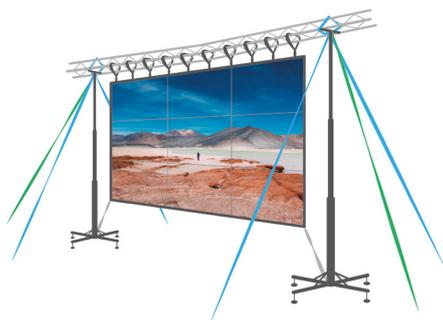
● Figure 1
Sketch of typical outdoor screen arrangement

The vertical supports appear to be typical for proprietary products with an axial capacity of around 200kg. Manufacturers may provide no data for use outside and do not provide any ratings for lateral loads. One manufacturer of this type of product includes the warning: *Do not use the tower as a support for banners as with strong winds this can de-stabilise the tower and make it fail.*

Screen systems of around 5m by 3m probably weigh about 400kg so the self-weight of the screen and truss is at the maximum capacity of the vertical supports, even without forces from wind actions. From observation in one case the horizontal truss was visibly deflecting. Whilst that does not prove it is overloaded, the deflection will be inducing bending forces into the vertical supports by displacing them laterally and thus reducing the axial capacity.

Such screens are solid and not designed to allow wind 'blow-through'. The screen may be restrained against lateral swaying with tension members to the bases of the vertical supports. As the bases are not anchored to the ground, any tension forces could cause the bases to slide, leading to immediate collapse.

The provision of 'truck' straps as guys from the tops of the towers at right angles to the screen will result in increased axial loads in the vertical supports, almost certainly, in the view of the reporter, leading to overload/failure in the event of significant wind forces. There are also no apparent measures to prevent guys or other equipment being tampered with by the public.

The screen system in use does not have 'tour frames' attached to the rear, which are designed to absorb bending forces between screen modules. With the modules restrained across the top and at the bottom corners, wind loads tend to cause the screen modules to deflect into a concave 'saucer' shape which over-stresses the module to module connections, an effect implicated in several screen failures to date. It is noted that this is a less likely failure mode here as the whole structure can be expected to overturn or collapse before a failure of the screen modules.

The IStructE AGOTS (Advisory Group on Temporary Structures) publication **Temporary demountable structures: Guidance on procurement, design and use (Fourth edition)**> includes guidance and recommendations on outdoor screens. It says there should be:

- an independent design check carried out by a Chartered Engineer having adequate skill and experience; and
- an independent erection check on the structure once it has been erected should be carried out by a competent person, who may be an employee of the supplier of the structure or a person nominated to carry out such checking by the Contractor.

Also, as they are wind sensitive structures, there should be a clear procedure for wind management to ensure safe operation.

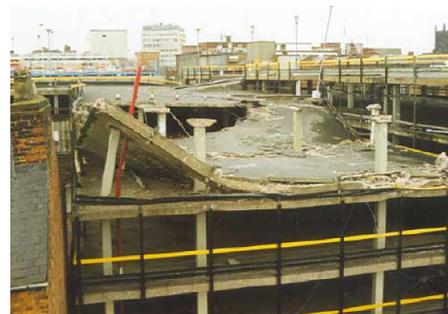
Figure 1
Pipers Row car park (photo: Jonathan Wood)

A dramatic example of flat slab collapse was at the Pipers Row car park in 1997: [Pipers Row Car Park, Wolverhampton](#)

It is of concern to think that other buildings may have deficient slab shear reinforcement at the column heads, especially as this type of failure is sudden and catastrophic. In any structural system, some modes of failure are more serious than others and flat slabs offer a prime example of this. Under overload, it is highly desirable that such slabs fail in bending before a support punching failure becomes critical, since the latter is brittle and gives little warning.
