Health and Safety Executive

**Final report of the
Advisory Committee
on Falsework.**

**Falsework
collapses**

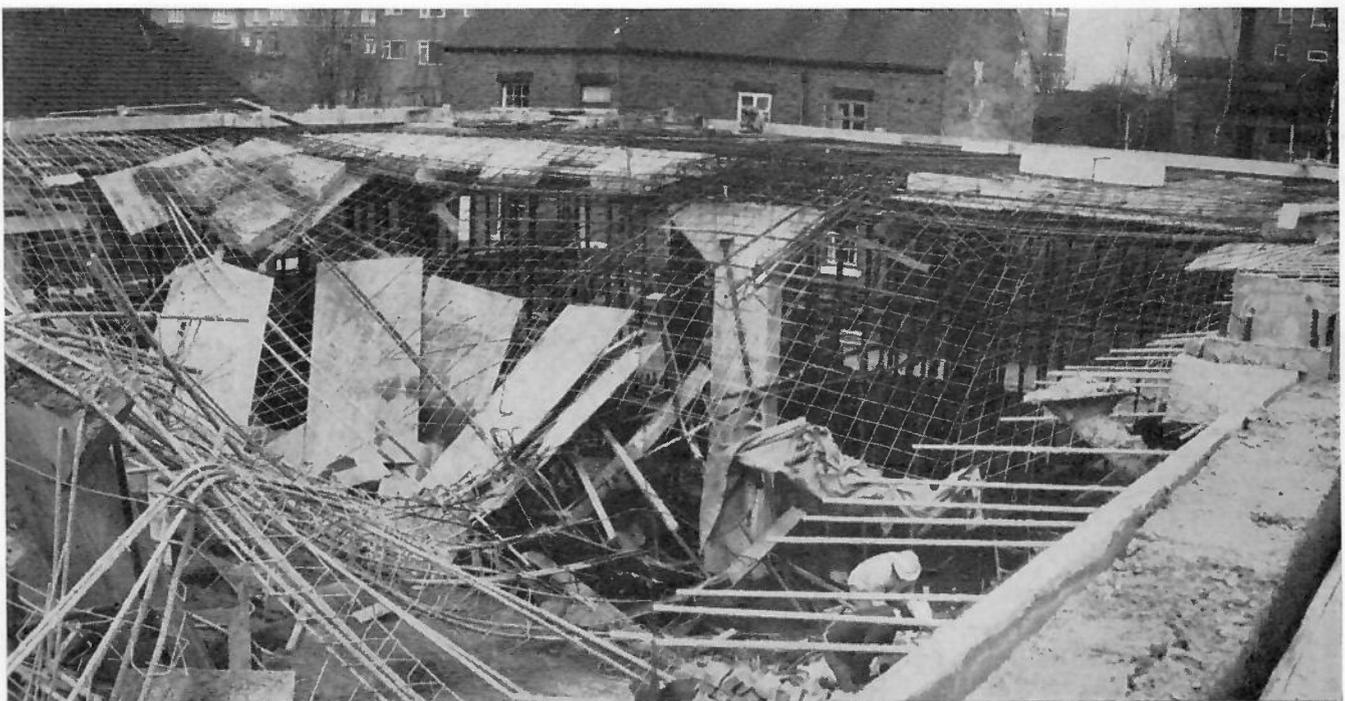
Typical failure of a prop-supported medium sized floor slab

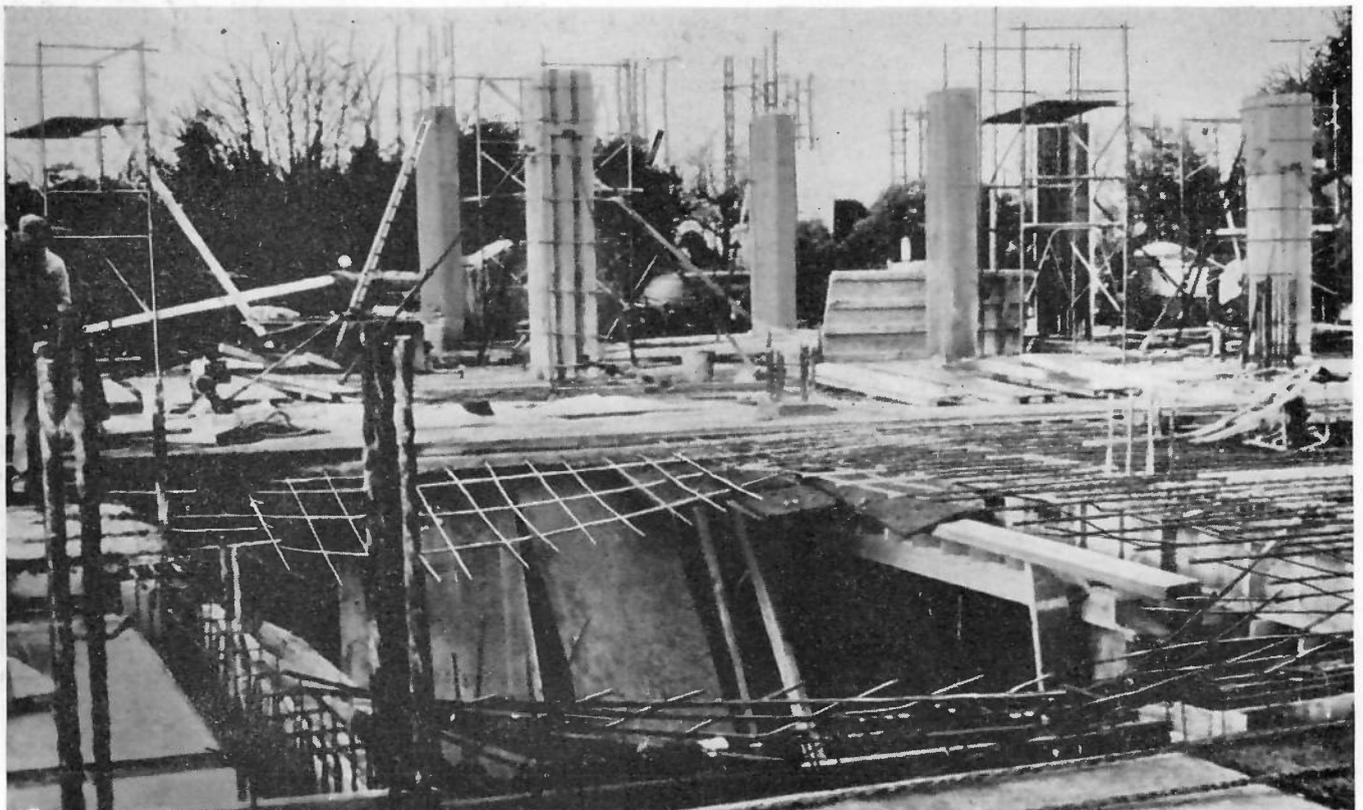
Aftermath of collapse showing damage caused to existing construction and loss of materials

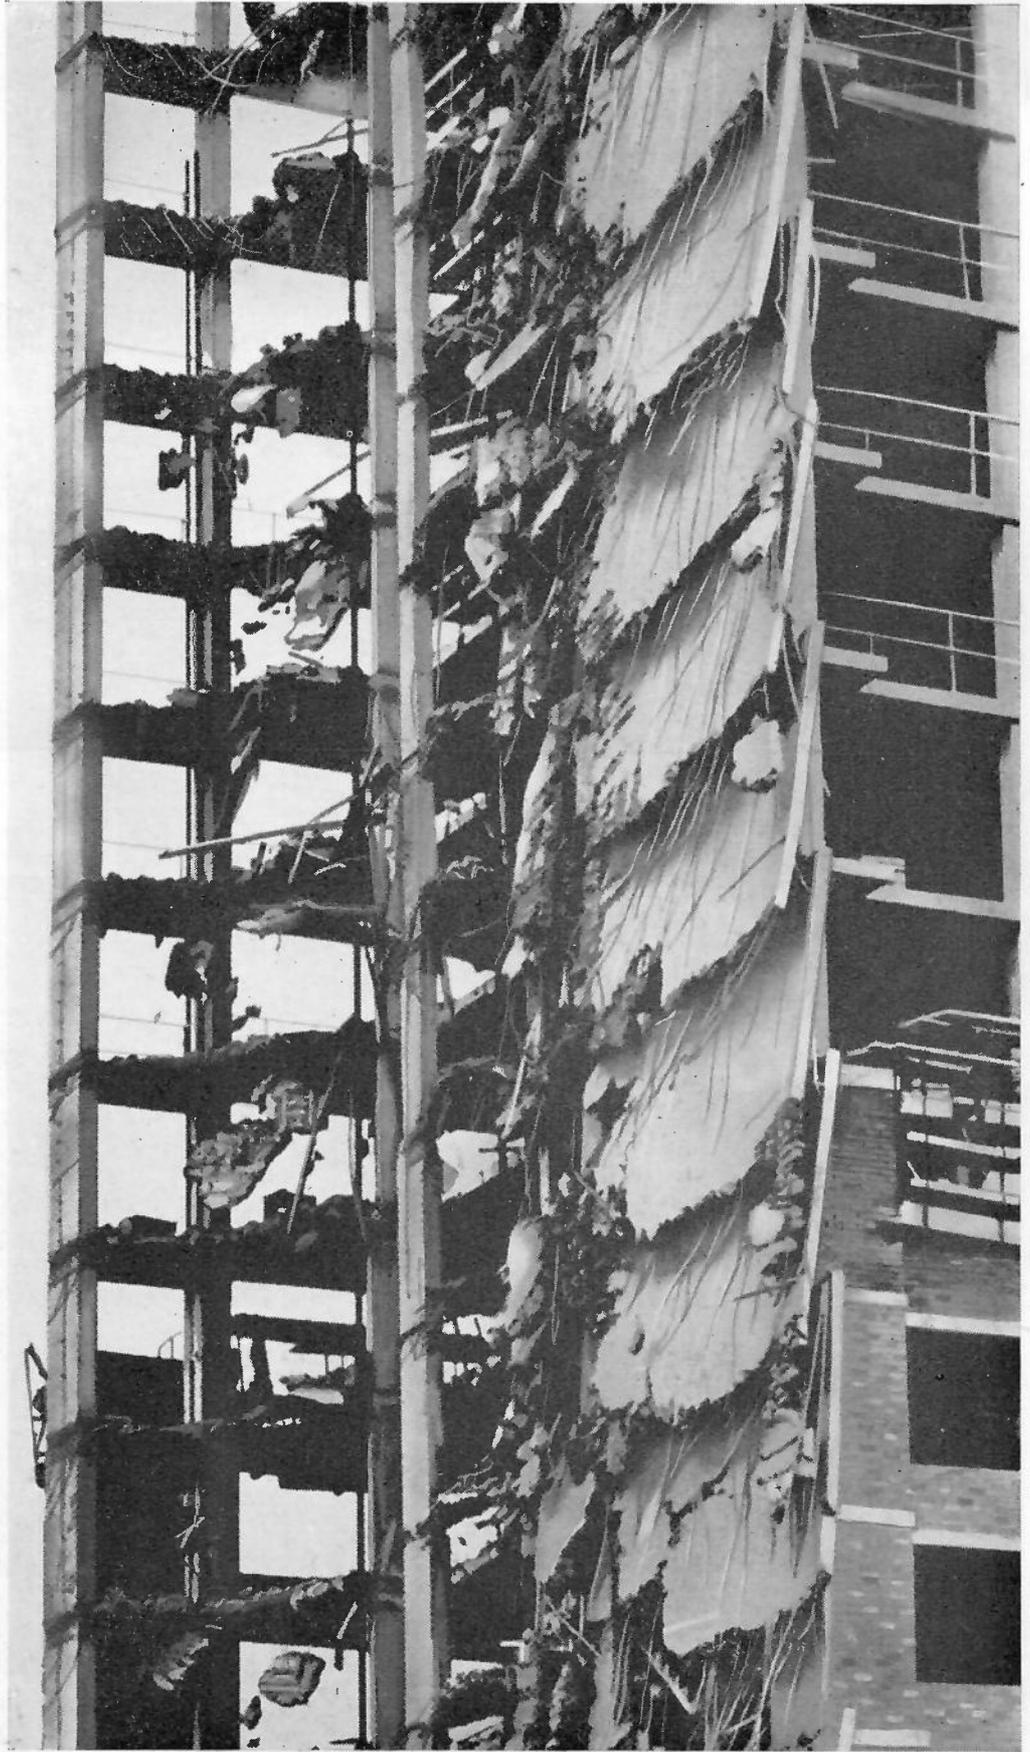
Progressive collapse of multi-storey column and slab structure caused by premature removal of the support props

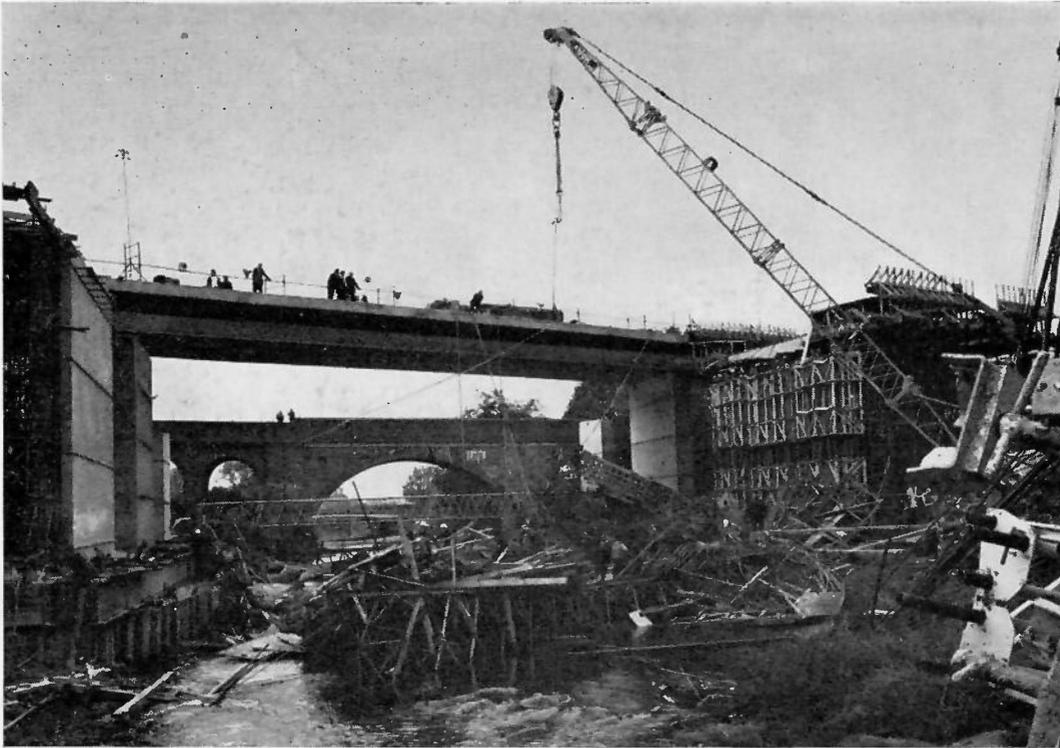
General view of collapsed falsework at Loddon Viaduct, October 1972

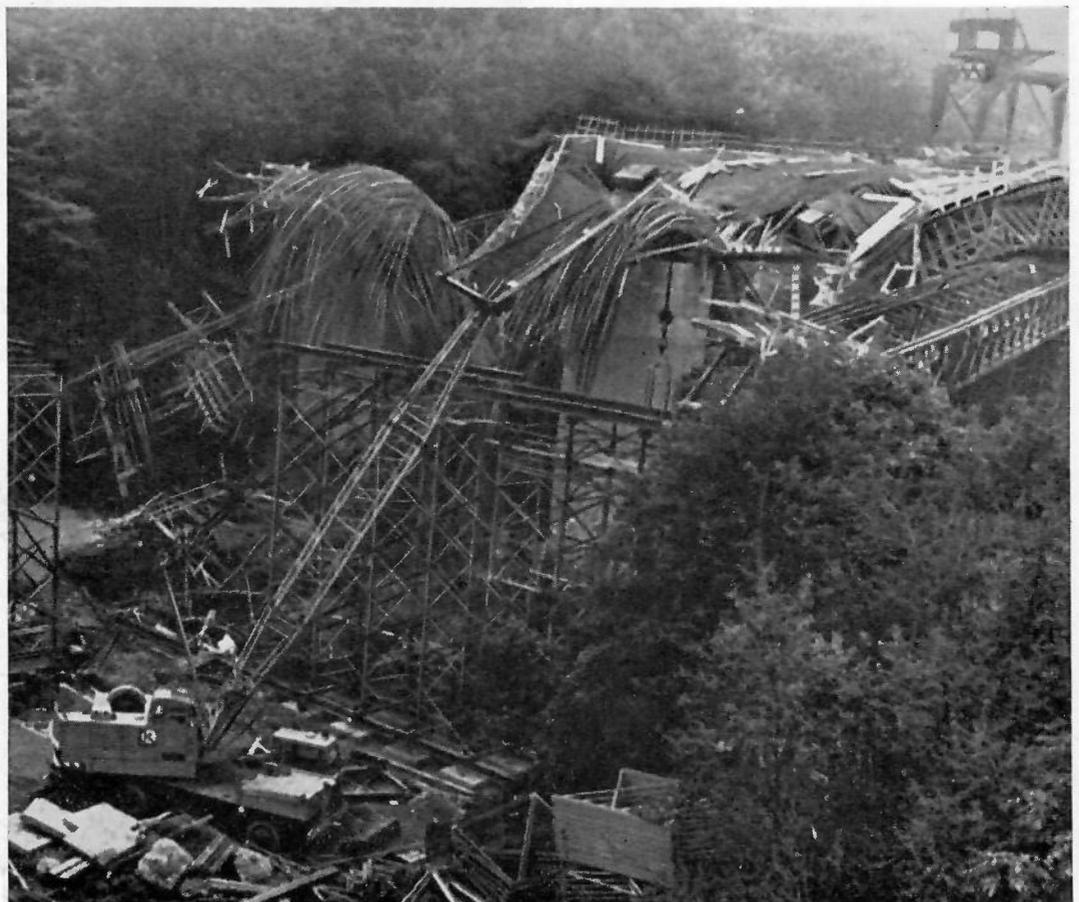
Large-scale falsework collapse on approach spans to Rhine bridge at Koblenz, September 1972

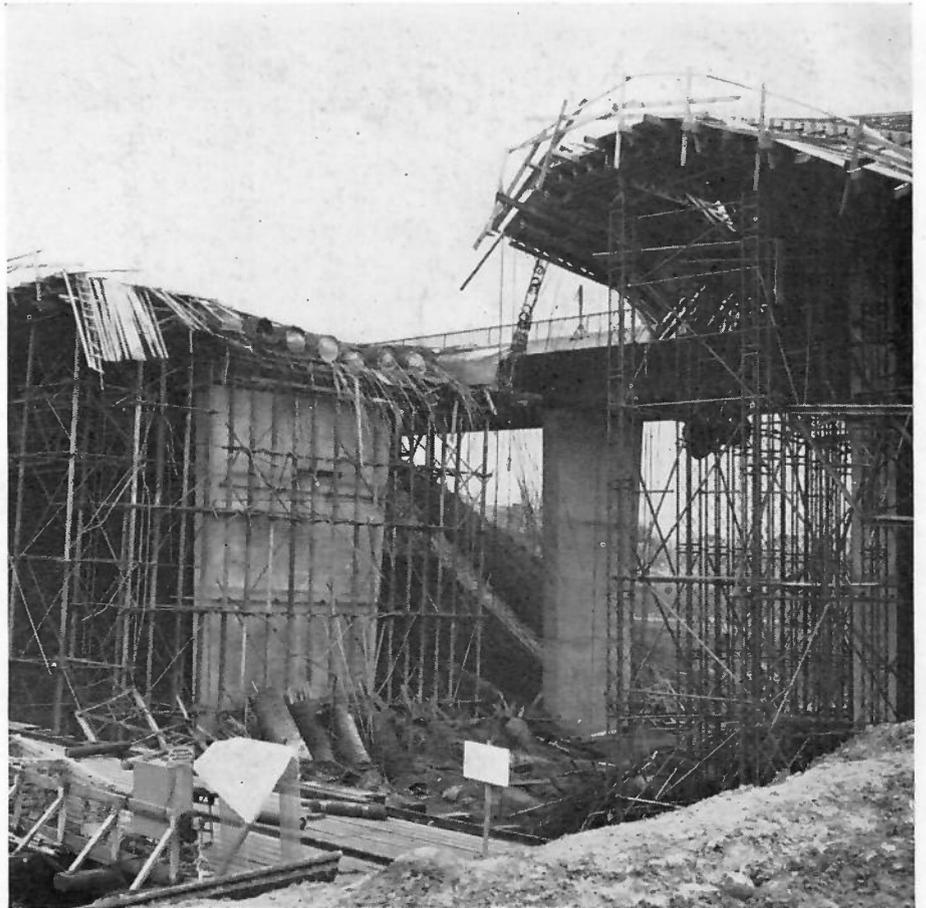
Collapse of truss-supported span of
Kempton bridge over the river
Leubas, Bavaria, April 1974

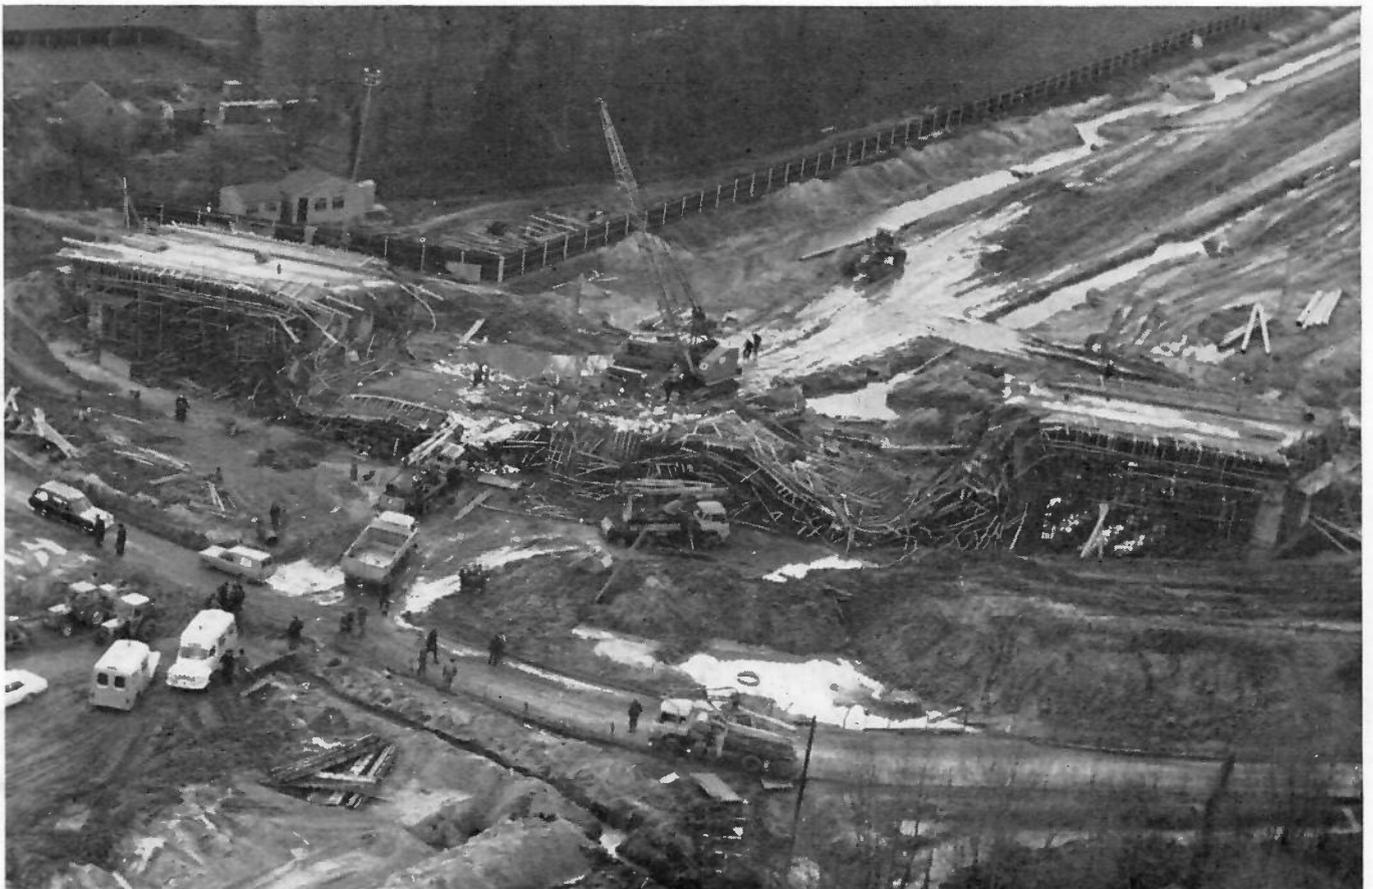
Aerial view of the devastation at
Birling Road Overbridge, Ditton,
Kent, March 1971

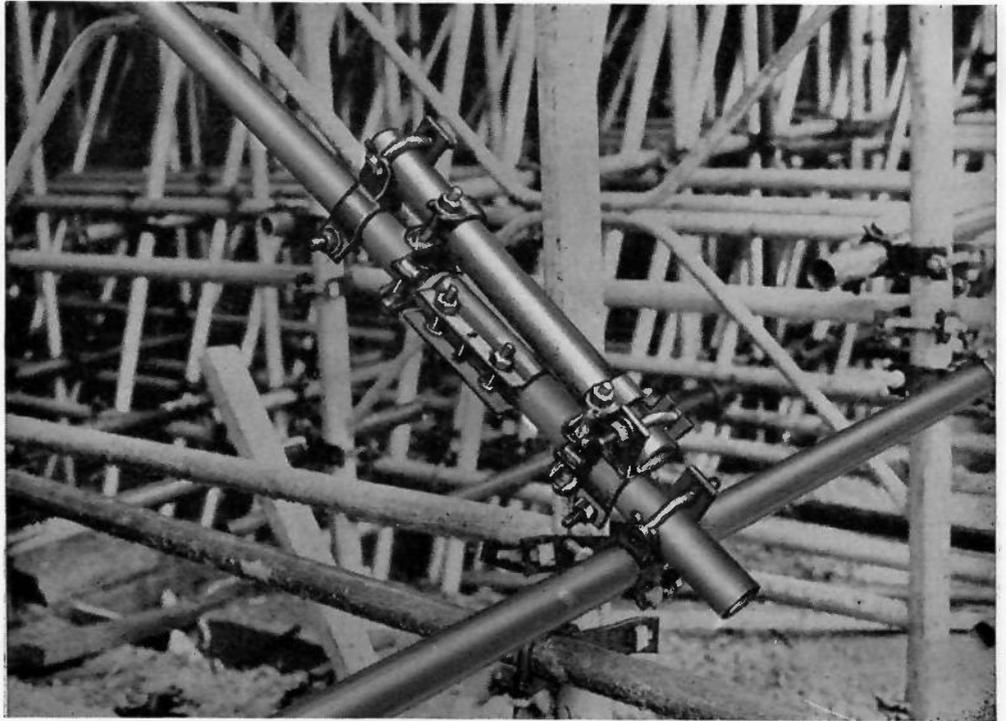
Over-elaborate lengthwise joint in diagonal. Brace connected too far from node

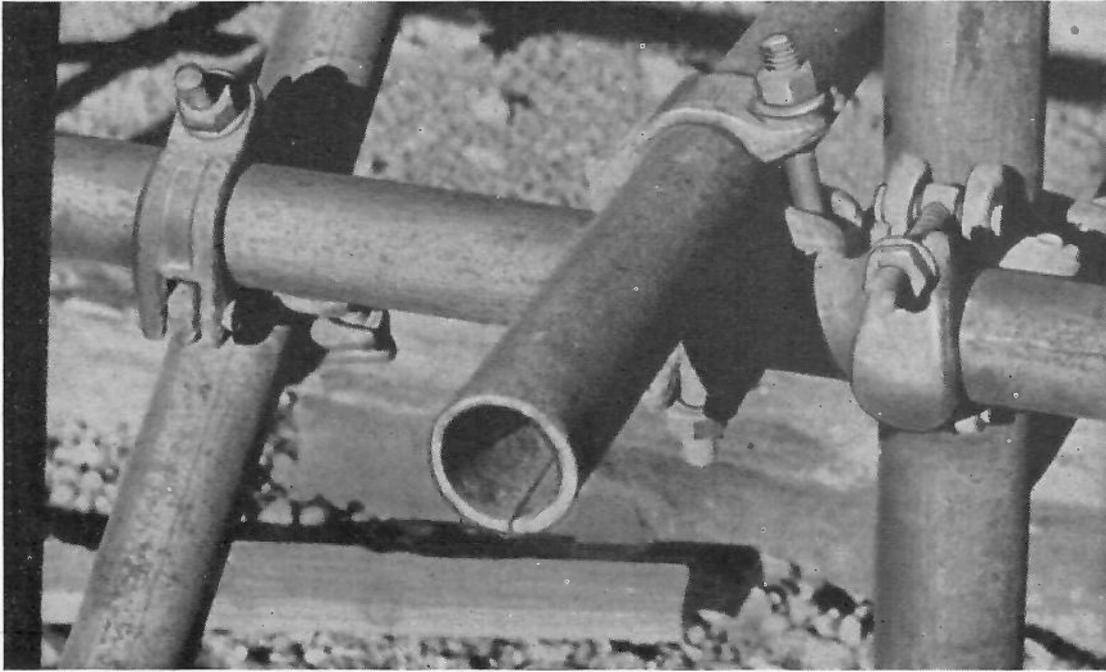
In contrast with figure on page 21, this shows undesirable separation of members at a node

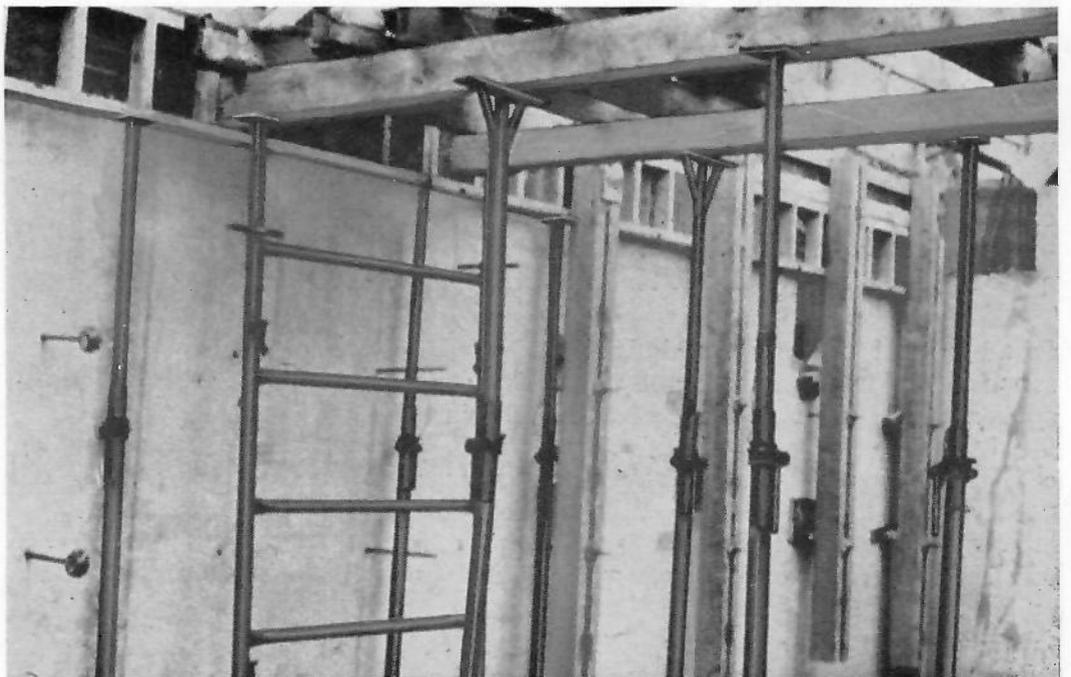
Poor practice in small-scale construction work, showing mixture of prefabricated support frame, beamhead and plain props. The props are buckled, out of vertical, not laced and have no forkheads

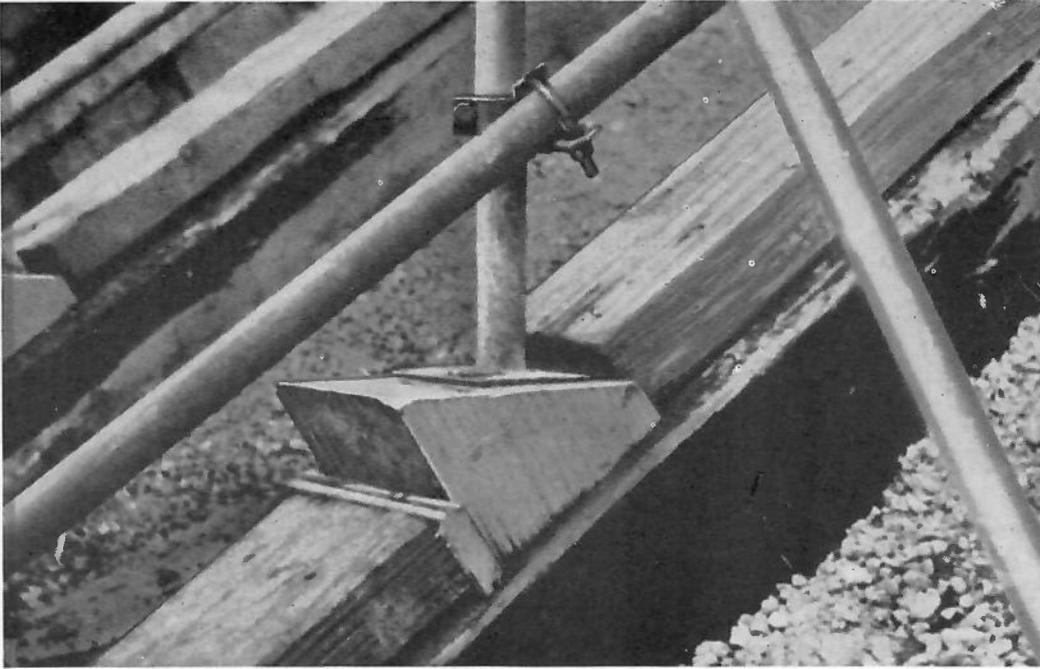
Attempt to provide adequate support on sloping base marred by incorrectly cut wedge with the load taken on the end-grain. The diagonal foot tie should have been lowered and a transverse lacing added

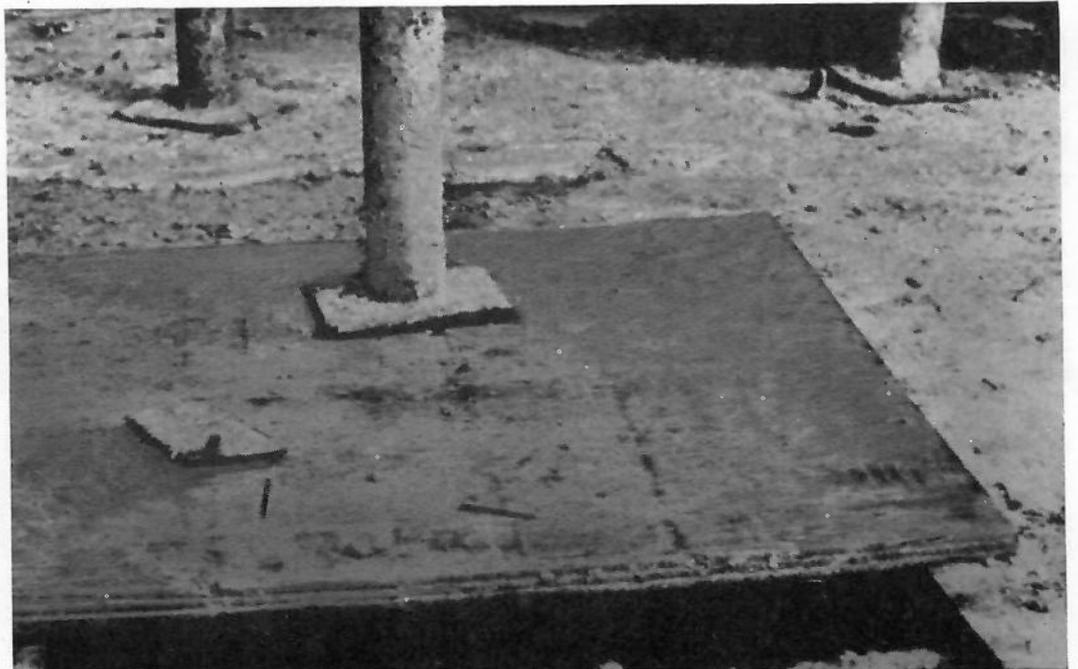
Dangerous practice: use of plywood sheet to bridge a floor opening under a prop base

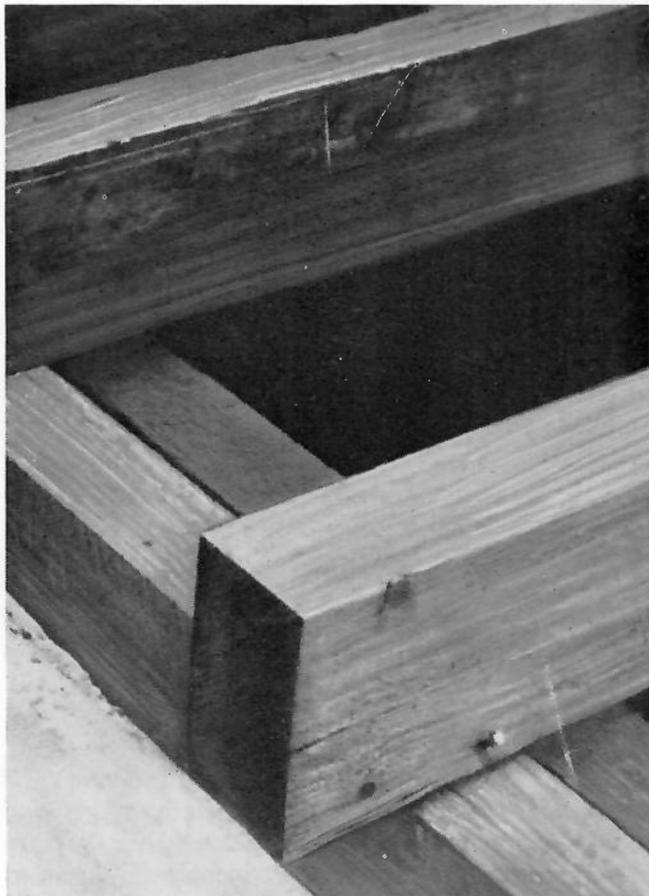
Doubling of timbers to distribute load rendered ineffective by their unequal size

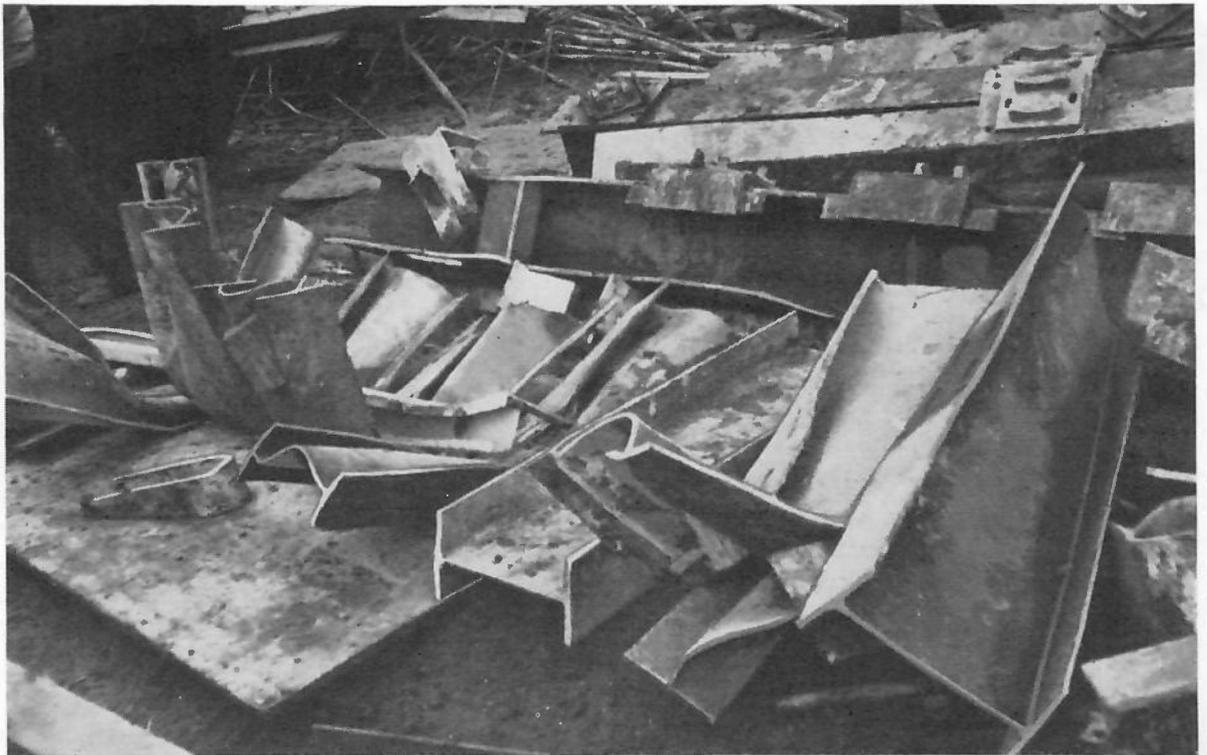
Buckling of unstiffened webs, and flange distortion of grillage beams in major falsework collapse

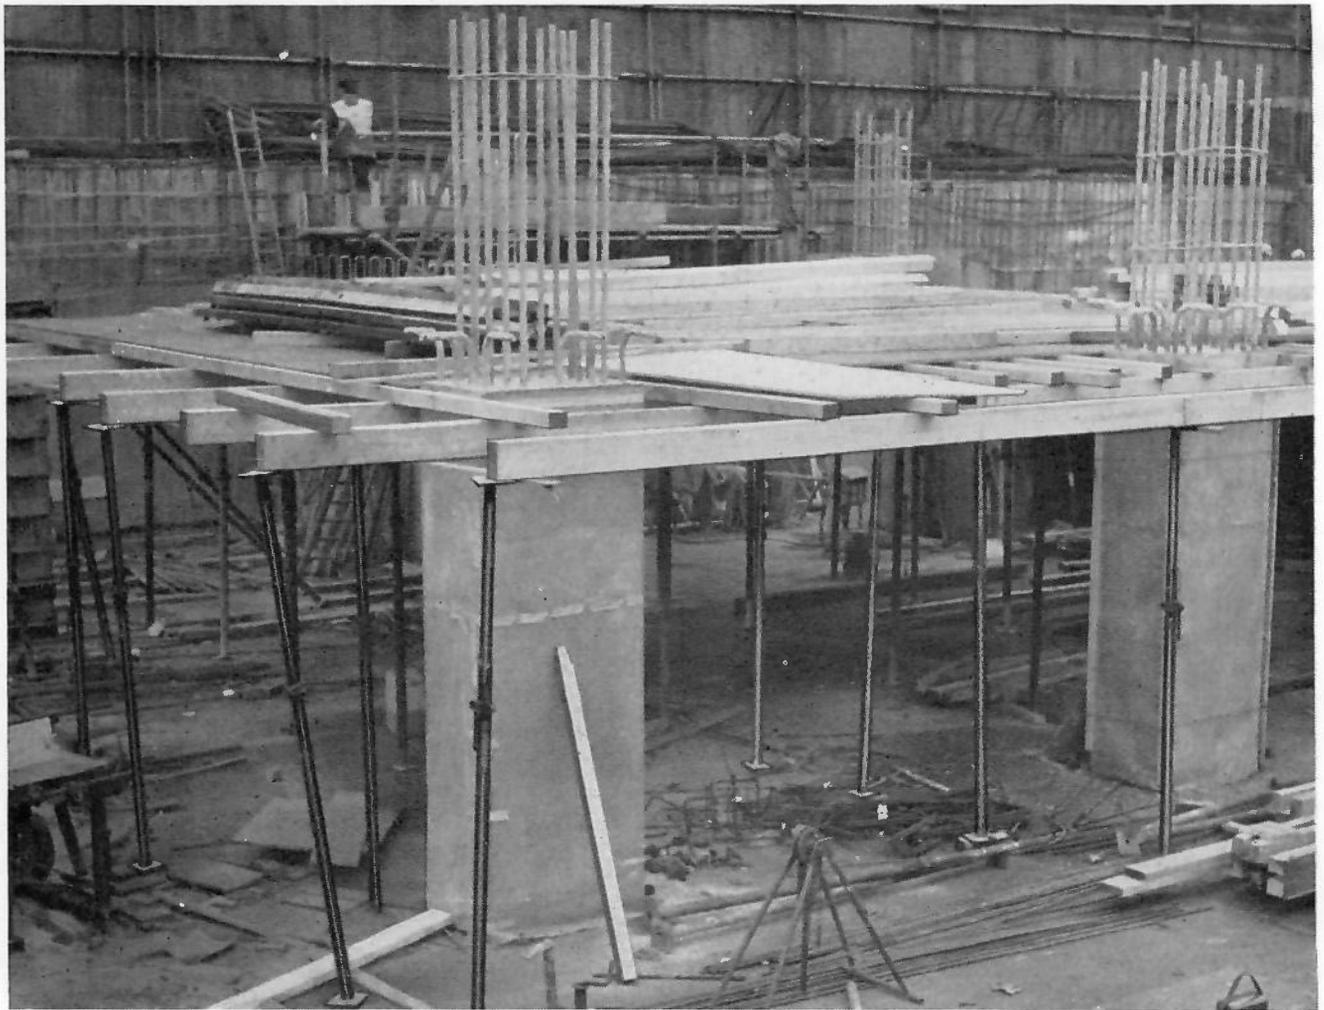
Example of insufficient attention paid to stability during intermediate stages of erection of propped shuttering. There is a risk of collapse of the incomplete and unloaded falsework by the failure to provide enough well-lined, plumbed and laced props from the outset

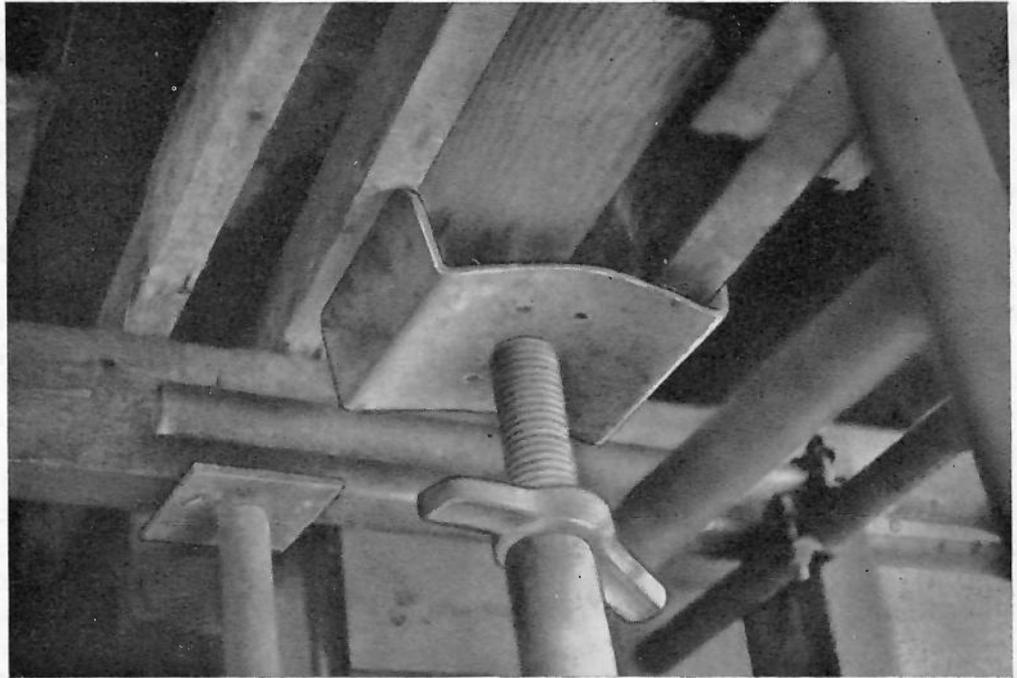
This damaged forkhead is being used in an attempt to support two timber members, only one of which lies within the forkhead

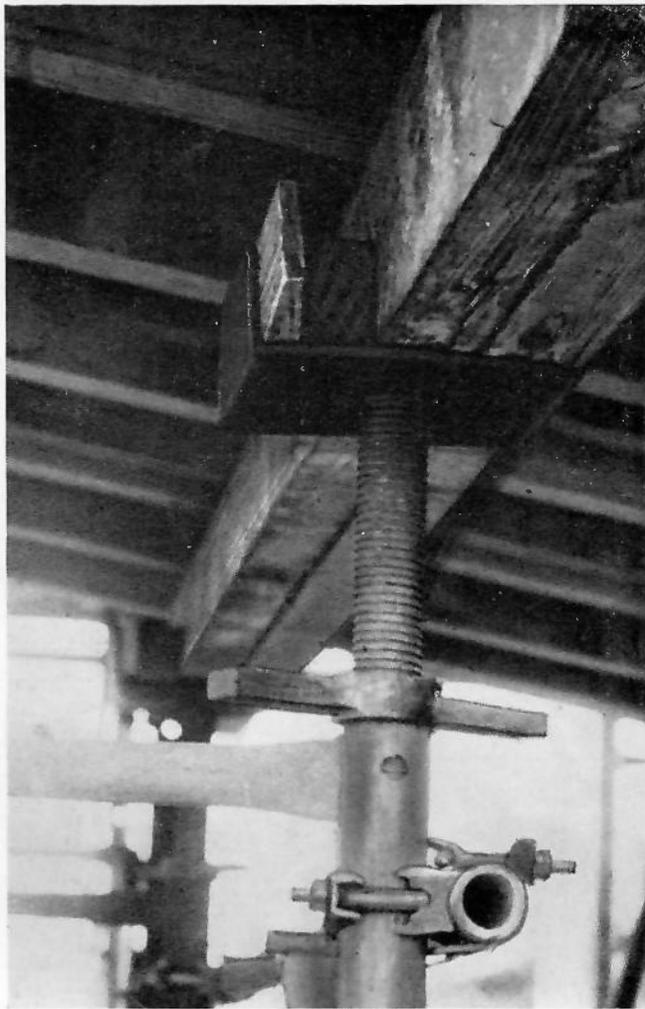
Oversize forkhead and incorrect use of folding wedges will produce eccentric loading

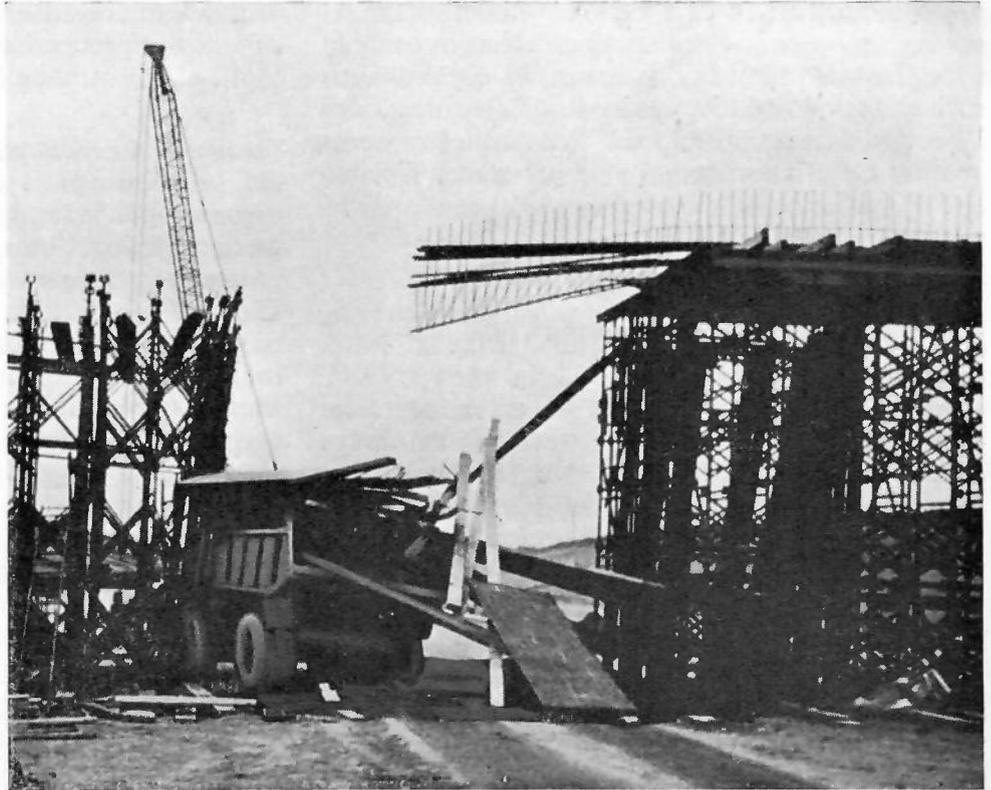
The effect of impact between a road vehicle and an unprotected access opening through falsework

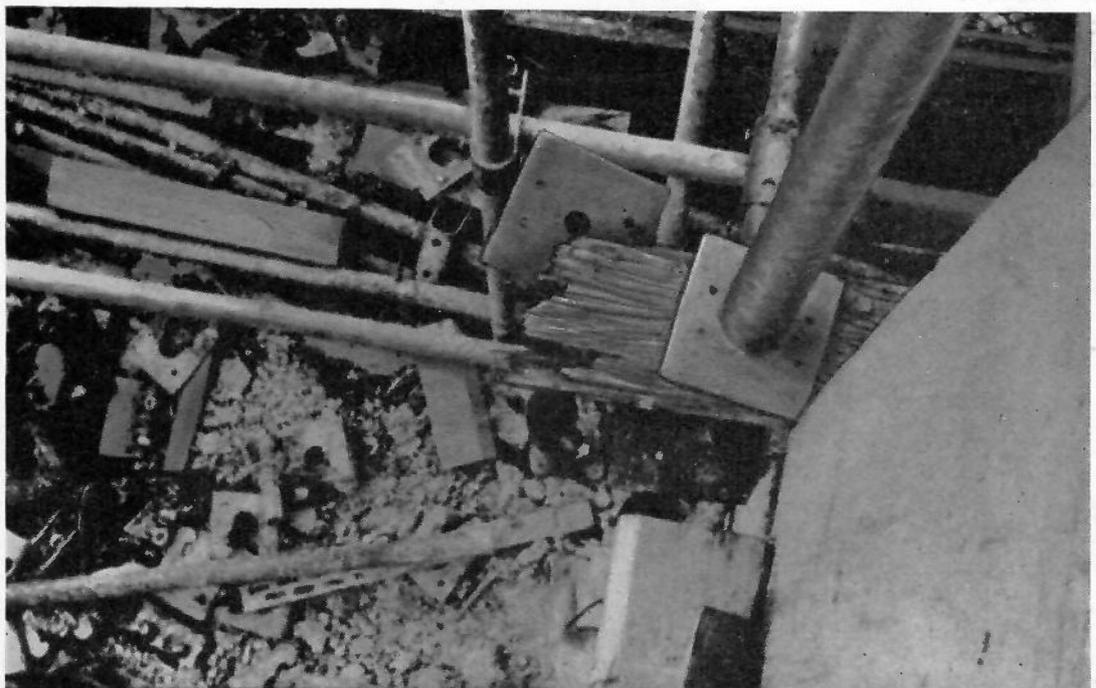
An example of bad improvisation for the extension of vertical support members. The offset vertical and the use of unsuitable timber packing is clearly shown

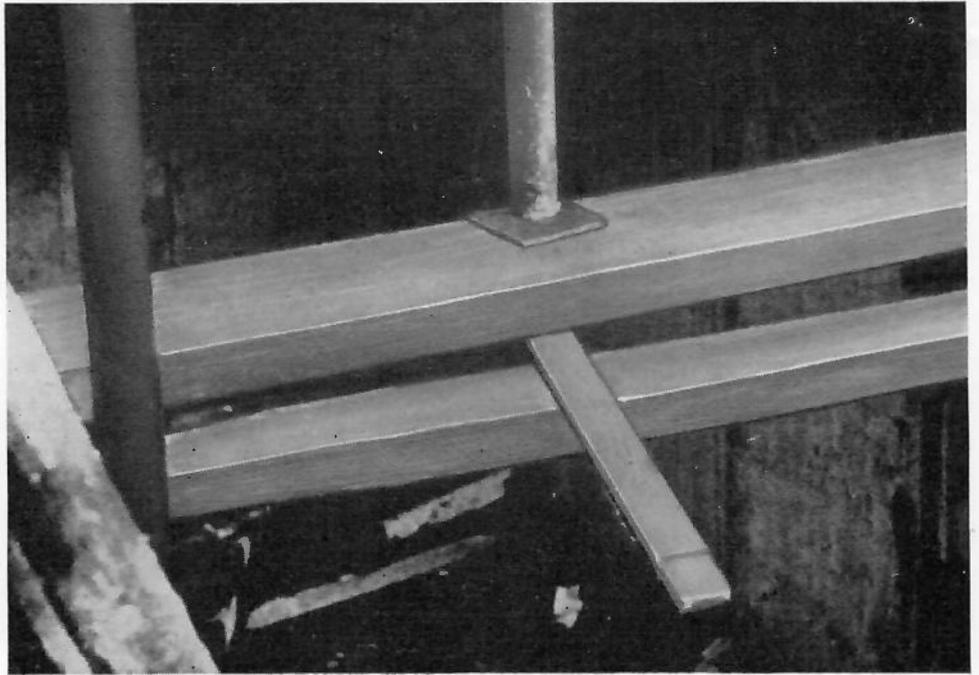
This badly improvised edge beam support was being prepared for concreting at the same site where the collapse of the floor slab is shown on page 13 had recently occurred

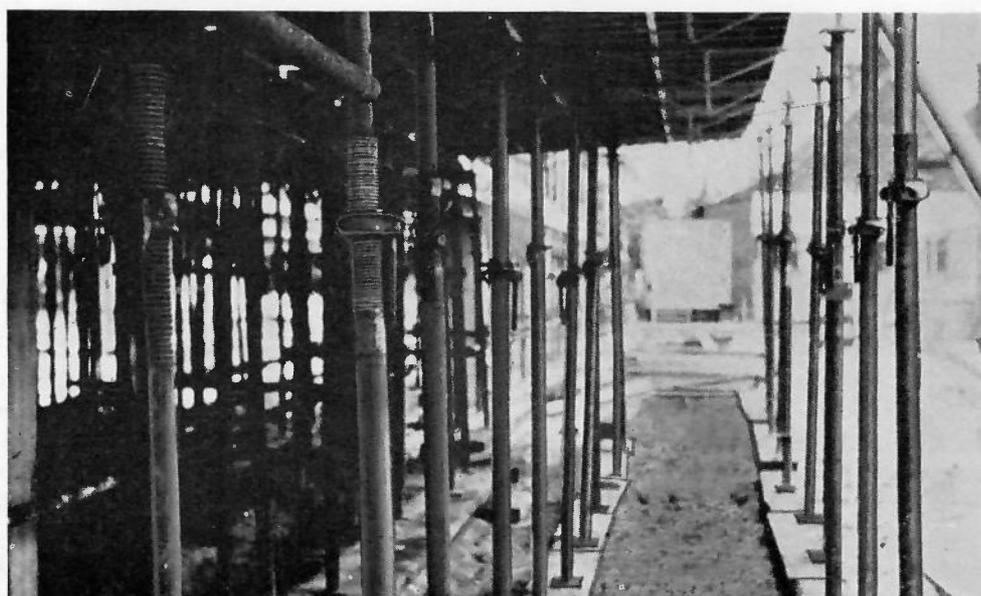
Badly placed, irregular, non-vertical rows of props do not lend themselves to fixing of the necessary lacing tubes, which have been omitted at this site
