CROSS-US Newsletter 3 | May 2021

Collaborative Reporting for
Safer Structures (CROSS)

Roof collapse of warehouse
structure under rainwater
ponding | Report ID 969

Channel slab roof deck
collapse during reroofing |
Report ID 970

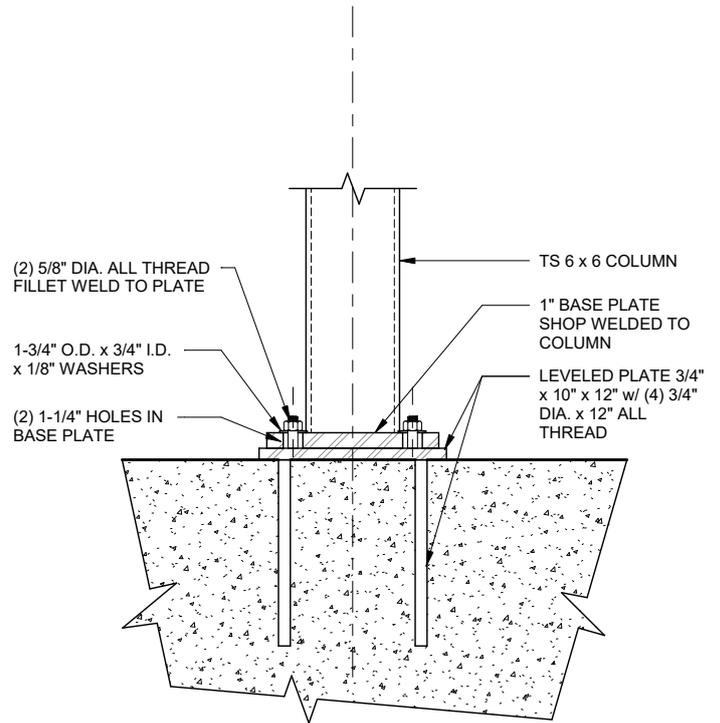
The column was a TS 6x6 (15x15 cm tube), two-stories tall. The design of the anchoring system consisted of four 3/4 in (1.9 cm) diameter all-thread bolts embedded into the concrete foundation and welded to a leveled base plate. The column had a 1 inch (2.5 cm) thick base plate welded to its end. This base plate had two 1-1/4 in (3.2 cm) (nominal 1 in) holes to receive two 5/8 in (1.6 cm) diameter bolts that the contractor field welded to the leveled baseplate. The column was temporarily secured with 1-3/4 in (4.4 cm) diameter by 1/8 in (3 mm) thick washers and 5/8 in (1.6 cm) nuts. The column base detail is shown in Figure 1.

shop drawings, reviewed by the engineer, contained the suggested detail without sufficient information to evaluate its capacity. The responsibility for determining the adequacy of the connection fell into the gap between the engineer and the fabricator/erector. The failure of the bolt weld was the weak link in the connection detail. Moreover, both the fabricator/erector and engineer failed to recognize the OSHA requirement that 'all columns shall be anchored by a minimum of 4 anchor rods (anchor bolts).' While four anchor bolts may not have prevented the accident, the designer of the connection should have been aware of the OSHA requirement.

If the design of a column base connection is shown fully on the design documents, the connection must have four anchor bolts as required by OSHA. Normally then, the structural engineer will design the connection, as a minimum, for the eccentric gravity load required by OSHA, as well as the in-service loads. If the structural engineering

Figure 1: Column base detail showing base plates and anchors. Figure drawn by REM Arch LLC.

design professional intends for the fabricator/detailer or its structural engineer to design the connection, then the contract documents must clearly state so, including specification of the required design capacity. The fabricator/detailer must also design the connection for erection conditions, again, as a minimum for the OSHA prescribed eccentric gravity load.
