# **CROSS Newsletter**

CROSS-UK Newsletter 62 | August 2021

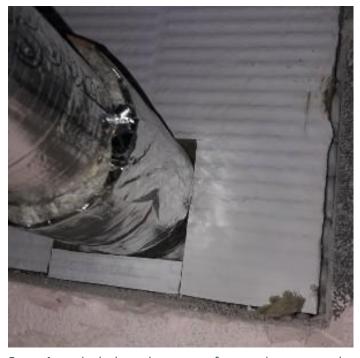
On inspection of several new builds and existing buildings, the reporter has identified fire batts that have been incorrectly installed. They say that the defective installations are endemic and not isolated occurrences. Figure 1 shows single thickness batts that have been cut to fit around services and into openings.

Figure 1: single thickness batts cut to fit around services and into openings

The joints between batts and between the structure and the batts have been sealed on one side only. The manufacturer's installation recommendations call for cut or exposed batt edges to be sealed and for joints in both faces to be sealed with intumescent mastic. In all cases, the installer was a specialist contractor with third party accreditation.

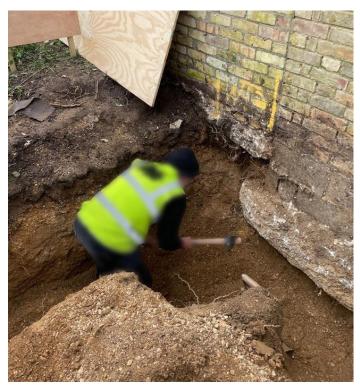
A reporter was called to inspect a foundation excavation and found the situation as shown in Figure 1. The builder said 'I haven't undermined the foundation at all.' The outer face of the excavation was neatly in line with the outer face of the 225mm wall to the neighbour's house; whose footing can be seen to the right.

- the load was now concentrated on a footing that was only two thirds of its original width
- the bearing capacity of the outer edge was almost zero, due to the lack of lateral resistance
- there is a natural tendency for any trench to fail under the weight of the soil alone never mind with a foundation load applied to its edge

Figure 1: Unsafe excavation undermines masonry wall

Undermining any foundation to the degree shown is an absolute failure without the sanction of an engineer with a method statement and risk assessment. Normally a method statement would give an indication of a type of hit and miss sequence with a limit on width exposed of between 1 and 1.2m depending upon the wall construction and ground condition.

Emergency propping was immediately installed, and the new foundation constructed a day later, and nothing untoward occurred on this occasion. The reporter can recall many cases where the outcome wasn't as happy; the number of lives lost or forever changed by such practice would be a sobering statistic worth knowing.
