CROSS-US Newsletter 4 | May 2023

Partial collapse of a shopping mall roof under drifting snow | Report ID 1009

Erroneous design snow loading assumption for indoor sports facility causes structural distress | Report ID 1012

Structural misunderstanding leads to historic church tower nearly being demolished | Report ID 1013

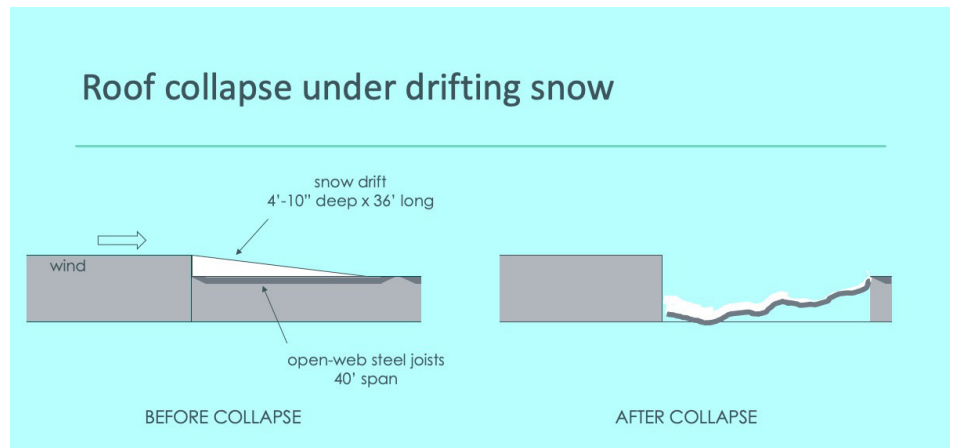
- **Capacity of roof joists relative to expectation:** The load tests of joists removed from the structure showed they had only 73% of their expected strength. (Rather than an expected strength of 1.65 times rated design capacity, the joists had an ultimate strength of only 1.20 times the rated design capacity.) The joists were produced by a manufacturer no longer in business. Their members were cold-formed steel, hat-shaped for the top and bottom chords and V-shaped for the web members. The fabrication resulted in large member eccentricities at

the joints, non-uniform stress flow in members, and embrittlement of the cold-formed steel. These fabrication deficiencies caused premature buckling of the compression diagonals and premature, brittle fracture in the end-tension diagonals.

Based on the findings of the investigation, approximately 270,000 SF of the mall roof structure employing the defective joists was reinforced.

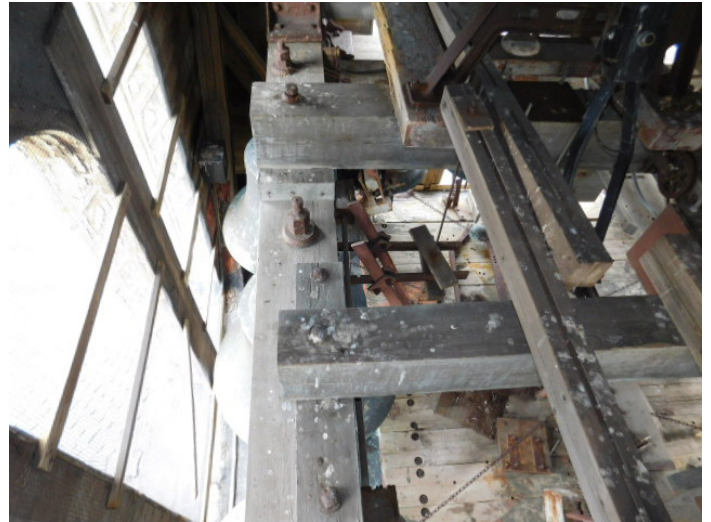
Significant gaps between the exterior masonry wall of the tower and the perpendicular flying buttresses of the adjacent side aisles were observed from windows of adjacent structures. Previous reports and assumptions had asserted that these gaps were specifically attributable to the usage of the carillon bells. Implementing some respectful skepticism of established assumptions, however, the structural design professional climbed several flights of stairs and a few seldom-used ladders, which afforded admission to the rarely accessed carillon belfry. One notable feature became immediately apparent: the aged timber structure supporting the bells was structurally isolated (Figure 1).

Figure 1: Timber structure supporting bells is structurally isolated from the exterior masonry walls

renewed insight, a phased masonry restoration program was initiated, the carillon restrictions lifted, and the community gathered around the spire once again to hear the bells ring.
