CROSS-UK Newsletter 69 | June 2023

Collapse of unusual
hybrid concrete and steel
strand truss on school roof

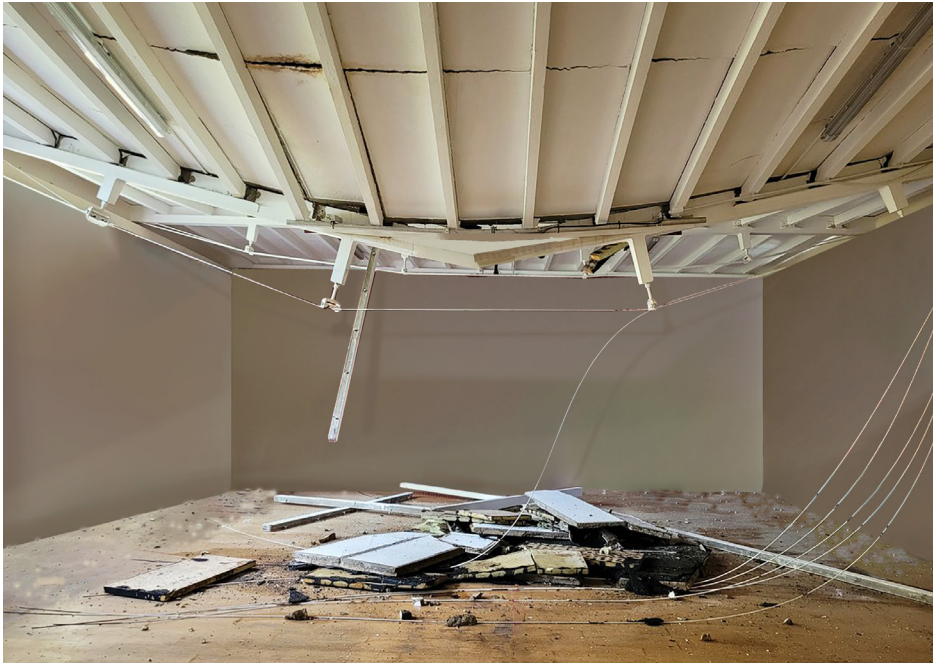
the truss, and a partial collapse of the adjacent roof. The failed truss is shown in Figure 1 below. Fortunately, the collapse happened outside of school hours and when the hall was not in use.

Figure 1: failed truss and partially collapsed roof

The reporter, a structural engineer, visited the site soon after the collapse. The roof truss had failed with six of the seven steel tensioning strands lying on the ground. The anchorage fixings for the detached end of the loose strands were found in the bearing pocket of the edge beam. The anchorages for the other end of the strands remained with the top chord endplate. The purlins on either side had collapsed or were damaged and hanging from one end, but the felt roof was still intact and holding water.

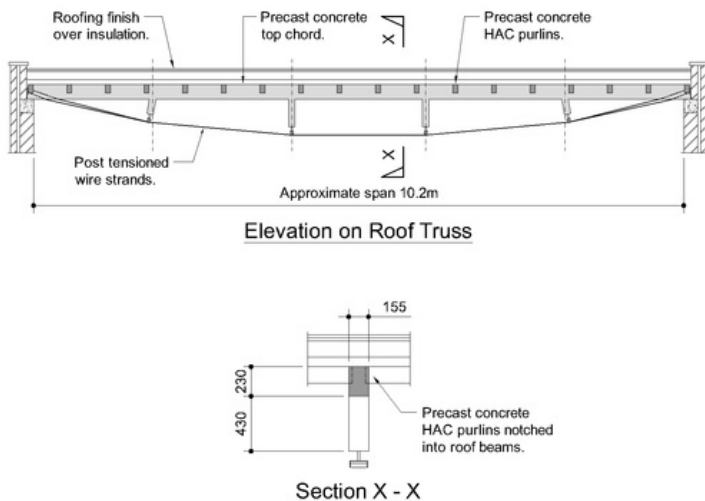
Figure 2: elevation and section through truss

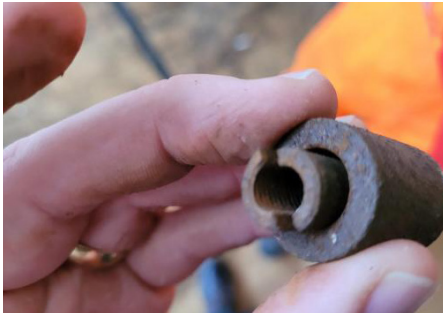
The tensioned strands were held at the endplates using a cylinder with two serrated split wedges, as shown in Figure 3 below. The strands were carried over the concrete verticals on support rollers. It was not clear to the reporter how the truss was originally tensioned. The reporter says that there may have been an initial tensioning at the factory, with further tensioning prior to installation using the threads on the steel mounts to lengthen the verticals, thus tensioning the strands. Figure 4 below shows the steel mounts and strand support rollers.

Figure 3: anchoring cylinder with two split wedges

The reporter believed the failure possibly resulted from anchorages of the tensioning strands slipping suddenly without warning. This could have led to a global failure of the truss in bending, as witnessed by the significant deflection and damage that occurred at the centre of the span. The reporter reasoned that once the anchorages had slipped, tension was lost in the strands and, owing to the poor detailing of the reinforcement at mid span, combined with the reduced capacity of the concrete chord, the truss likely failed in bending at mid span and collapsed. This caused the purlins to become dislodged and the roof structure in the two bays on either side of the truss to fail and deflect or collapse to the ground.

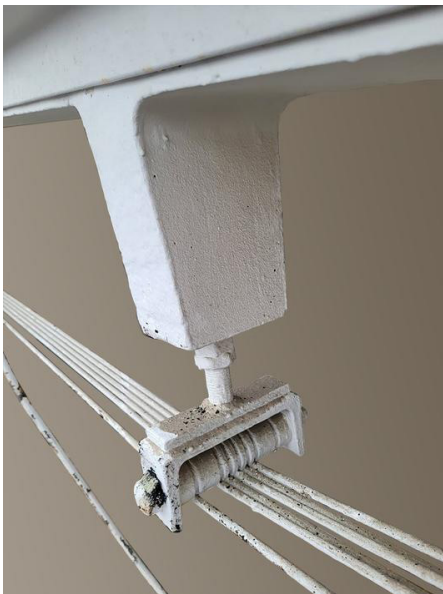
Figure 4: steel mount on concrete vertical carrying tensioned strands

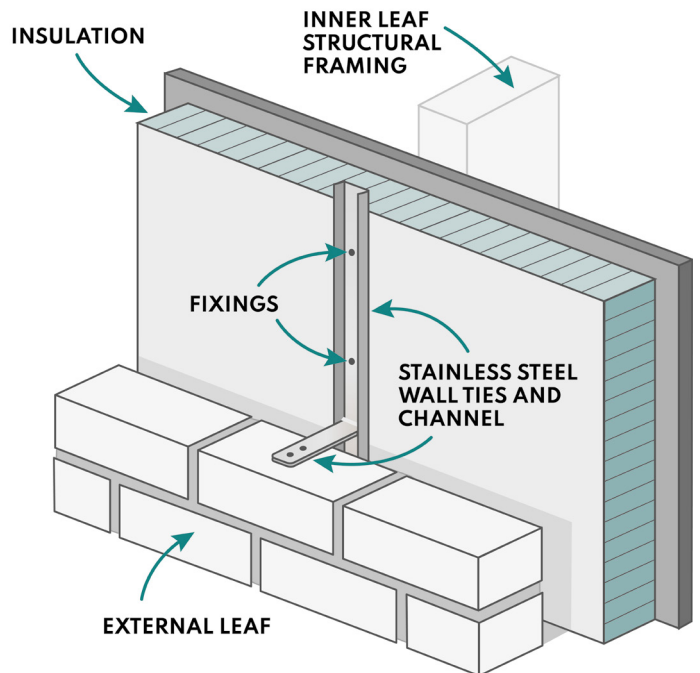
A reporter is concerned about corrosion that may occur between dissimilar metals that can be used in cavity wall tie systems. In particular, the reporter has identified that stainless steel and carbon steel may be fixed together in wall cavities that could be considered damp environments. The reporter cites that, as modern methods of construction evolve, this situation could occur more frequently with metal components, which are likely to be stainless steel, positioned in the cavity and fixed back to framing or other structural elements forming part of the 'inner skin'. The reporter is concerned that the fixings holding the stainless steel components could be more susceptible to corrosion if they are made of carbon steel and are positioned in the cavity. The issue is illustrated in Figure 1.

Figure 1: fixings that could be susceptible to corrosion

As in the reported case, where stainless steel channels are fixed back to the structural framing with carbon steel fixings, dissimilar metals may come into contact. The channels are generally fixed to the structural framing of the building by self-drilling, self-tapping fixings which pass through a hole in the channel, through the insulation and fix to the structural framing which could be concrete, steel or timber. Where the fixings pass through the stainless steel channel and a mechanically secure connection is made, this is likely also an electrical connection and where the carbon steel could corrode.

Structural designers and other specifiers should take the lead in specifying stainless steel systems and compatible fixings for damp environments where corrosion between dissimilar metals may be a concern, unless other measures to avoid dissimilar metal corrosion are taken. These fixings are more expensive, but their use will completely avoid the problem of dissimilar metal contact inside the cladding system. Designers should specify the whole wall tie system on construction drawings. Arrangements should also be made to check installations on site. Manufacturers should be consulted regarding the life of fixings, taking into account the site exposure conditions. Manufacturers should ensure that the design life for varying exposure conditions for all systems and materials is readily available to specifiers.

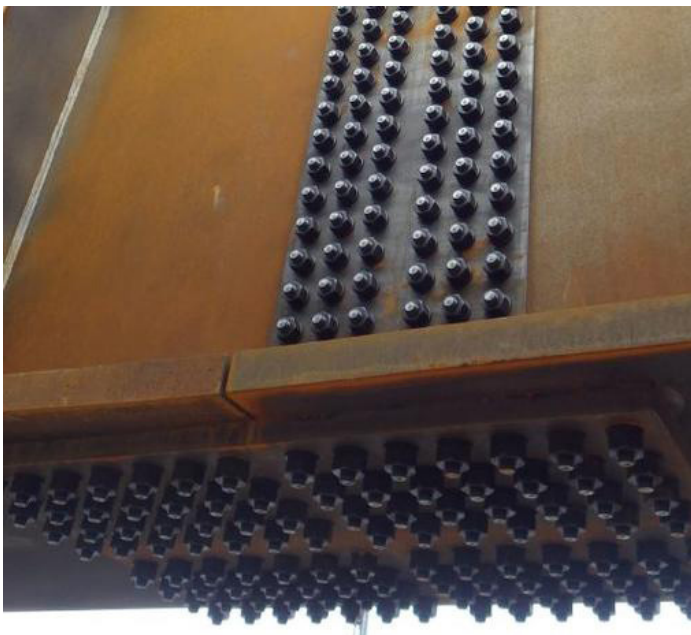
During an inspection of the site assembly of large steel plate girders for a highway bridge over a railway line, as shown in Figure 1 below, a reporter observed a bolting operative incorrectly installing 24mm diameter tension control bolts at a joint.

Figure 1: a bolted joint in a plate girder

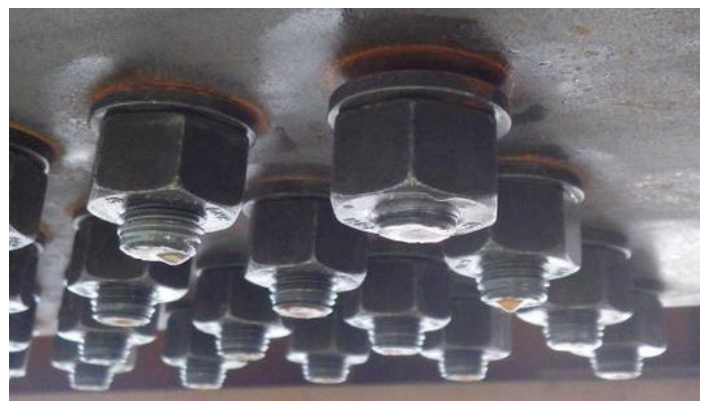
In the case observed by the reporter, an operative was tightening in one stage using a specialist wrench and working in no particular order. After completion of the joint, a bolt that was supposedly fully tightened was observed to be loose, as shown in Figure 2, and could be easily unscrewed by hand.

Figure 2: a loose tension control bolt after completion of joint
