CROSS-UK Newsletter 71 | December 2023

Fire performance of
timber cladding

Collapse of folded plate
timber roof at a school

Serious inconsistencies
when installing passive
fire protection

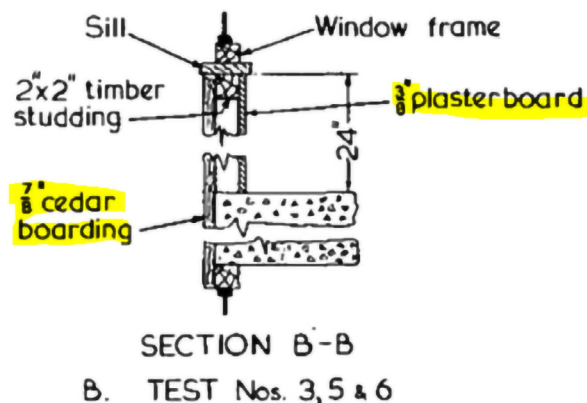
Figure 3: A section of the report noting thickness of the cedarwood

A section is provided below, with the thickness figure differing from the text of the report, noting the cedarwood to be $\frac{7}{8}$ inch in thickness and not 1 inch.

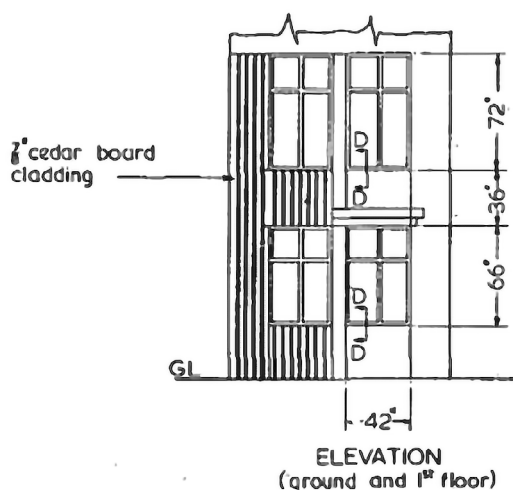
Figure 4: The elevation of cladding

An elevation of the cladding is provided below to show the nature of the assembly that was tested:

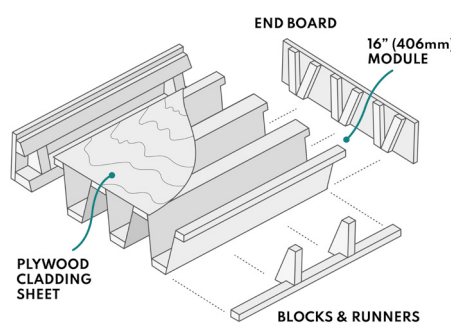
Figure 1: sketch of roof system

The reporter considers that if the cases are similar, the end blocks of the roof, which were likely just held with glue and panel pins, may have become detached, as they did in the previous case, resulting in a sudden shear failure and the collapse of the roof.

The cause of the collapse was not clear, however any structure that relies upon glue and panel pins is unlikely to be robust if water damage occurs at critical connections. It may be that a lack of maintenance permitted water penetration which impacted critical connections and precipitated the collapse. Any roof with suspected water penetration or water shedding problems should be inspected and repaired as a priority, as water degradation can cause structural damage and failures. Water and moisture generally are contributing factors to much deterioration and failure of buildings. Good detailing, construction, and maintenance of weatherproofing systems are essential.

Any roof with suspected water penetration or water shedding problems should be inspected and repaired as a priority

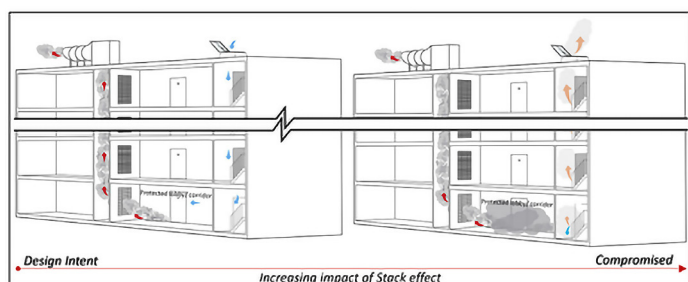
Figure 1: Fire safety impact of stack effect

As illustrated in Figure 1, the stack effect can interfere with the operation of certain types of smoke control systems by encouraging a flow of air that is opposite to the desired direction of airflow.

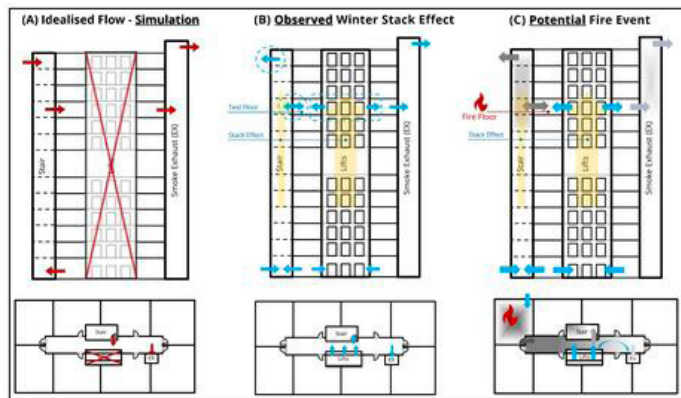
Figure 2: Observation Test 1

Figure 2(A) illustrates the typical idealised flow to remove air via a smoke shaft in the lift lobby (driven by a smoke extract fan) with airflow being drawn from the stairwell's open AOV. During a test of the smoke control systems, the main entrance and exterior stair doors at ground level were open.

Figure 2(B) shows what was observed during the test, namely how the smoke exhaust systems were unable to counter stack effect driven flow up the stair shaft. This required retroactive amendments to the system which may not have been undertaken in other buildings, particularly those commissioned on warmer days.

Finally, Figure 2(C) demonstrates that if a fire occurred while the building was experiencing a winter stack effect condition, smoke could be actively pulled into the stair as the exhaust shaft is unable to overcome the draw of air into the stair. Furthermore, it shows it is likely to be exacerbated by fire driven mechanisms such as a buoyancy driven upwards air flow, increasing pressure in the lobby corridor.

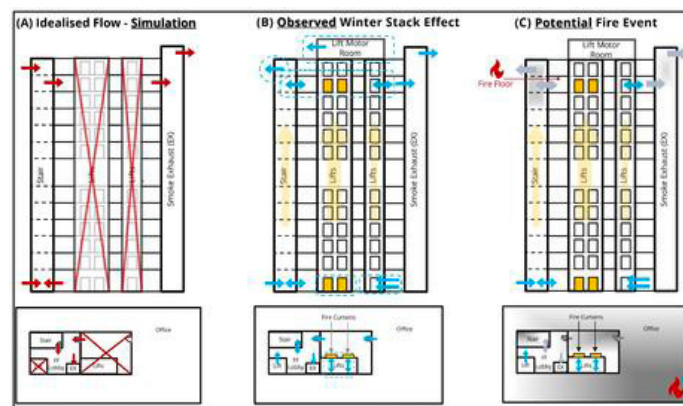
Figure 3: Observation Test 2

Figure 3(A) illustrates the idealised design flow, which was observed to not sufficiently account for flow through the firefighting lift. The exhaust function was intended to generate a pressure differential across the escape stair door to prevent airflow into the escape stairwell. During the test, the lift motor room vent was open as well as the main entrance and exterior stair doors at ground level.

Similar to Observation Test 1, Figure 3(B) shows how, during the test, the air flows within the escape stair were reversed compared to the design flow. Additionally, the combined force of the smoke extract system and stack effect caused fire curtains in front of the lift doors to fail to fully close on the fire floor and the ground floor. However, it should be noted that in a similar case with a taller building, the ground level fire curtains were pulled out of the runners when the ground level doors from the lobby to the exterior were opened. In some instances, particularly when the firefighting lobby door to the main office floorspace was opened, the firefighting lobby exhaust was also unable to prevent airflow into the adjacent escape stairwell.

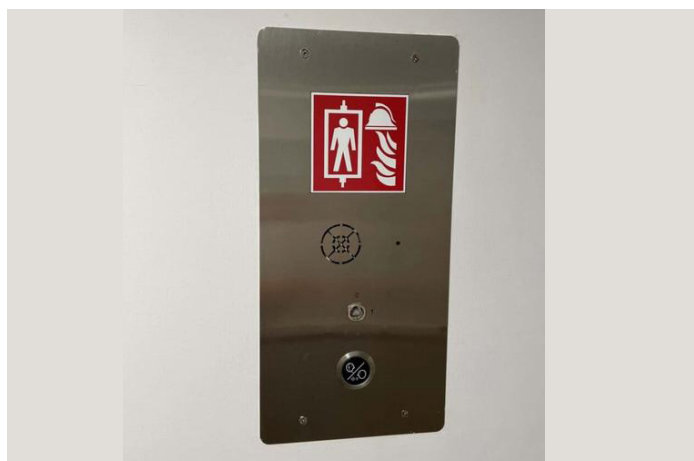
Figure 1: Example of Firefighters lift control

persons with responsibility for buildings are not conducting regular checks on lifts provided for the fire and rescue service
