# CROSS Newsletter

CROSS-UK Newsletter 72 | March 2024

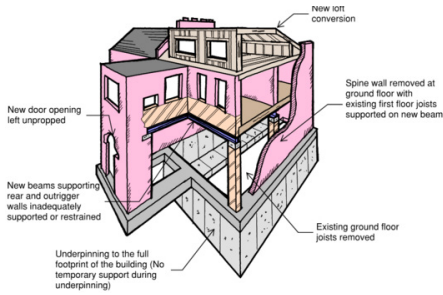
The whole building had been underpinned and excavated to form a new basement. This had been done while simultaneously removing internal and rear walls. When reviewing the work on site (from a safe distance due to a prohibition order preventing entry), the reporter observed that inadequate temporary works had been put in place.

**Figure 1:** A view from the rear

Figure 1 shows the extent of works partially completed to the rear and internally when the reporter visited the properties.

The reporter concludes that this highlights the need for clients to ensure that there is a competent design team and competent site team who understand the risks associated with the complex task of adding a basement to an existing terrace property.

Along with an understanding of the temporary works that are required on site, the reporter feels that basement works such as this, should need full building control approval and planning permission prior to work being started. This would ensure that works are appropriately designed and will not cause undue risks.

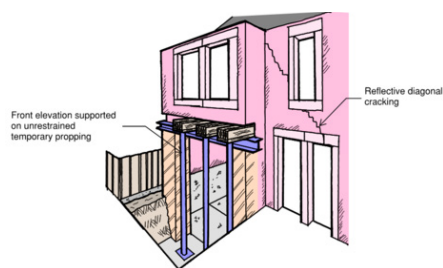
**Figure 2:** A view from the front

Figure 2 shows the extent of the works partially completed to the front of the property when the reporter visited the properties.

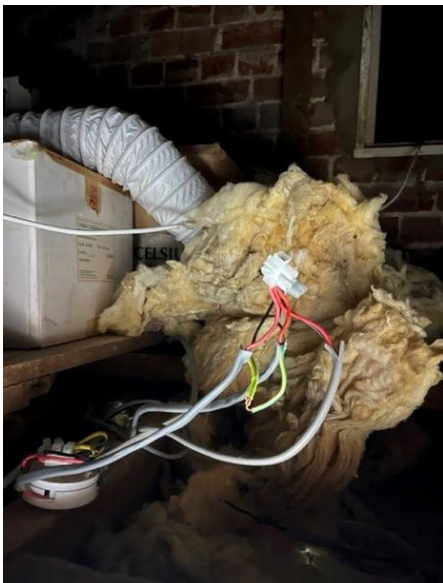
The first incidence was an electrical installation that was found to be faulty following an emergency call to a care home specialising in end of life and palliative care. The firefighters discovered that the electrical connections for a light fitting had been shorting, causing overheating and smoke.

The installation was later confirmed by a qualified electrician to have been clearly undertaken by an unqualified maintenance person. The reporter states that the responsible person for this and four other care homes were sent an official letter reminding them of their responsibilities under the Fire Safety Order, and to investigate who was responsible for the dangerous works, and urgently requesting they review the wiring in all their premises where this maintenance person worked. The letter also recommended that the RP suggest to the maintenance person that they do not attempt any further work for which they were not qualified or competent.

Faulty electrical installation that caused overheating and a fire alarm activation

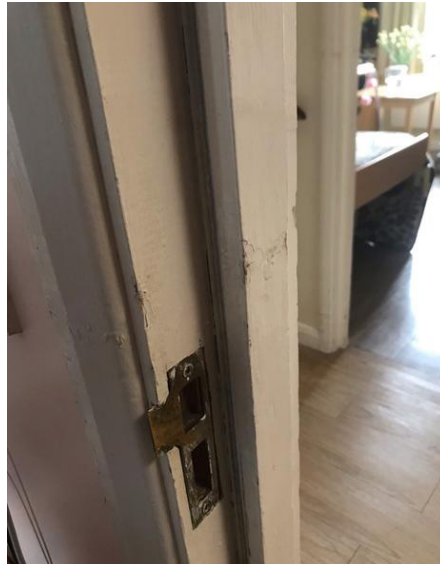
A follow up inspection of the remedial works found that the intumescent strips and cold smoke seals were incorrectly fitted to the door frame. The combined strip and seals were fitted to a channel, that was routed incorrectly, into the corner of the frame. The reporter suggests that in the event of a fire, the intumescent strip would swell and effectively lever the door open and allow passage of fire and smoke into the means of escape, compromising the evacuation. The door and frame were described as 'relatively old but substantial' and (if the combined strip and seal had been fitted correctly) would likely have given the level of protection required. Instead, they lost integrity and are now unfit for purpose.

Fire door rebate showing intumescent strip fitted incorrectly

A competent fire risk assessor critically challenging installation, testing and maintenance records should uncover these failings. The Panel points to some best practices by The Regulation and Quality Improvement Authority (RQIA), the care home regulator in Northern Ireland, including the **requirement for all fire risk assessments in care homes (including residential and nursing homes) to be undertaken by fire risk assessors holding third part accreditation**>.

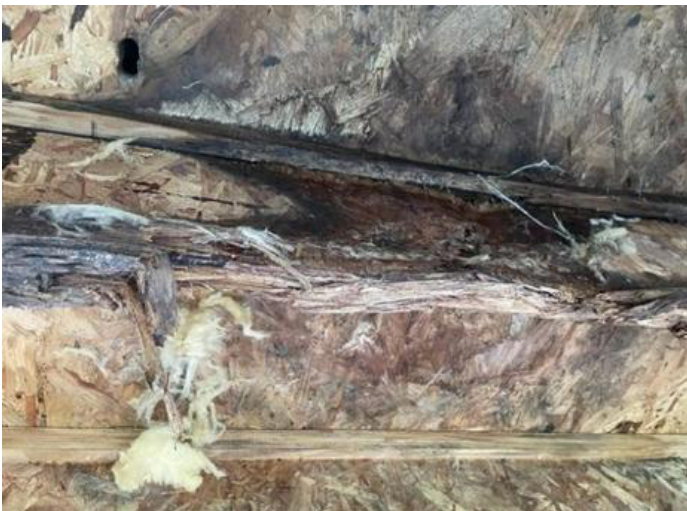
**Figure 1:** An example of OSB board deterioration

Figure 1 shows a top floor property within a development less than 15 years old. Water ingress and possibly condensation issues have resulted in significant deterioration of the engineered timber rafters and Oriented Strand Board (OSB) sheathing.

If a material is only suitable for a dry environment, then it is essential that water ingress is prevented by sound detailing and correctly applied coverings. Maintenance is similarly essential and owners should be vigilant in taking action if there are observable leaks or excessive condensation.

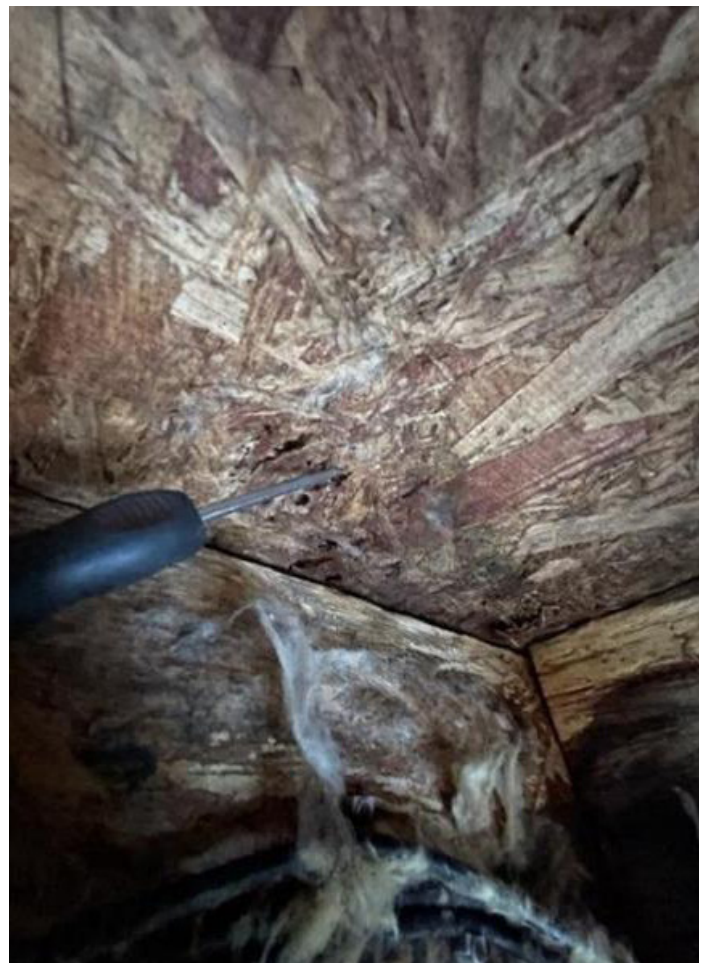
**Figure 2:** Another example of OSB board deterioration

Figure 2 also shows a top floor property within a development again less than 15 years old. Water ingress and possibly condensation issues have resulted in significant deterioration of the OSB sheathing. The engineered rafters have been saturated but they are still sound in this case although they have areas of cracking after drying out.

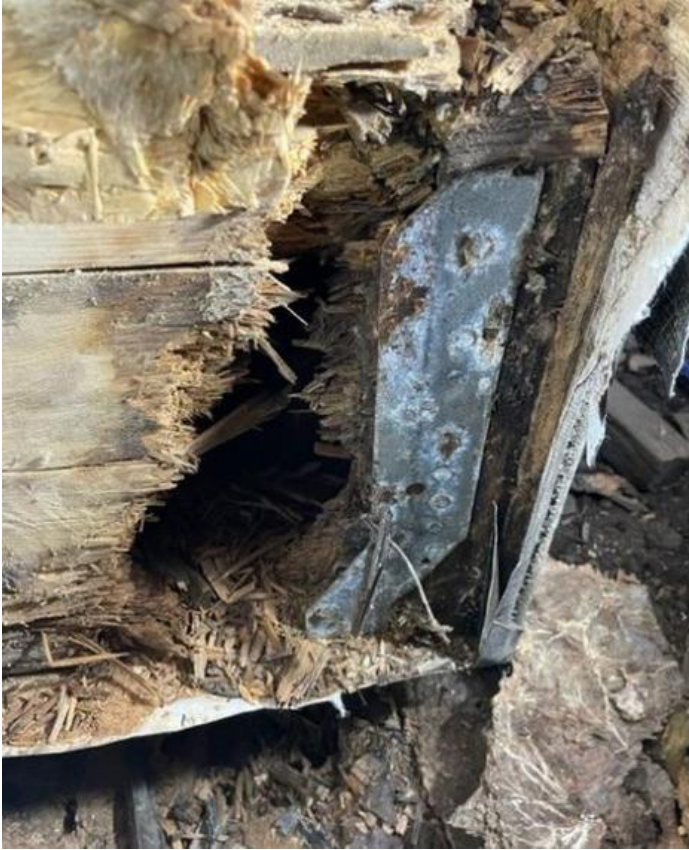
**Figure 3:** Engineered timber joist deterioration

Figure 3 shows a dwelling less than 13 years old. Again, this issue is likely a combination of water ingress and possible condensation issues because it has been designed as a passive house with high levels of insulation and cold bridging may have resulted locally. Engineered timber products were specified on the original plans, with glulam ring beams which the reporter notes have deteriorated significantly.
