Confidential Reporting on Structural Safety

Newsletter No 23, July 2011

Reports in this Issue

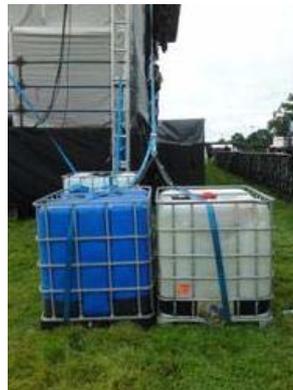
Typical water filled containers used as ballast

The reporter is a local authority Environmental Health Officer who is responsible for licensing the safety aspects at a local festival. As part of the structure of the main stage, water filled plastic containers are used as anchors/ballast. He says that he has concerns over the suitability of these as he believes they could become crushed quickly and not provide the weight that is intended. The rigging, straps, lines and other components, which have all been tested for their suitability and strength, are secured to a riveted fixed aluminium frame around the container. Neither the frames nor the containers, so far as the reporter is aware, have been tested for their capacity as fixing points. When the reporter has questioned the suitability of the system he has been told it is industry practice. The reporter would if possible like guidance for the sector with which he works closely.

CROSS comments: *There are systems that use water in purpose made steel tanks. Some vehicle based fairground rides contain water (typically 12,000 to 15,000 litres) in 'belly' tanks in the chassis to aid stability. Also some very large tower base systems have in built steel tanks to provide stability and in both of these cases there are proper valves and methods to make sure the water stays in place. However in the example given by the reporter the water ballast appears to be in plastic 1,000 litre ISO containers. These are quite expensive to buy new but are widely available on the second-hand market. A significant premium is charged to provide certification that they are not contaminated so many that are in use may not have been cleaned and this may present a number of hazards. The valve mechanisms are prone to damage, to failure due to contamination of the seals, and to simple vandalism.*

The tanks, if in vulnerable positions, could be damaged by vehicle impact. Also the walls of the tanks are very easily pierced with a screwdriver or similar tool. In one city with an annual event requiring a large number of such tanks the problem of vandalism was so severe that the plastic containers had to be encased in protective steel jackets. A secondary problem with tanks in winter is that the water may freeze and be impossible to remove. A practical solution at one site was to add plenty of salt to the water. How to fill the tanks, and how and where to discharge water after an event, are issues that have to be considered. These are examples of just some of the problems that might arise.

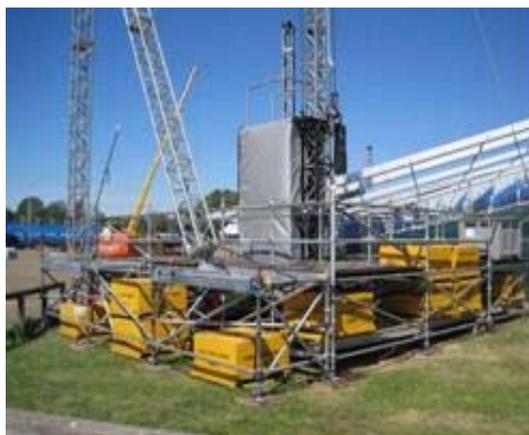
Concrete ballast blocks within a structural frame

It may be difficult to attach the tanks externally to a structure in an effective way. Examples have been seen where there is no proper load path from the ballast to the structure, or where the load is transferred through inadequate arrangement of ropes. The commercially available tanks often have surrounding lightweight alloy cages which are intended to stop them bulging outwards when full but are completely inadequate as fixing points. Any tensile system for transferring the ballast load it should be through a properly designed and robust structure. An alternative way of doing this (depending on the circumstances) is to place the ballast within the structure, so that all the weight is properly transferred to the structure. The above illustration is of concrete blocks used in this way. Advantages of concrete are that it is 2.2 times denser than water and hence less bulky, it cannot leak away, be vandalised, or potentially contaminate the ground. This solution of course depends on the particular nature of the circumstances involved. In short if water is being used as ballast for significant structures the support and rigging systems must be properly designed and constructed. General advice on temporary structures is to be found in the Institution of Structural Engineers publication, [Temporary demountable structures: Guidance on procurement, design and use, 3rd Ed, 2007.](#)

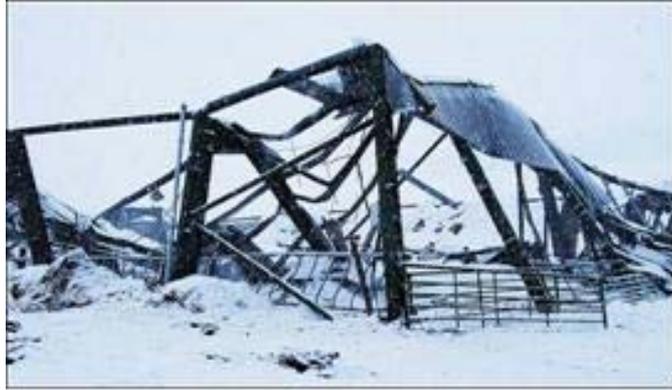
Steel framed agricultural building in northern Scotland

One reporter encountered collapses of two modern well built structures - one was a 1,000 m² portal frame shed and another was a very large domestic building with a flat roof carried on glu-lam beams. In both cases the reporter observed a build-up of ice on the roofs ranging in depth from 75 to 150 mm overlain by around 400 mm of snow. Arguably, and very likely he said, the loadings were even higher when the failure occurred. Another report was about a lightweight pressed metal framed building that completely collapsed with a snow depth of approximately 500 mm on the roof.

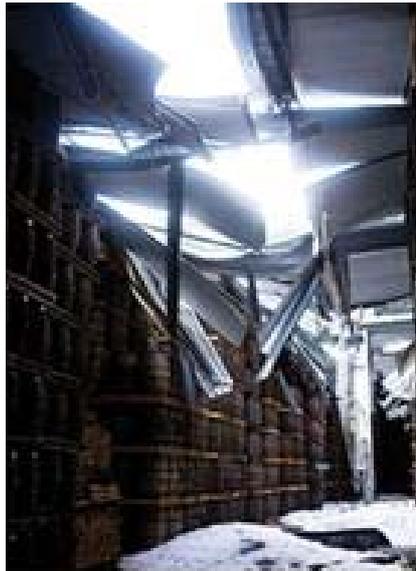
A collapsed warehouse roof (courtesy of World of Whiskies)

A significant report was about forty whisky storage warehouse buildings that suffered from partial or full roof collapses. These were generally steel frames with steel lattice roof trusses from 20-40 years old and 2,000 - 2,500 m² in area.

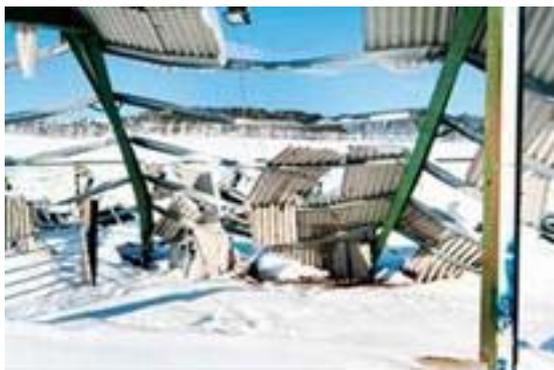
Most were steel framed portals with spans around 20 - 30 m and generally the purlins failed first. The reporter recommends that in such buildings purlins should be at no more than 1.2 - 1.3 m centres and that frame centres should be at 6 m. Most of these buildings were clad with cementitious sheeting which is favoured by farmers because there are no drips, particularly onto cattle, from condensation. In one case a farmer had lost two sheds and had a newly completed shed which was at risk of collapsing so he took in a number of straw bales and set fire to them to melt the snow.

One reporter noted evidence of lateral torsional buckling instability of rafters between rafter restraints due to over load. Instability of the rafter in the apex haunch area suggests to him that it would be good detailing practice to fit rafter stays at each purlin position on either side of the rafter and at the two penultimate purlin positions either side of the apex, as these are in the vicinity of plastic hinge positions which are very likely to form should the roof be overloaded.

Typical purlin failures
