Confidential Reporting on Structural Safety

NEWSLETTER No 30, APRIL 2013

REPORTS IN THIS ISSUE:

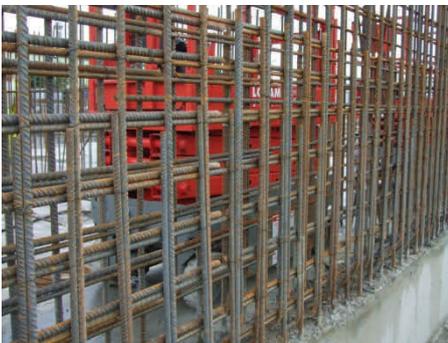
A reporter asks about best practice guidance for the installation of pre-assembled reinforcement cages as shown on this photograph. He can find very little guidance on the web and in this case the contractor appears to have left the solution to the steel fixers on site. Whilst the reporter is not suggesting they are not suitably experienced, he does not consider that this is the right approach. He would have expected a qualified Temporary Works Engineer to have designed a system for the work which should have included:

- Consideration of the bending moment and shear force induced as the cage is moved from the horizontal to the vertical, the dynamic loading effects and where applicable, the loads induced by the cage trapping onto a casing or guide-wall.

- Individual cage weights.
- Specification of lifting points including details of type (bands, bar or helical), steel grade, size and connections details (tying wire or welding).

- Position of lifting points for horizontal lifts, vertical lifts, lifting from horizontal to the vertical and for moving cages (note: these may be the same).

- Method of identifying lifting point. For example, coloured spray or tags.
- Details of how cage is to be lifted (i.e. single cage or multi-cage lifts).

- Details of pre-slinging requirements, including details of sling type (i.e. single or multi-use), length and safe working load.
- The amount and position of ties required and thickness of tying wire to take into account the strains placed on the ties by the cage in buffeting winds. It may be necessary to weld some vertical steels together.

- Any temporary support necessary.
- Establish that the recently poured concrete slab containing the starter bars had reached sufficient strength to withstand the uplift forces that would be imposed upon it by movement of the installed cage, which may be buffeted by the strong winds.

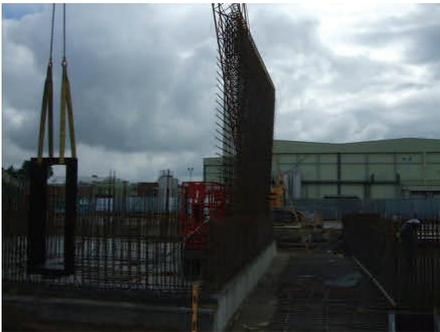
A rebar cage similar to those referred to above

The reporter has made very valid observations and it does seem that little advice is publicly available. The comments made on report 357 "Wall reinforcement cages collapse" (below in this Newsletter) are general and may be of some help but more work is needed and the views of readers will be welcome.

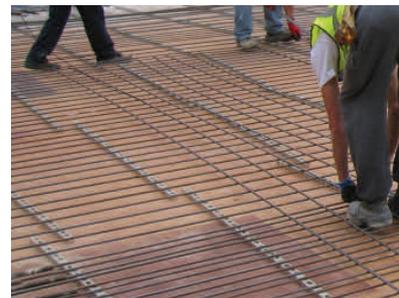
Concrete strip spacers are increasingly being used to support the bottom reinforcement in slabs says a reporter. They come in a variety of sizes to suit the required cover and generally are 1m in length. However if used incorrectly they can act as crack inducers. The problem, which is believed to be widespread, arises if when they are laid end to end in a continuous unbroken line and form a discontinuity in the structure. Spacer strips regardless of their material should be installed in accordance with the requirements of BS7973-1:2001, "Spacers and chairs for steel reinforcement and their specification". Corrosion caused by the lack of cover is hidden from view e.g. in the case of ground bearing slabs, and will lead to failure if left unchecked. The worst example seen by the reporter's firm was on a wind turbine base subject to aggressive ground conditions.

Example of bad practice – spacers laid in continuous lines

This seems to be a common issue as it has frequently been observed by others that spacers are placed in long lines. Whilst this is unlikely to result in immediate failure it could result in long term problems such as corrosion of reinforcement. It illustrates the need for designers to ensure that specifications reflect current practice and techniques. Where such spacers may be used the requirement for staggering should be specified as reference made to BS 7973-1:2001 Spacers and chairs for steel reinforcement.
