SC/14/03 March 2014

SCOSS ALERT

Tension systems and post-drilled resin fixings

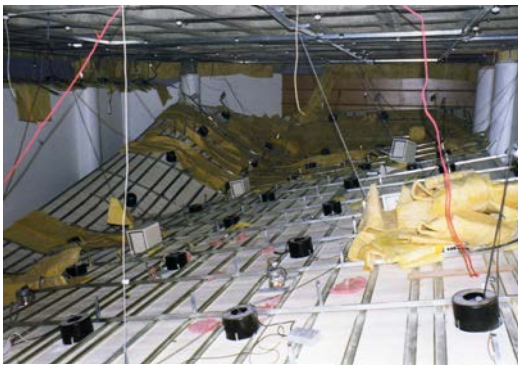
Fig 1 Heavy ceiling

Grids or service ducts can mean that the structures are indeterminate and may contain stiff load paths not considered in simple designs. This affects the way their load is applied to a grid of hangers and just how much load will be on any one hanger is imprecise. The Sea Gem failure was of a rigid unit supported at 4 corners, so the actual corner load was indeterminate. In any grid of hangers or multiple units, the probability is that some fixings will be carrying a load higher than the nominal one presumed in design, and this may be exacerbated by long term creep effects. Some of the bridge failures were precipitated by single support failure due to fatigue, the relevance being that fatigue life is a function of actual load not nominal load. If a hanger is subject to fatigue, and is carrying a heavier load than the nominal design value, then its life can be drastically shortened.
