Confidential Reporting on Structural-Safety

NEWSLETTER No 45, JANUARY 2017

612 NUMBER OF NEAR MISSES AND THE REGULATORY REGIME.....	2
614 COLUMNS MISSING DUE TO 3-D MODELLING.....	3
581 REQUIREMENT FOR CDM SAFETY FILES TO BE TRANSFERRED.....	3
610 HIGH MAST LIGHT POLES.....	4
579 FURTHER REPORT ON FREEZING OF WATER IN ZINC PLATED HOLLOW SECTIONS.....	5
575 UNDERGROUND SCAFFOLD OVERTURNS IN WIND.....	6
599 HERITAGE BALUSTRADES AND BUILDING STANDARDS.....	6

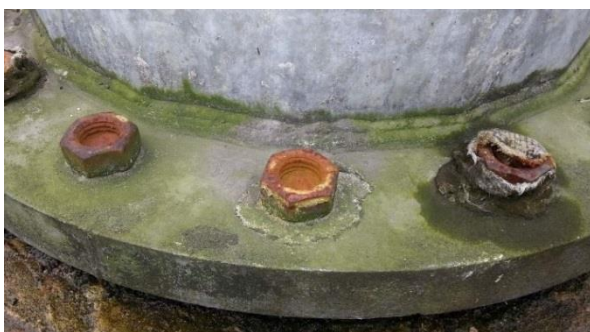
Holding down nuts

Five High Mast Light Poles (HMLPs) were removed from a public site as it was considered that there was a possibility of collapse. One was a particularly obvious risk because about half of the nuts on its anchor bolts were not fully engaged. The reporter believed that the remaining four were also a high risk because of the same inherent design features and the inability to inspect critical parts. HMLPs usually consist of tapered polygonal mast fixed to a concrete foundation using multiple anchor bolts connected to a circular flange. The flange is fixed using two nuts on each anchor bolt. One nut is located below and one above the flange. The lower nut is often referred to as the levelling nut and this design is known as a stand-off base plate. The most safety critical features of an HMLP are its base-plate and anchor bolts. Failure of any one bolt will transfer load to adjacent bolts. If adjacent bolts were not able to withstand the increased load, then collapse could occur. In the reporter's opinion, the design of stand-off base plates as used on HMLPs have several severe inherent design weaknesses that could lead to collapse even when installed as-designed. Concerns expressed by the reporter about this case, but also about such structures in general include:

- Inadequate design of base-plates
- Base-plates and fixings obscured by finishes or soil/vegetation
- Nuts not fully engaged
- Corrosion of bolts
- Bolt fatigue due to stress concentration in the threads
- No pre-tensioning of bolts
- Thread type

The reporter is quite right to be concerned about risk of corrosion to holding down bolts, especially when hidden in 'porous' materials that can hold air and water against steel. In this case the poor quality of erection demonstrated by the inadequate anchor nut installation was sufficient reason to take down the columns. There have been many fatigue failures of this family of structures (lighting columns, cantilever gantries, etc...) but failure has been in the structure, not the HD bolts. The aero-dynamic damping in these structures means fatigue damage due to wind buffeting is highly unlikely. However, Structural-Safety knows of a case where improvements in quality of fabrication led to a vortex shedding problem which caused large amplitude motion resulting in fatigue. In the past, there has always been some movement in the slip joints between stacked sections that dissipated energy and so improved structural damping. There have also been historic cases of lamp posts failing due to corrosion of the pole.

There are several practical points to be considered such as the design of the fixings and their ancillary parts to provide security against loosening, the ability to take all applied forces (which may include shear and bending as well as tension), protection against corrosion, and the possibility of inspecting the assembly in future.

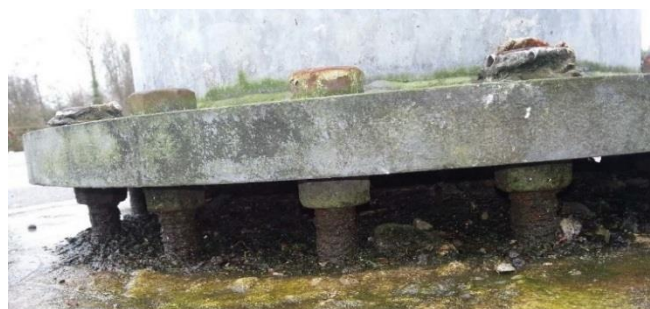
Base plate

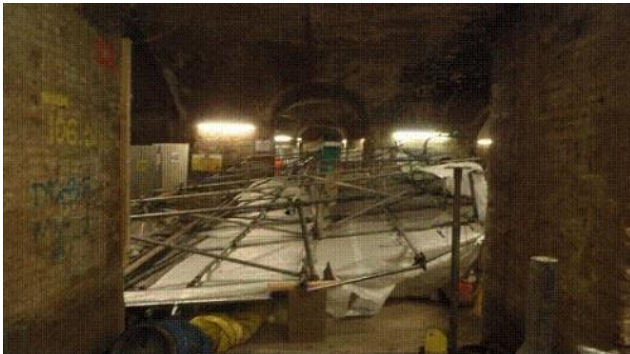
Underground scaffold blown over

This concerns a 5m high scaffold screened with fabric that was erected to protect against debris and dust from adjacent demolition works of the arched structures below a building. When the demolition broke through into the arched structure, airflow was introduced producing horizontal load on the scaffold which overturned. It fell onto a section of a pedestrian route for the site team and fortunately there were no injuries. The root cause of the event, says the report, was misinterpretation of the scaffold standard TG20:13 in that the need for a designed scaffold was not appreciated, wind loading was not considered, and there were inadequate ties to the masonry arch. A procedure was in place that stated all classes of temporary works/scaffold should be on a register which this was not, and whilst the scaffold requirement was discussed on site at a temporary works planning meeting this did not cover the scaffold screens.

All internal structures can be subjected to horizontal loads, including wind pressures, and should be designed as such. This is almost a classic case of not considering the safety attribute of 'sensitivity'. The original assumption of no wind was wrong so even a slight pressure would have been serious. Achieving robustness always requires a presumption of some horizontal forces but there is always also danger in assuming low wind speeds for temporary works designs. The force difference in say going from 2m/sec to 4m/sec is $(4/2)^2 =$ an increase of 400%. It is essential that temporary works are designed and constructed to BS5975 and associated [TWf guidance](#), with any fixings needed for stability designed and constructed to [BS8539](#) and [CFA guidance](#).
