# CROSS

Confidential Reporting on Structural Safety

## Newsletter 58 | April 2020

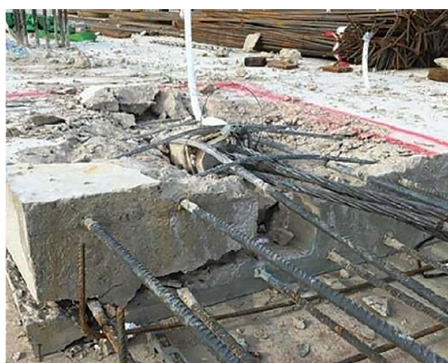
Figure 1  
Post-tensioned slab failure

A reporter has shared some key points from an investigation after the end of a slab burst during a cable tensioning operation. An operative hit by the debris sustained relatively minor injuries, however the consequences could have been much worse. The 'live' end of the cable being tensioned moved as the fixing in the concrete failed, exploding the slab in an area around 1.5x1.5m.

There was a range of potential causal factors including over stressing of the cable, concrete strength and structural design. The contractor, the post-tensioning (PT) installer and the PT designer concluded that localised under-strength concrete was used, due to the method adopted on site of grouting the mobile pump line and discharging into the permanent works.

### The contractor, the post-tensioning installer and the post-tensioning designer concluded that localised under-strength concrete was used

**a) Concrete concerns:** The fabric of the slab was destroyed near a tendon 'block' arrangement which was only tensioned once the concrete had reached a strength of 25N. Procedures were in place and were used to verify the strength of the concrete from both the concrete frame contractor and PT contractors' perspectives, thus the concrete should not have failed.

*Outcome: grout in pump lines must not be discharged into the slab area and must not form part of the permanent works.*

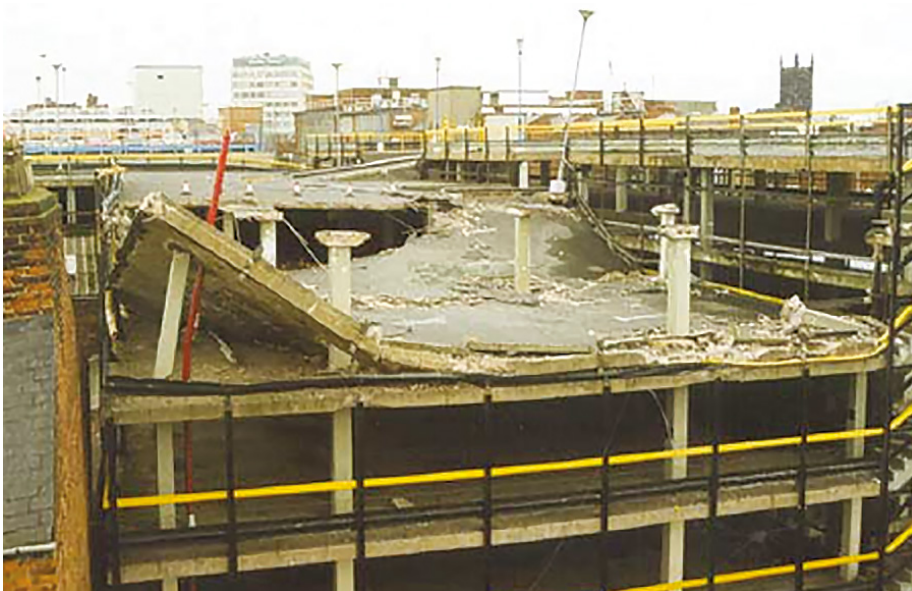
● **Figure 2**  
**Pipers Row car park collapse**

Issues about shear reinforcement in slabs, particularly flat slabs, have been around for many years and were highlighted by the failure of the **Pipers Row Car Park**>. This multi-storey structure was built in 1965 and a 120-tonne section of the top floor collapsed during the night of 20th March 1997. An initial punching shear failure developed into a progressive collapse.

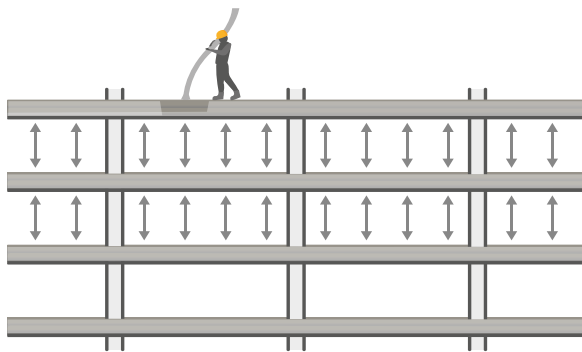
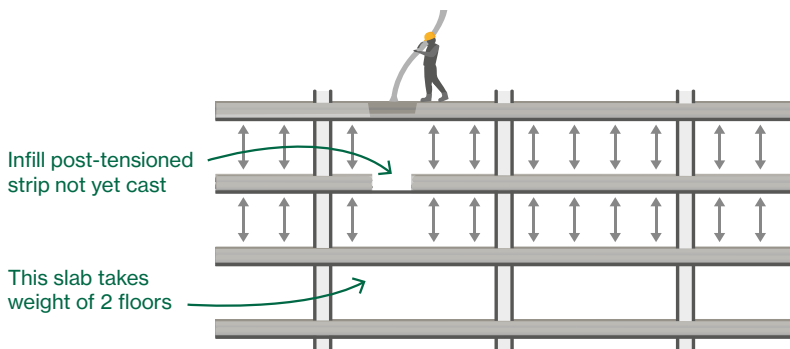
● **Figure 3**  
Propping of post-tensioned slabs

During the construction at one level, the infill slab strip at the level below had not yet been poured. Therefore, the weight of the slab being cast, and the weight of the floor below was all being taken solely by the floor two levels below. Fortunately, this slab was designed for high superimposed and finishes loads. If this had not been the case, the slab could have failed, says the reporter.

**Normal good practice - load spread over 2 floors**

**Propping as installed - lower floor taking all of the load**
