Standing Committee on Structural Safety

SCOSS Alert | December 2020

LESSONS LEARNED FROM THE 2018 FLORIDA BRIDGE COLLAPSE DURING CONSTRUCTION

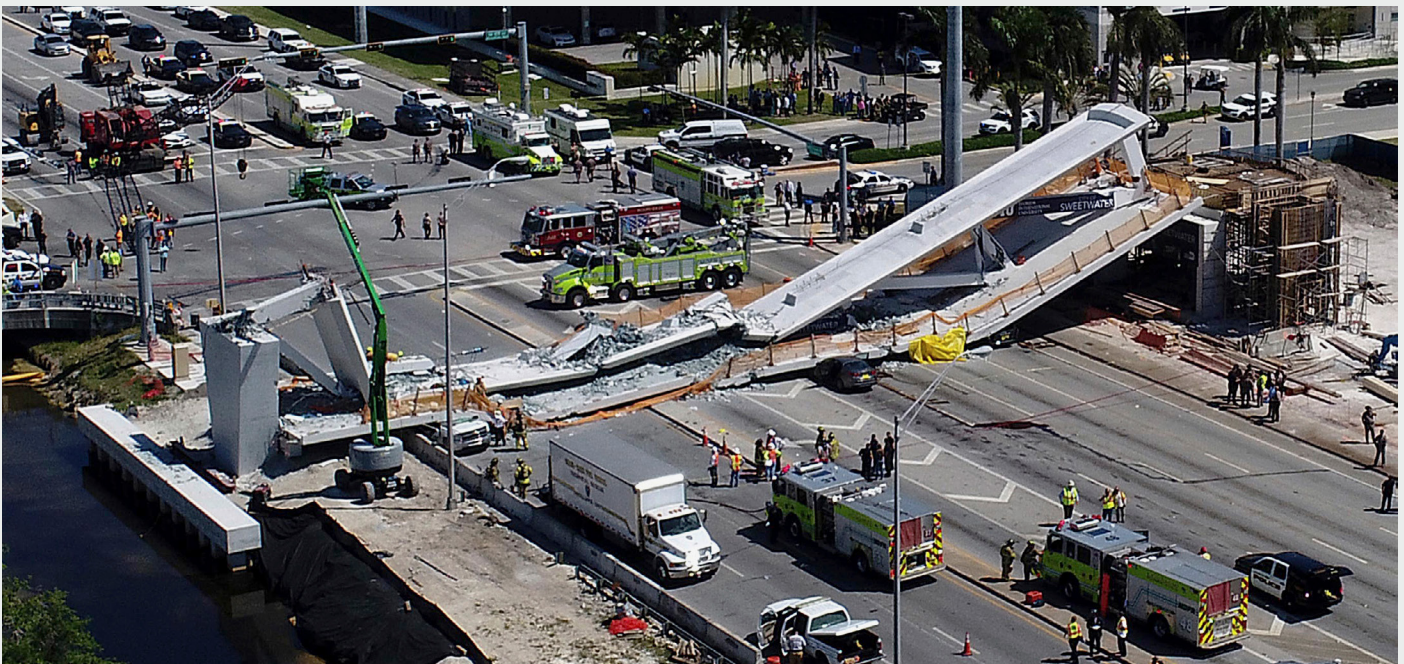
● Photo 1
Miami Herald via AP

This was a bridge of an unusual design and was being constructed in an unusual manner. The main 53m pre-stressed pre-cast concrete span truss was in position when cracks appeared at a node and over a period of almost three weeks they visibly worsened until collapse occurred.

All parties apparently failed to recognise the bridge was in danger when inspected hours before the collapse. In hindsight, the magnitude of the cracks warranted that

the road be immediately closed, and the truss supported to reduce loads, pending evaluation.

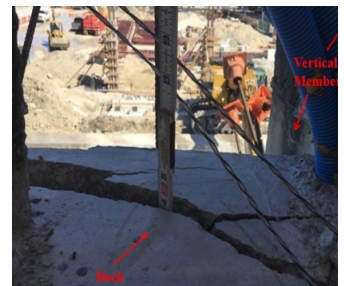
● **Photo 2**
Slab cracking (taken from NTSB Ref 1)

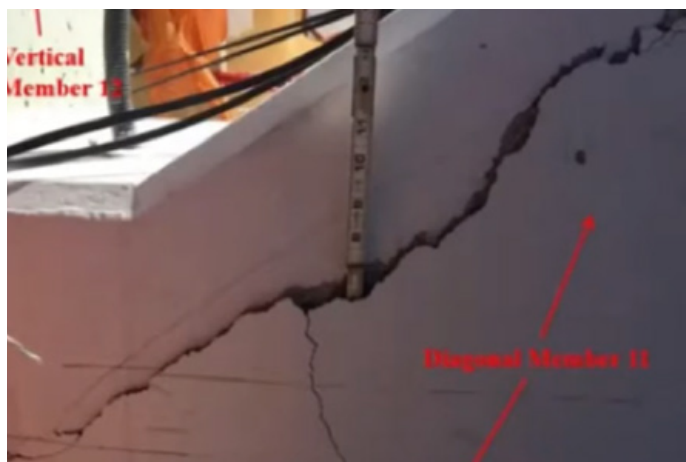
● **Photo 3**
Cracking to diagonal member 11 (taken from NTSB Ref 1)

Over the next nineteen days, the cracks grew until the bridge collapsed. The construction and inspection firms working on the bridge were aware of the cracks, and reported the cracks to the design firm, asking for guidance. In this instance, for this particular Design and Build contract, the Engineer of Record (see note) inspected the cracks. The NTSB report stated that *'...The Engineer of Record repeatedly indicated that the cracks were of no safety concern...'*

On the morning of the collapse, a decision had been made to re-tension the bars in the distressed diagonal under compression thus leading to further compression.

The evaluation of the cracks, and the decision to re-tension the diagonal member, made by the EOR, constituted a change from the original design, and as such should have been subjected to an independent design check.

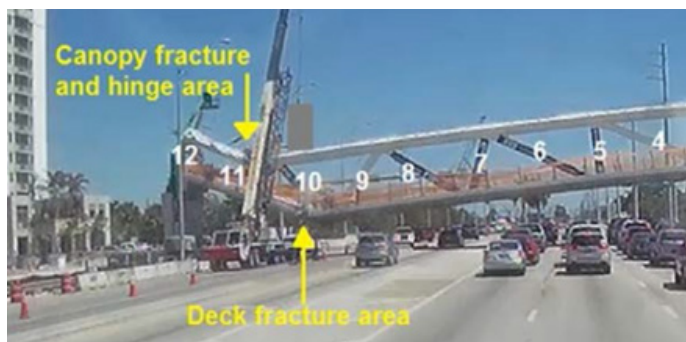
On Thursday 15 March 2018, during the re-tensioning operation, the main span collapsed onto a live road. See Photo 4.

● **Photo 4**
Catastrophic failure of bridge during re-tensioning activities. (taken from NTSB Ref 2)

Only two of the eight traffic lanes were closed at the time of collapse. Eight vehicles, stopped below the bridge at traffic lights, were fully or partially crushed. One bridge worker and five vehicle occupants died. Eight people were injured. The investigations began.

Construction oversight – All parties apparently failed to recognise the bridge was in danger when inspected hours before the collapse. The Construction Engineer and Inspector apparently failed to classify the cracks as structurally significant. In hindsight, the magnitude of the cracks warranted that the road be immediately closed, and the truss supported to reduce loads, pending evaluation.
