CROSS Safety Alert
AMBER

Safety issues associated with balconies

Region: CROSS-UK Published: February 2022

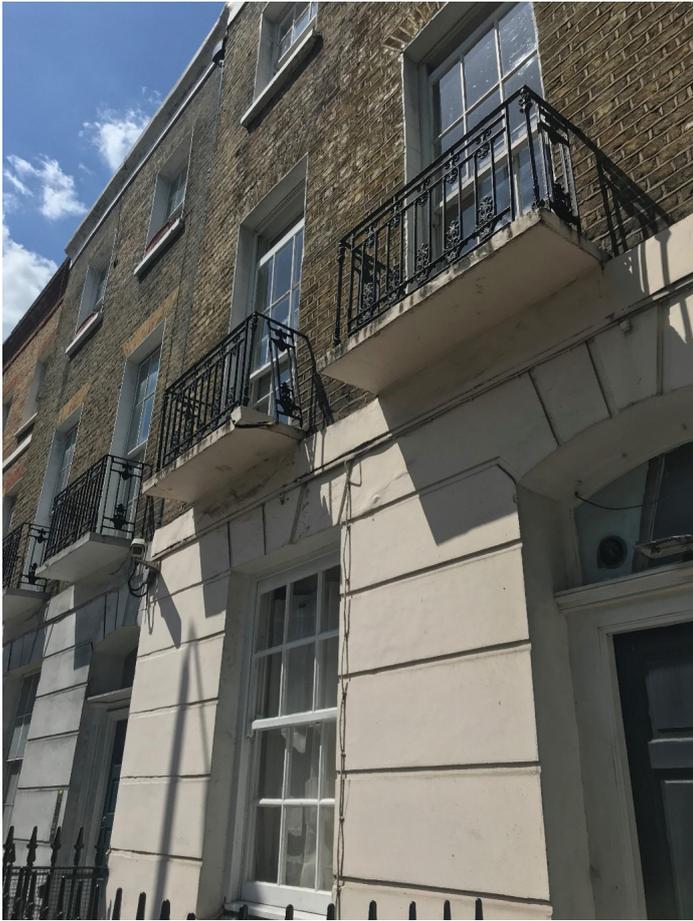
In the UK a number of CROSS reports (Appendix 1) have related to balconies and their balustrades. The UK Royal Society for the Prevention of Accidents (RoSPA) website states that in the UK: “around 10 children die as a result of falls each year - some from windows and balconies and the remainder mostly from stairs”. Injuries can also be caused by getting heads or limbs stuck in railings, whilst fatalities can be caused by climbing over parapets or falling through excessive railing gaps. Other injuries and fatalities have been reported as resulting from inappropriate adult behaviour, from balustrades/railings giving way, or even total collapse of the balconies themselves as shown in Figure 1.

- Debris from any failed balcony may cascade down a façade onto lower units creating a progressive collapse (Figure 1): robustness is required. Putting aside the fact that vertigo and wind may severely restrict the use of balconies on tall buildings (perhaps to be considered by architects) the risk assessment for the potential structural failure of balcony connections on tall buildings needs to reflect the more rigorous design procedures applicable to the main structure. Opportunities for through life inspection are recommended.

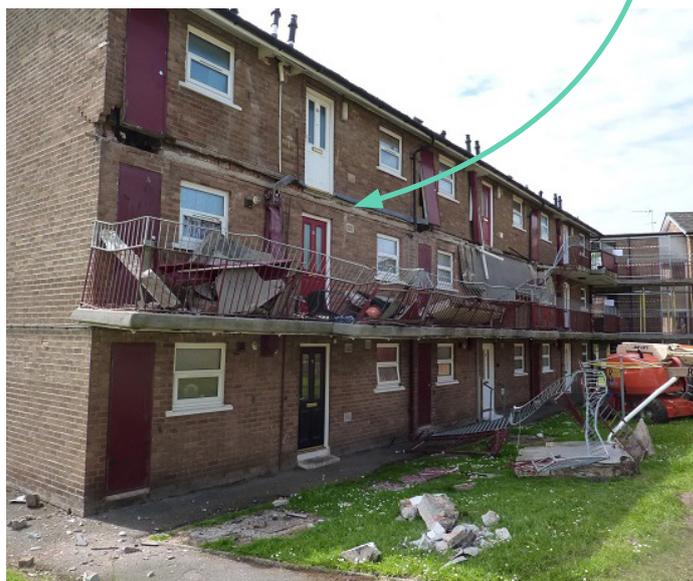
Location of balcony prior to collapse

Figure 1: CROSS report 341 Balcony collapse at block of flats

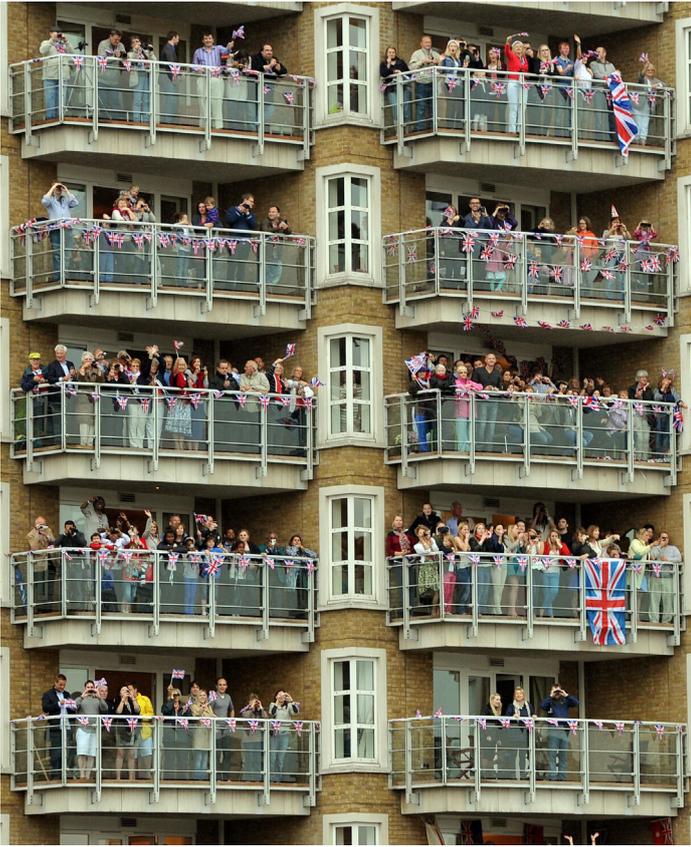
Figure 2: Crowd loading on balconies

- Live loading might well be very high if balconies become crowded, self-evidently there is a likely load case of a concentration of people all along the cantilever tip. Moreover, the effective gravity loading may be amplified by dynamic effects from occupant’s behaviour. Risks are highest where balconies are observational locations for events (Figure 2). Balconies might also be used for storage or within an increasing trend to use balconies as green spaces with extensive shrubbery (Figure 3). Dead loads have been known to increase where owners have screeded or tiled over existing surfaces (given balcony slabs are ‘thin’, the increased load can be significant).

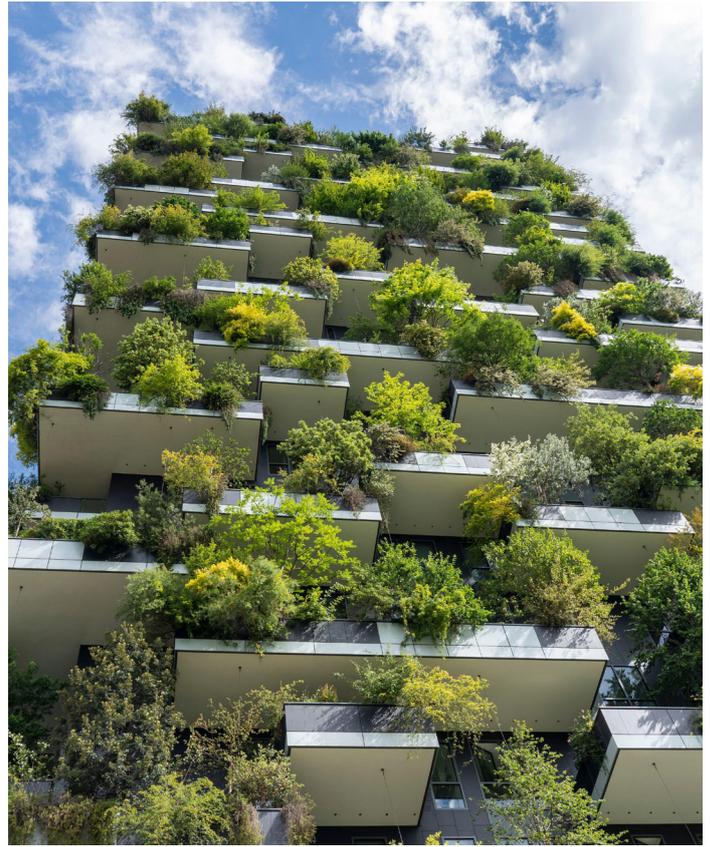
Figure 3: Balconies used as gardens

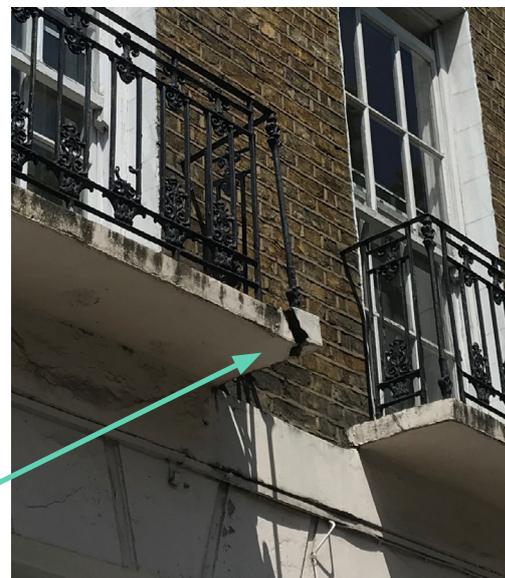
- Older balconies (say dating from the early 19th century) which are common in London streets (and other cities with comparable stock) form a special case. The slabs are mostly stone cantilevers, sometimes with iron supports below. Balustrades are often cast iron. Because the slabs are stone, they are prone to weathering and degradation and prone to cracking induced by uneven settlement of the supporting brickwork. Corrosion of embedded balustrade posts can split off parts of the stonework endangering the balcony itself and posing risks to passers-by from falling debris (Figure 5).

Figure 5: Spalled corner of stone balcony

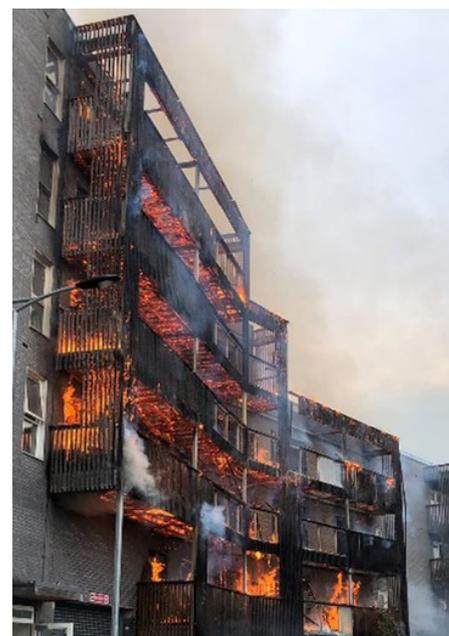
Figure 6: Fire on timber balconies in London (Attribution: @sakukrish)

Fire on balconies is also a severe risk. In December 2017, a fire on a timber balcony in a multi-storey building in Manchester (UK) spread up the façade balcony by balcony so allowing the fire to spread between fire compartments. This effect had dramatic consequences in June 2019 with a fire on timber balconies in London, apparently started by a barbecue. Very rapidly the whole façade was engulfed (Figure 6). Timber may have been used as structural supports, as decking, or as railings. However, **Changes to the Building Regulations in November 2018** (post Grenfell, UK) (Reference 7) have banned combustible material on newly constructed facades, including balconies, but self-evidently the risk on existing buildings is high (Reference 8, which relates to fire issues on balconies).
