Confidential Reporting on Structural Safety

Newsletter No 18, April 2010

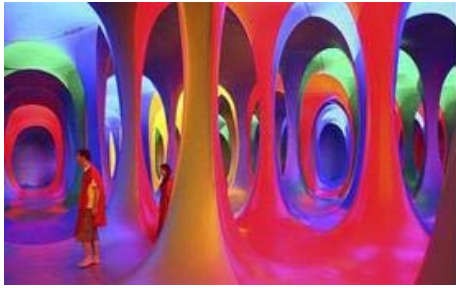
He then instructed staff to add additional ropes and anchors, and to possibly reposition some of the existing ties, to the front and along one side of the structure. Many of the ropes were weakened by knots and the methods used to secure the pods. Later that afternoon a gust of wind from the rear corner caused the structure to break free from the moorings and rise into the air.

Impression of the interior experience

- There are relevant standards for structures like Dreamspace and these should be followed. Where there are no apparent standards, a competent person will have to work from first principles. HSG175 requires a full risk assessment to determine all potential hazards that might affect persons using the device.

- Training of staff and emergency procedures must also be well documented - another requirement of HSG 175.
- A Third party review of complex or high risk structures is recommended. Any 'Ride' used in the UK must be independently certified for use by a registered inspection body.
