Health and Safety Executive

**Final report of the
Advisory Committee
on Falsework.**

**Falsework
collapses**

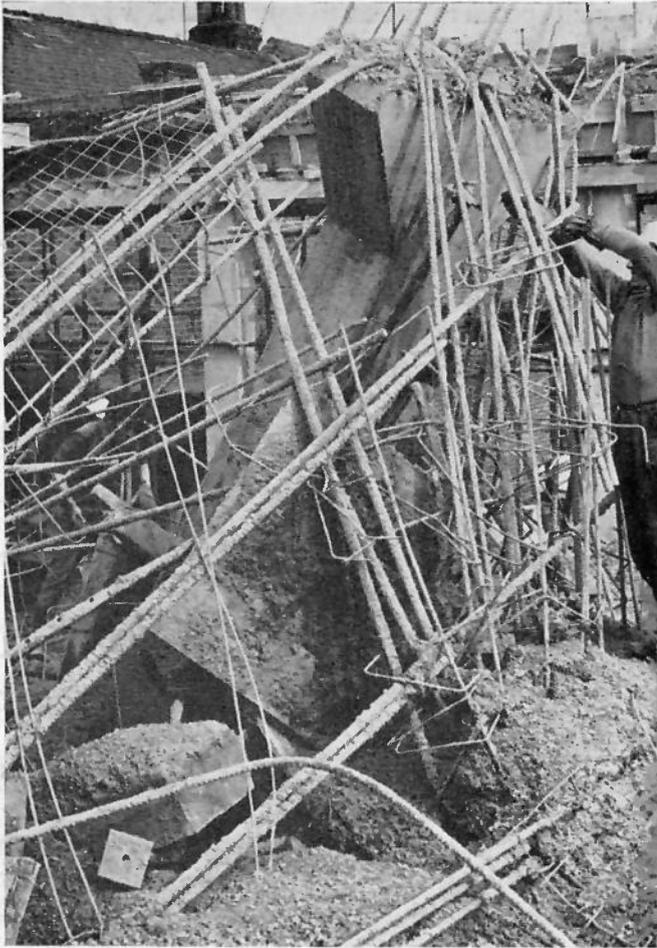
Typical failure of a prop-supported medium sized floor slab

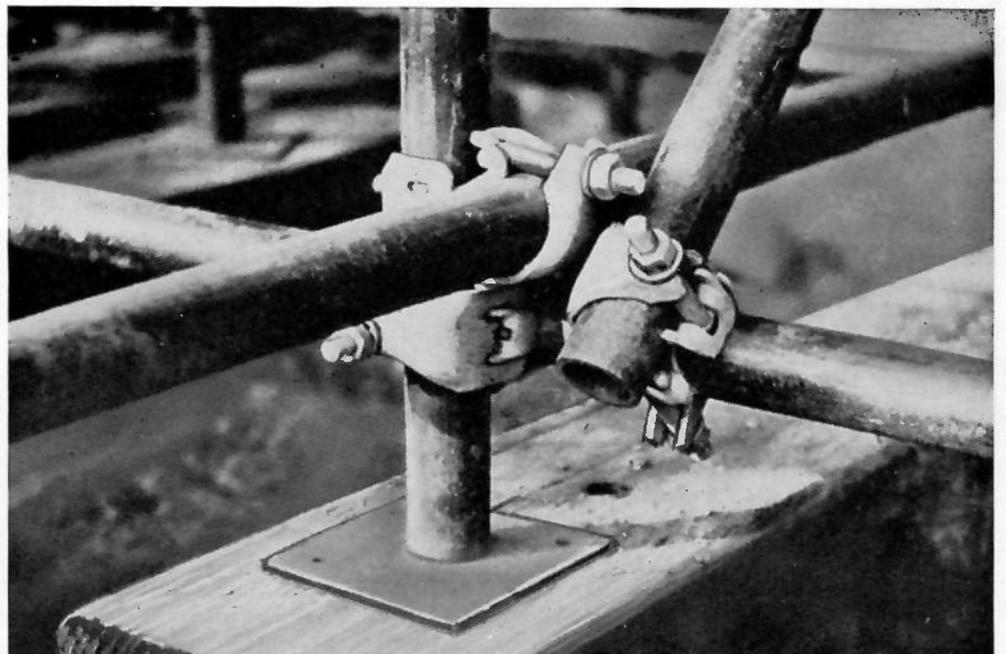
Good example of concentricity of connections at a node

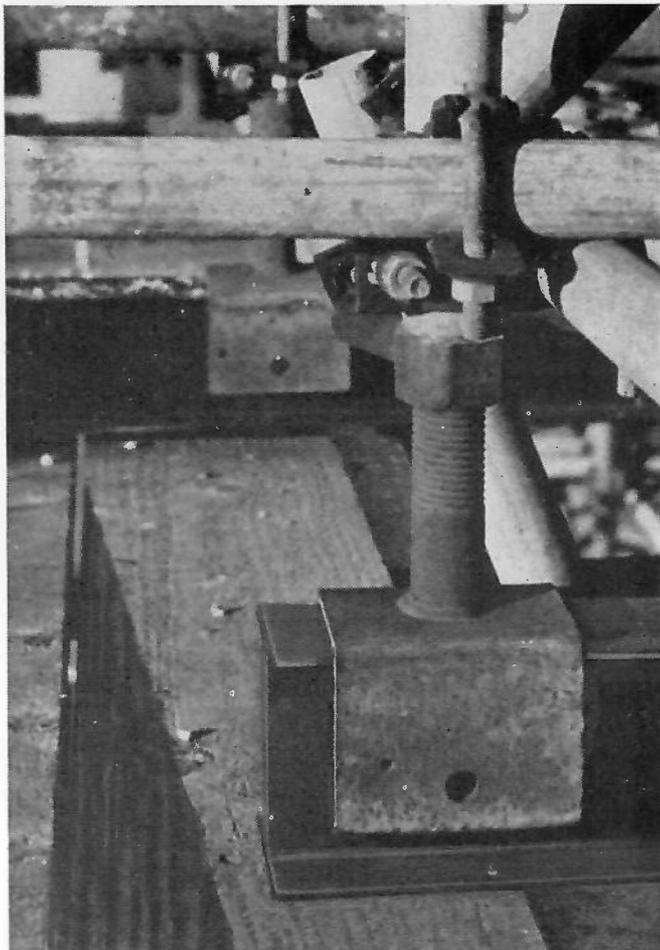
Good use of inverted forkhead to ensure stability of base support on steel beam

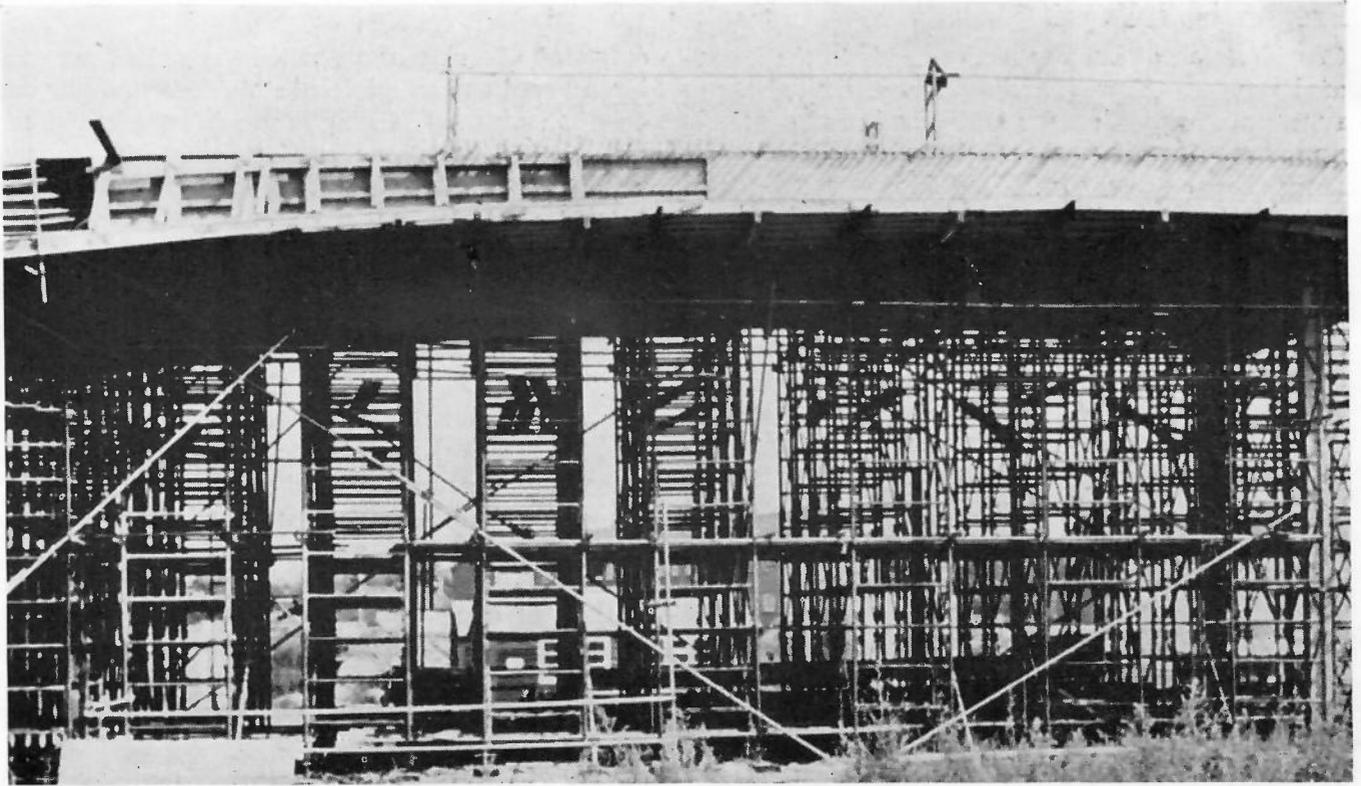
Example of prefabricated system falsework, horizontal and diagonal interconnections, and regularity of construction

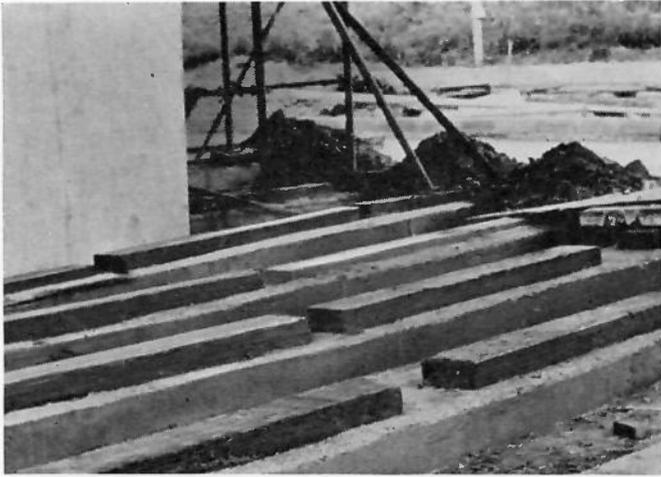
Excellent preparation of base supports, using heavy timber on concrete ribs

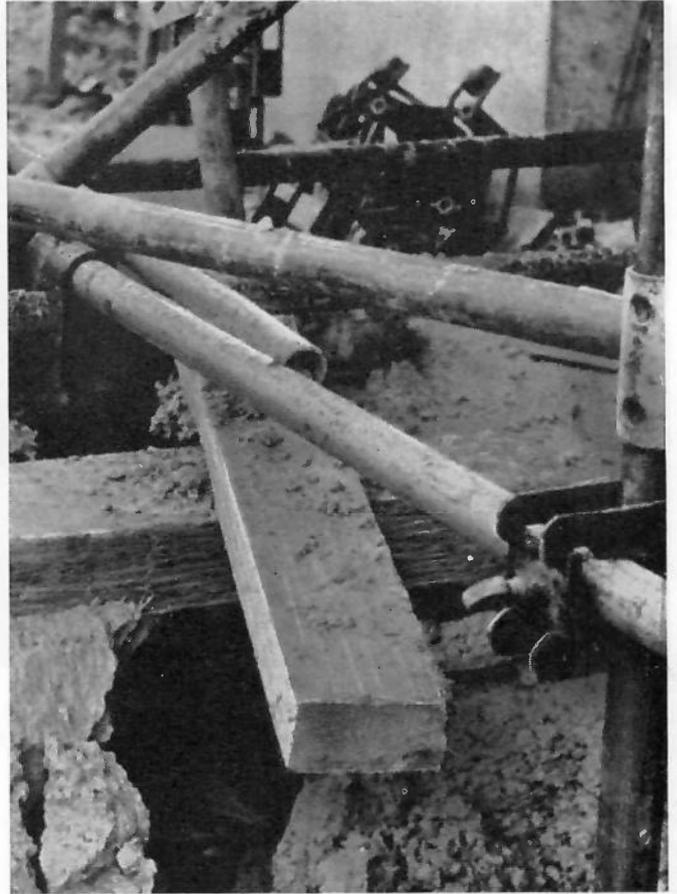
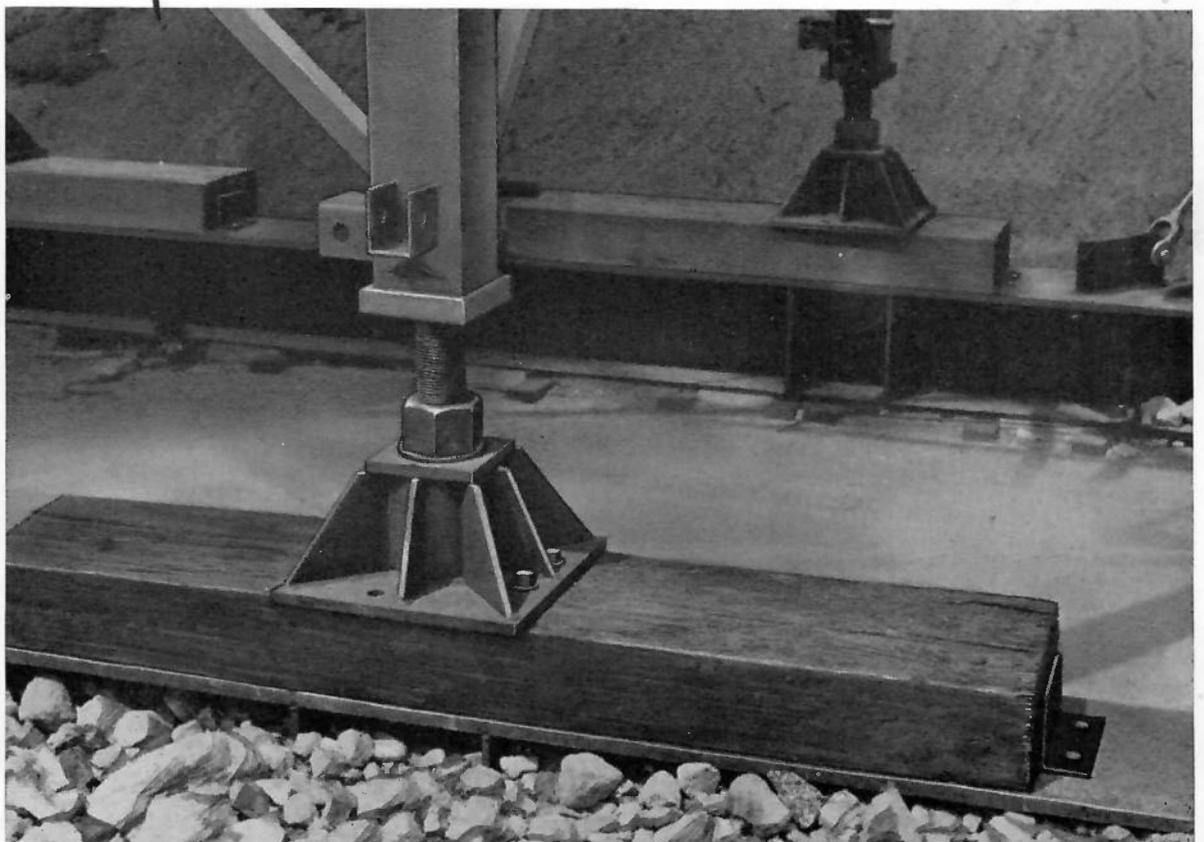
Falsework undermined by scour due to failure to provide site drainage

Excellent detailing of main jack bases, showing chair bolted to substantial timber pad, cleated to web-stiffened bearer beams

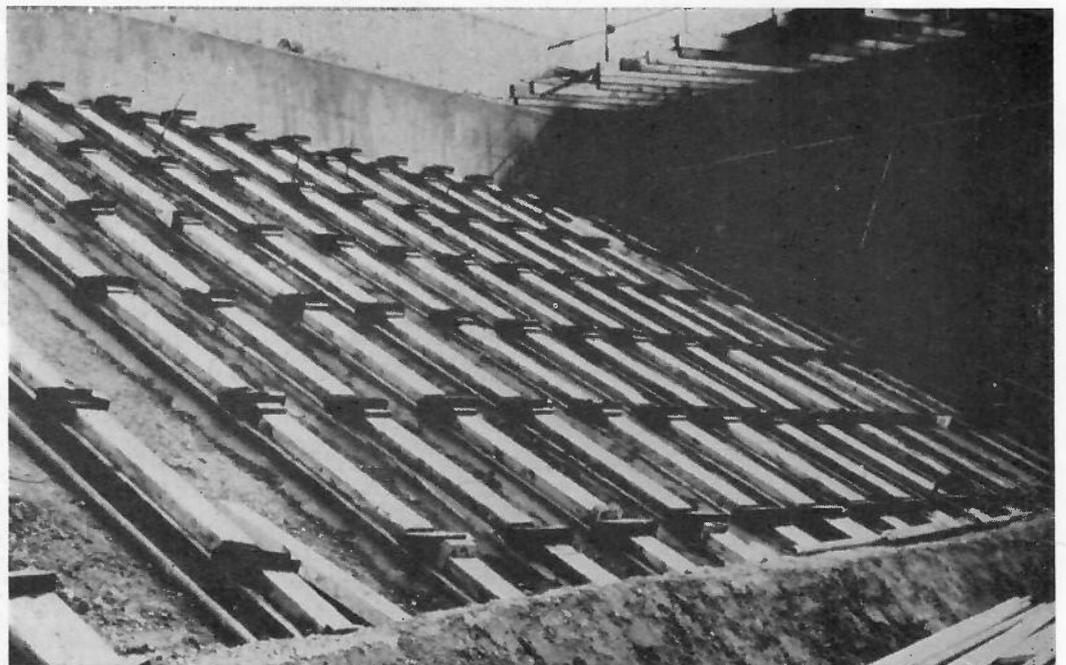
Careful preparation of sloping surface, with over-site concrete and timber bearers, carrying accurately located wedge pieces

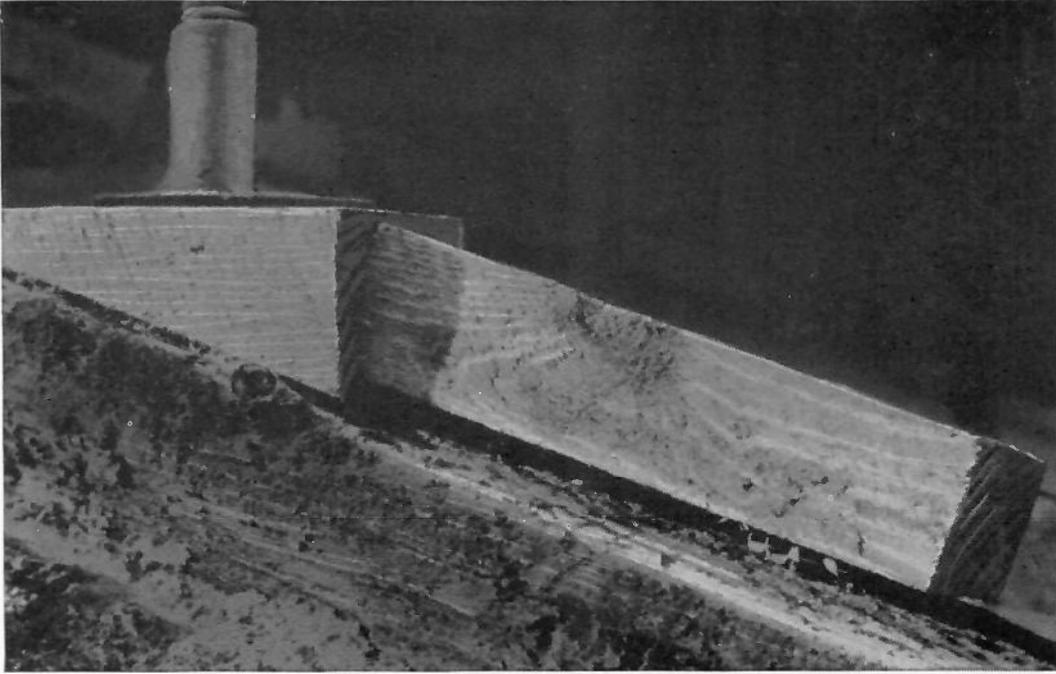
Detail showing excellent use of wedge piece, and cleat bolted to bearer with timber connector

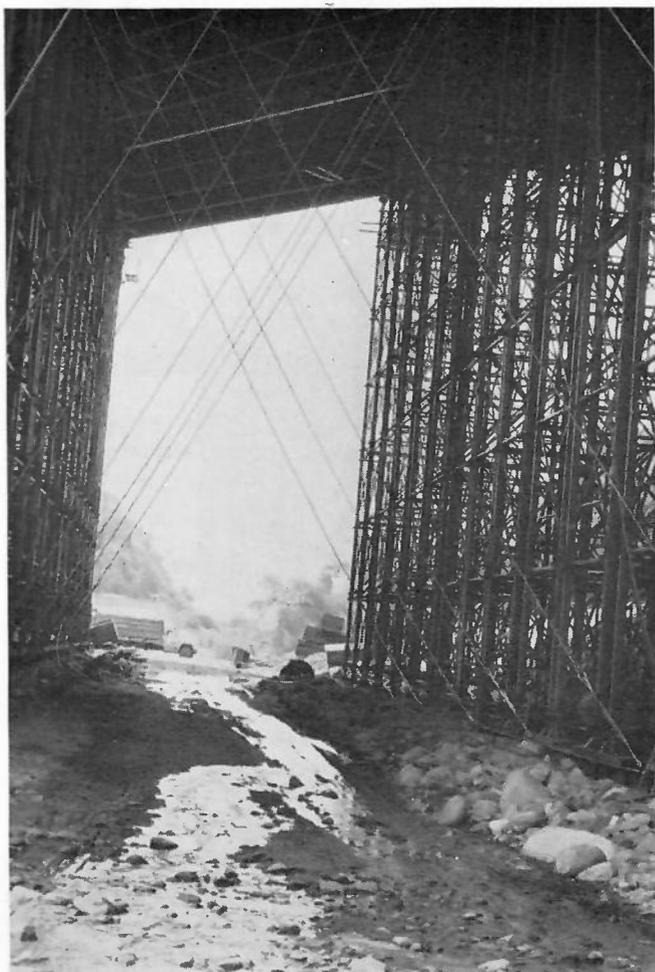
Good use of heavy duty proprietary system falsework supporting decking of a bridge spanning a deep canyon in California, USA

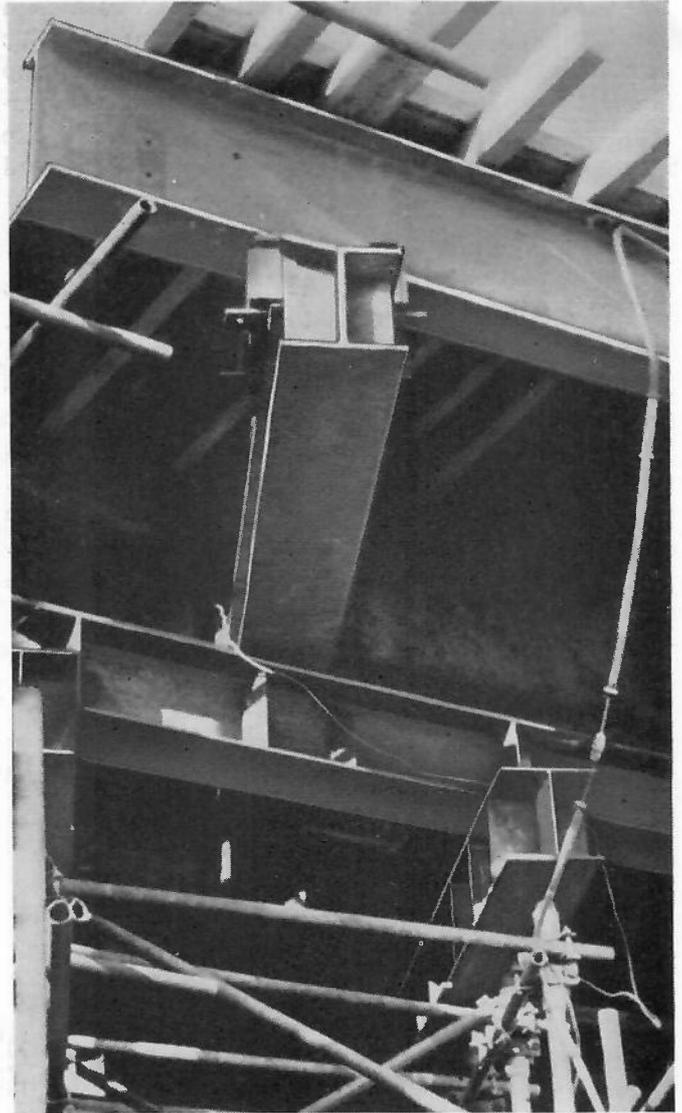
Heavy duty grillage beams provided with web stiffeners at load transfer points with separate components securely interconnected

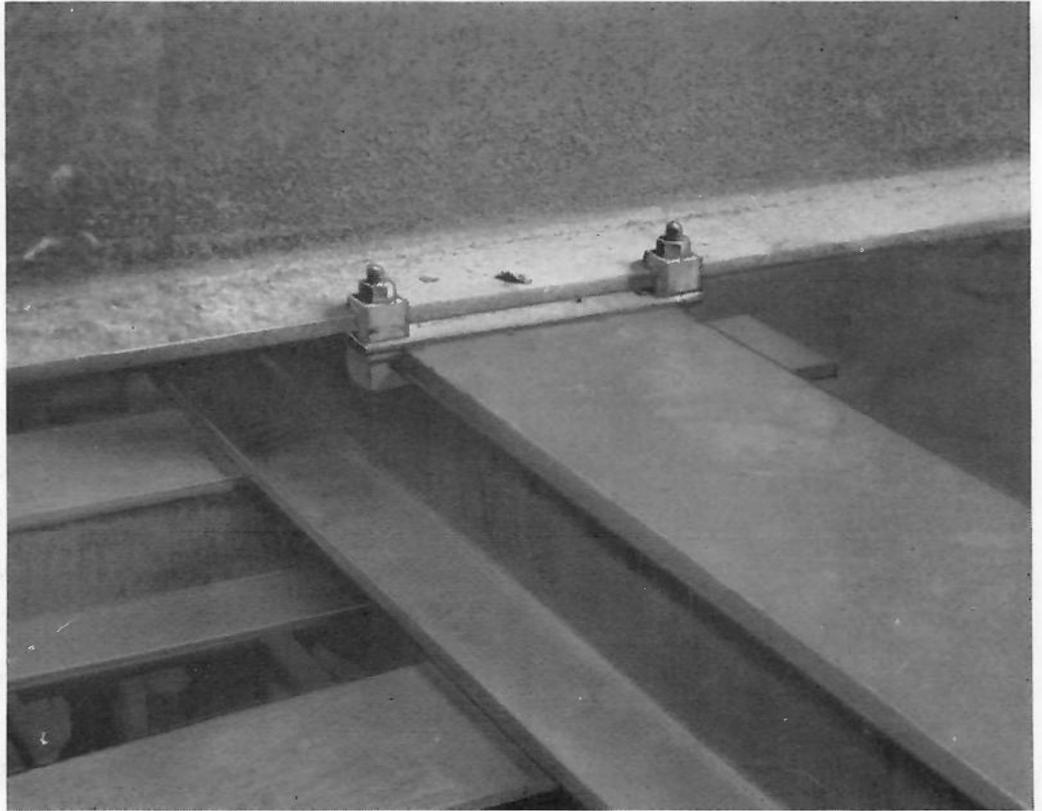
Detail of proprietary connector for use with steel beam grillages

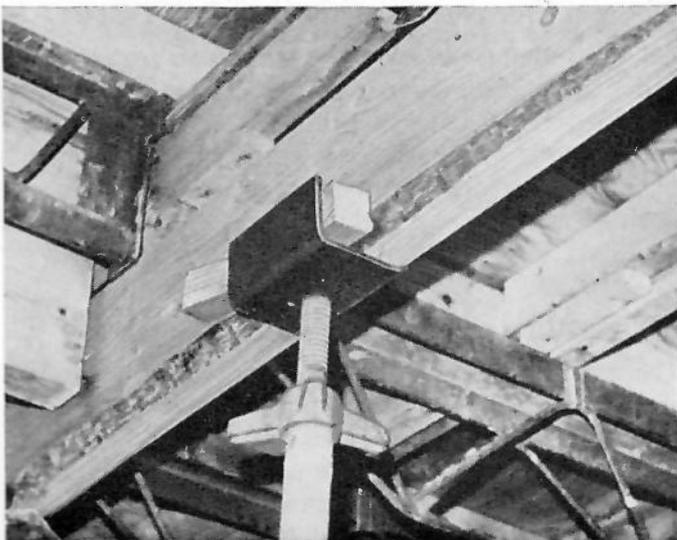
Concentric loading ensured by use of opposed pair of folding wedges

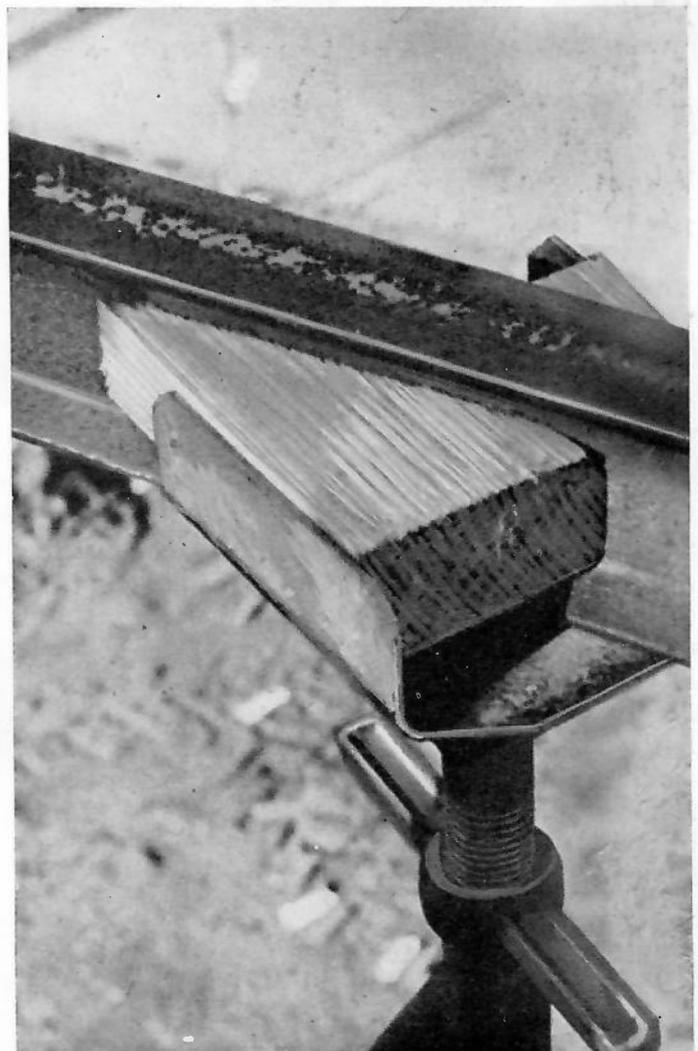
Oversize forkhead and incorrect use of folding wedges will produce eccentric loading

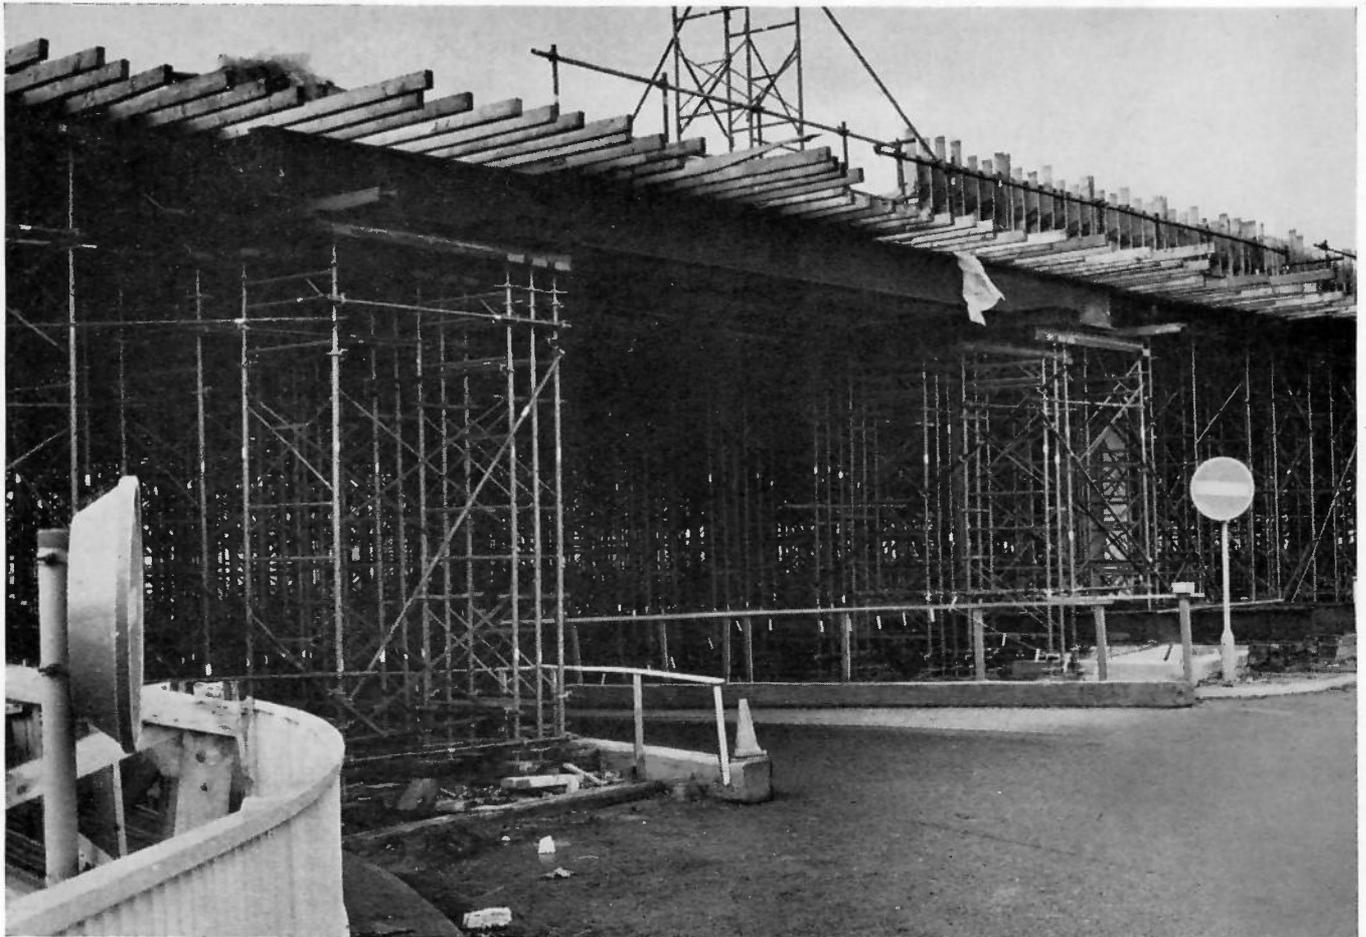
Protection provided at an access opening in falsework to prevent accidental damage by traffic

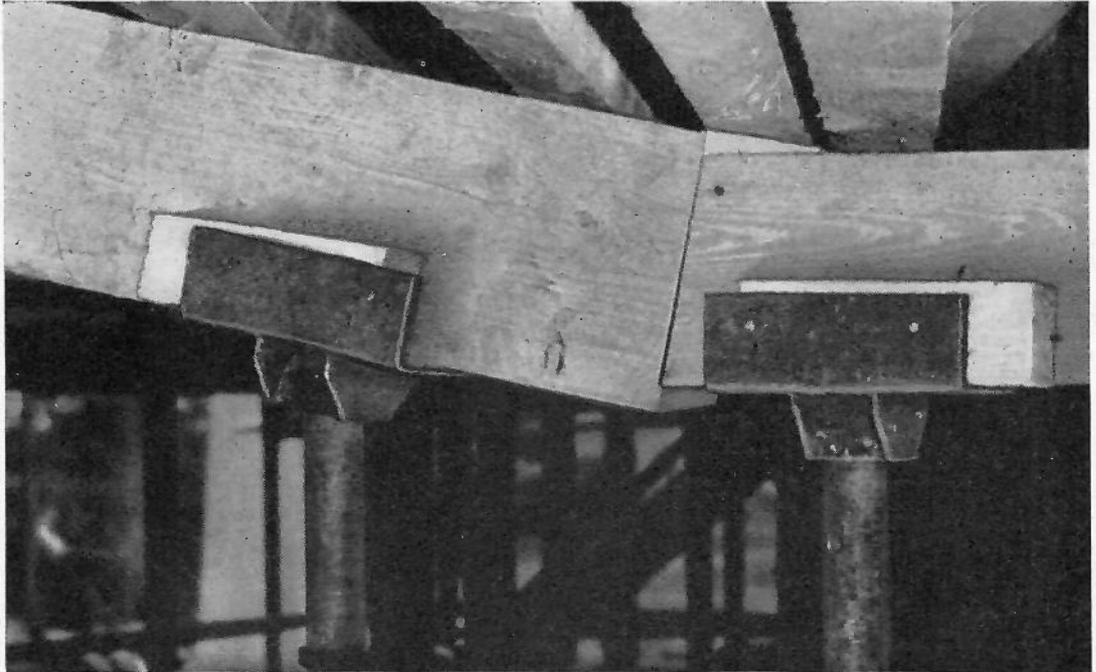
A good example of the care taken to absorb horizontal loads by butting the beams properly wedged in angled forkeads

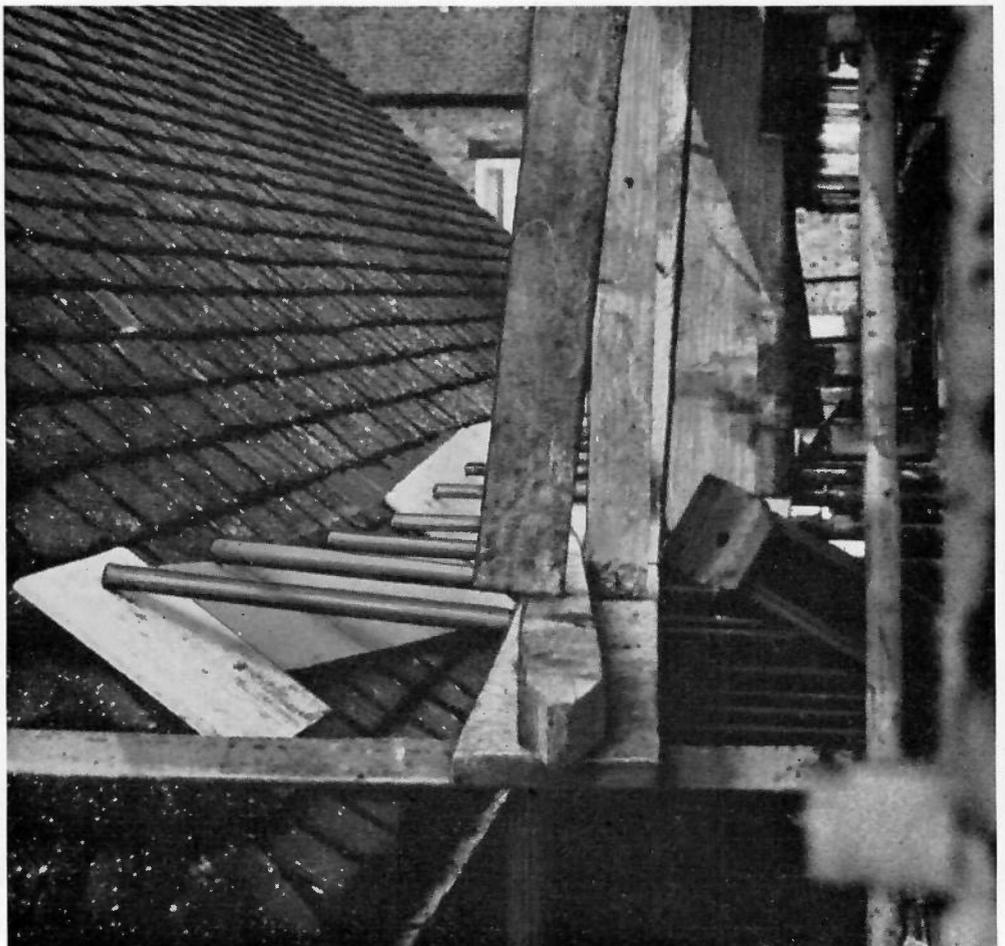
This badly improvised edge beam support was being prepared for concreting at the same site where the collapse of the floor slab is shown on page 13 had recently occurred

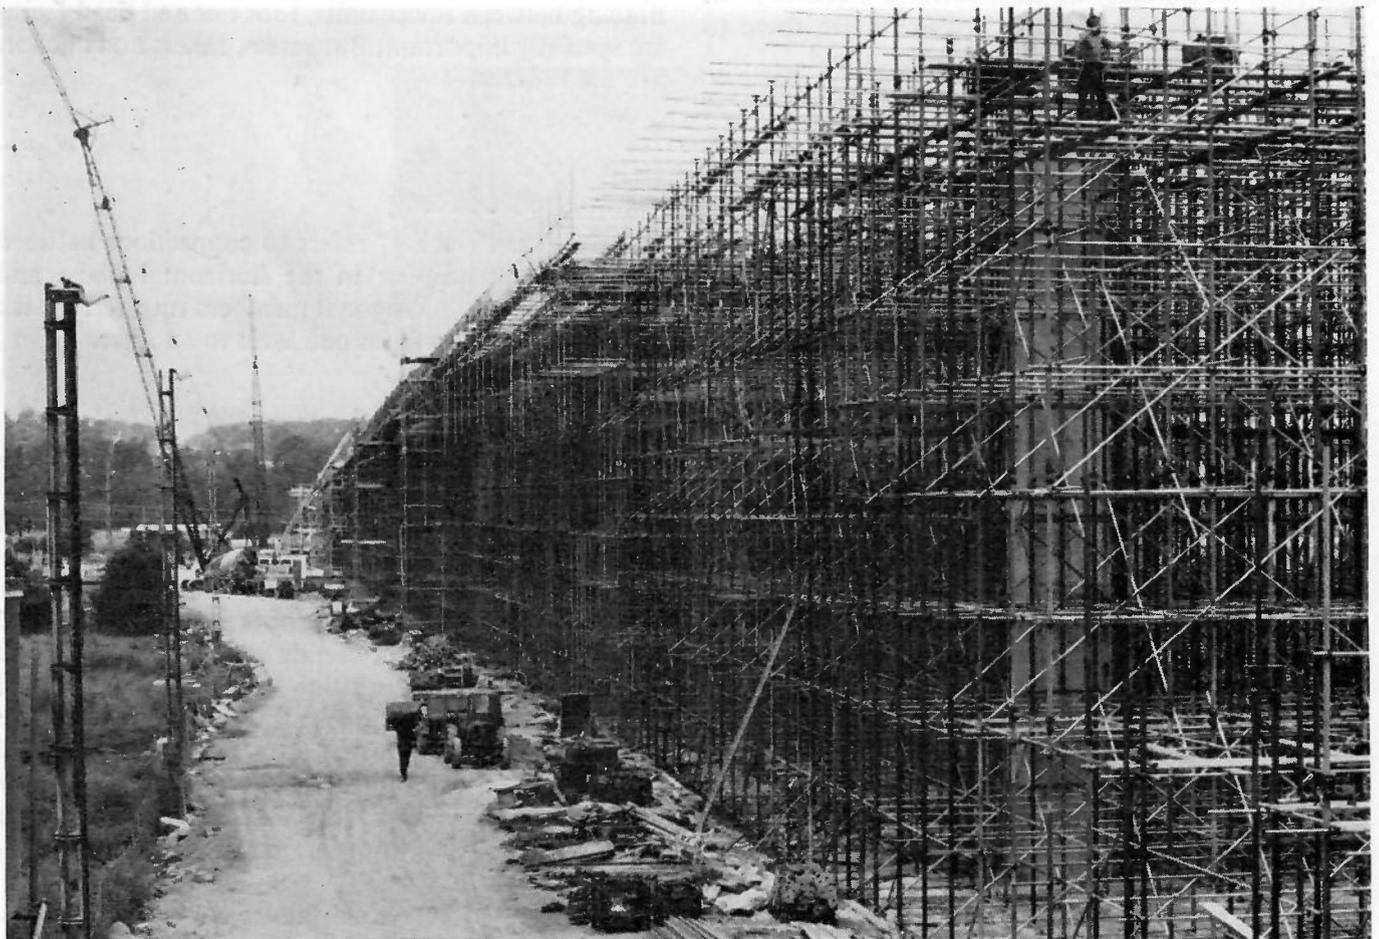
An example of the benefits of careful setting-out and design is shown in this large-scale falsework, where excellent bracing and lacing is facilitated by the regular construction

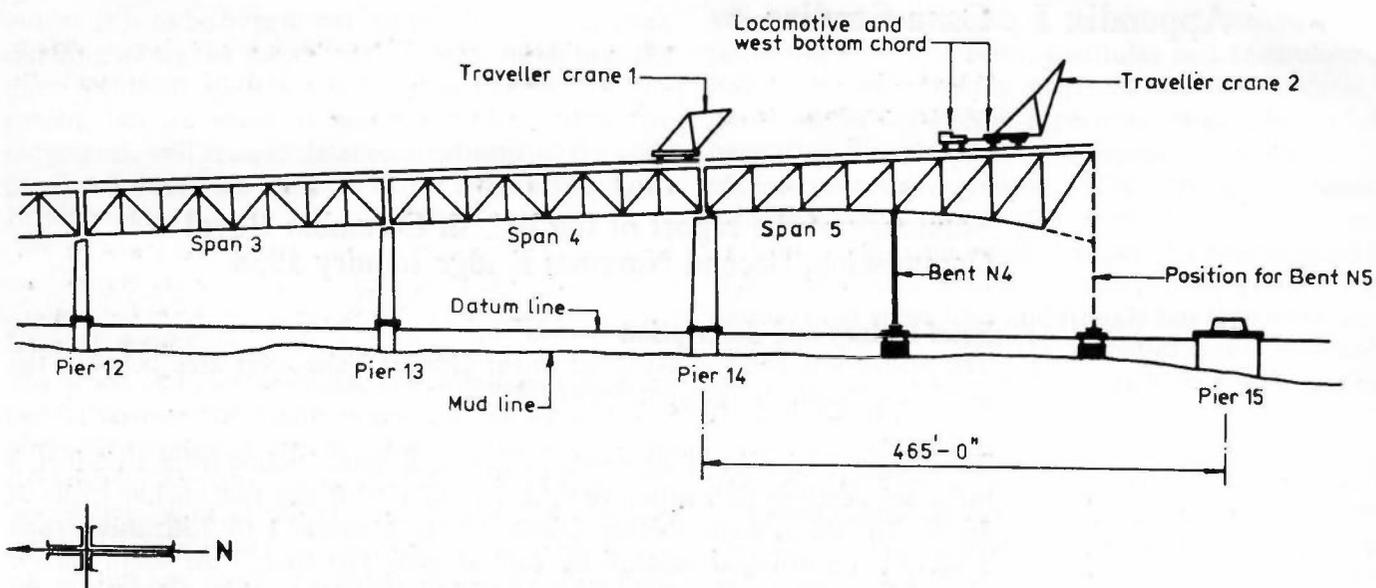
(1) The collapse of span 5 took place in three stages:

- (a) a short initial dip or drop, variously estimated by eye-witnesses as from from 1 to 6 ft

- (b) a pause, or "hesitation"
- (c) the collapse into the water of its south end, the north end remaining supported on pier 14;
- (2) The top of pier 14 was deflected towards the south;
- (3) The south end of span 4 collapsed into the water from the north side of pier 14.

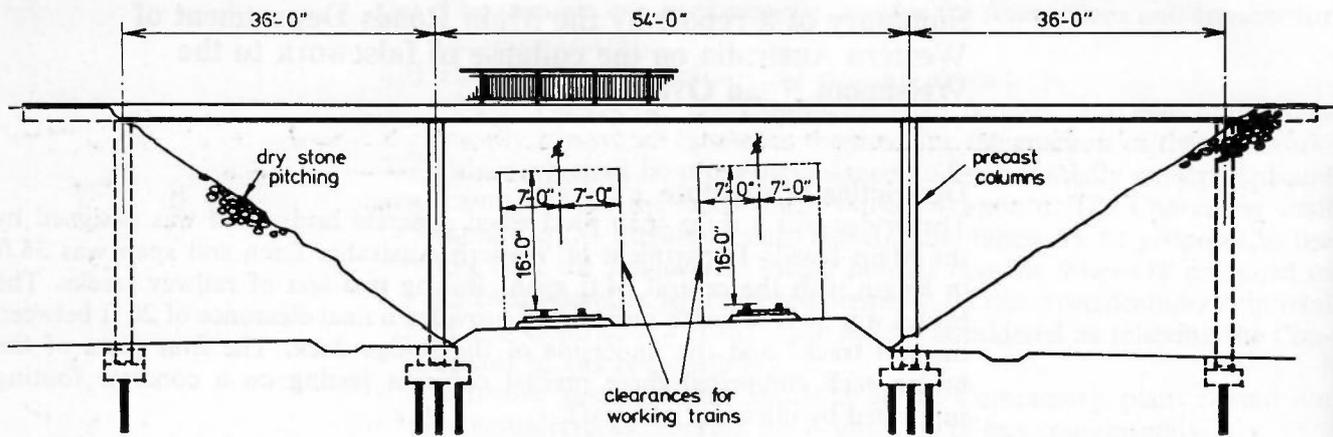
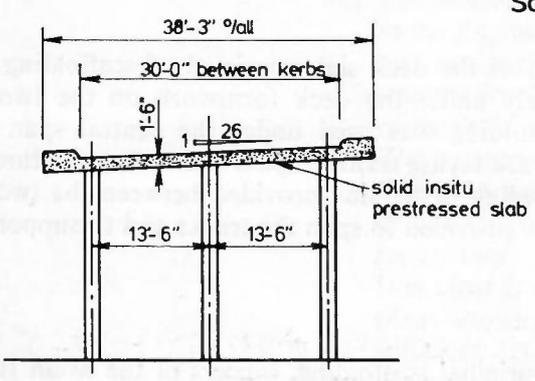
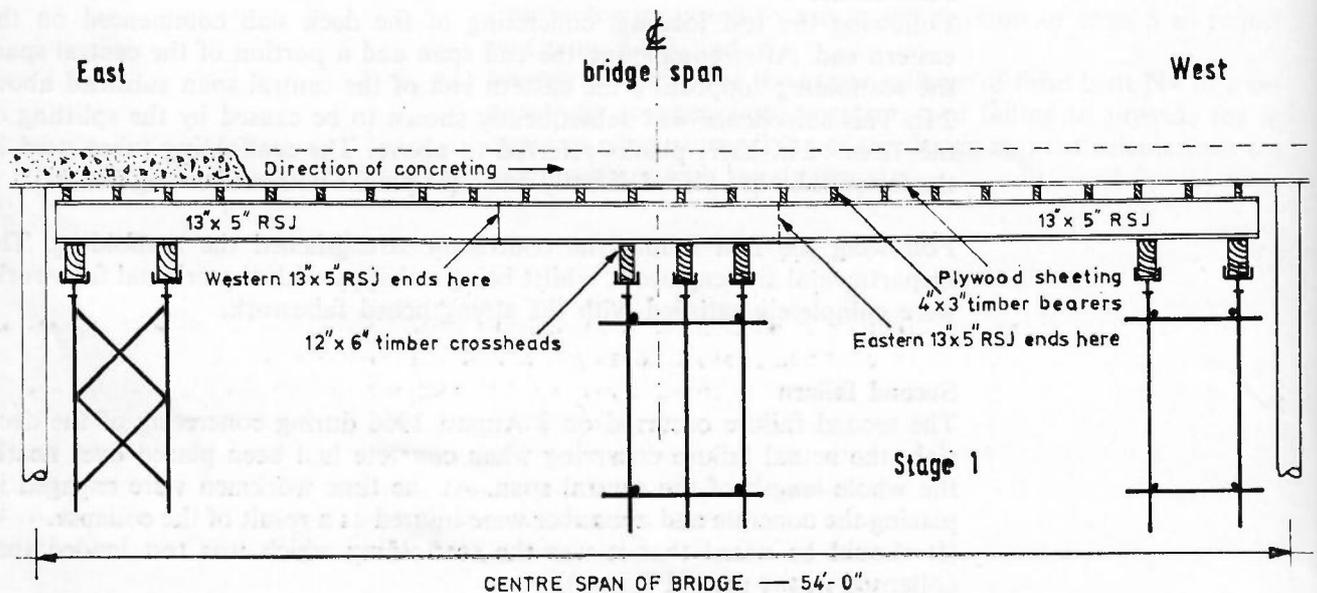
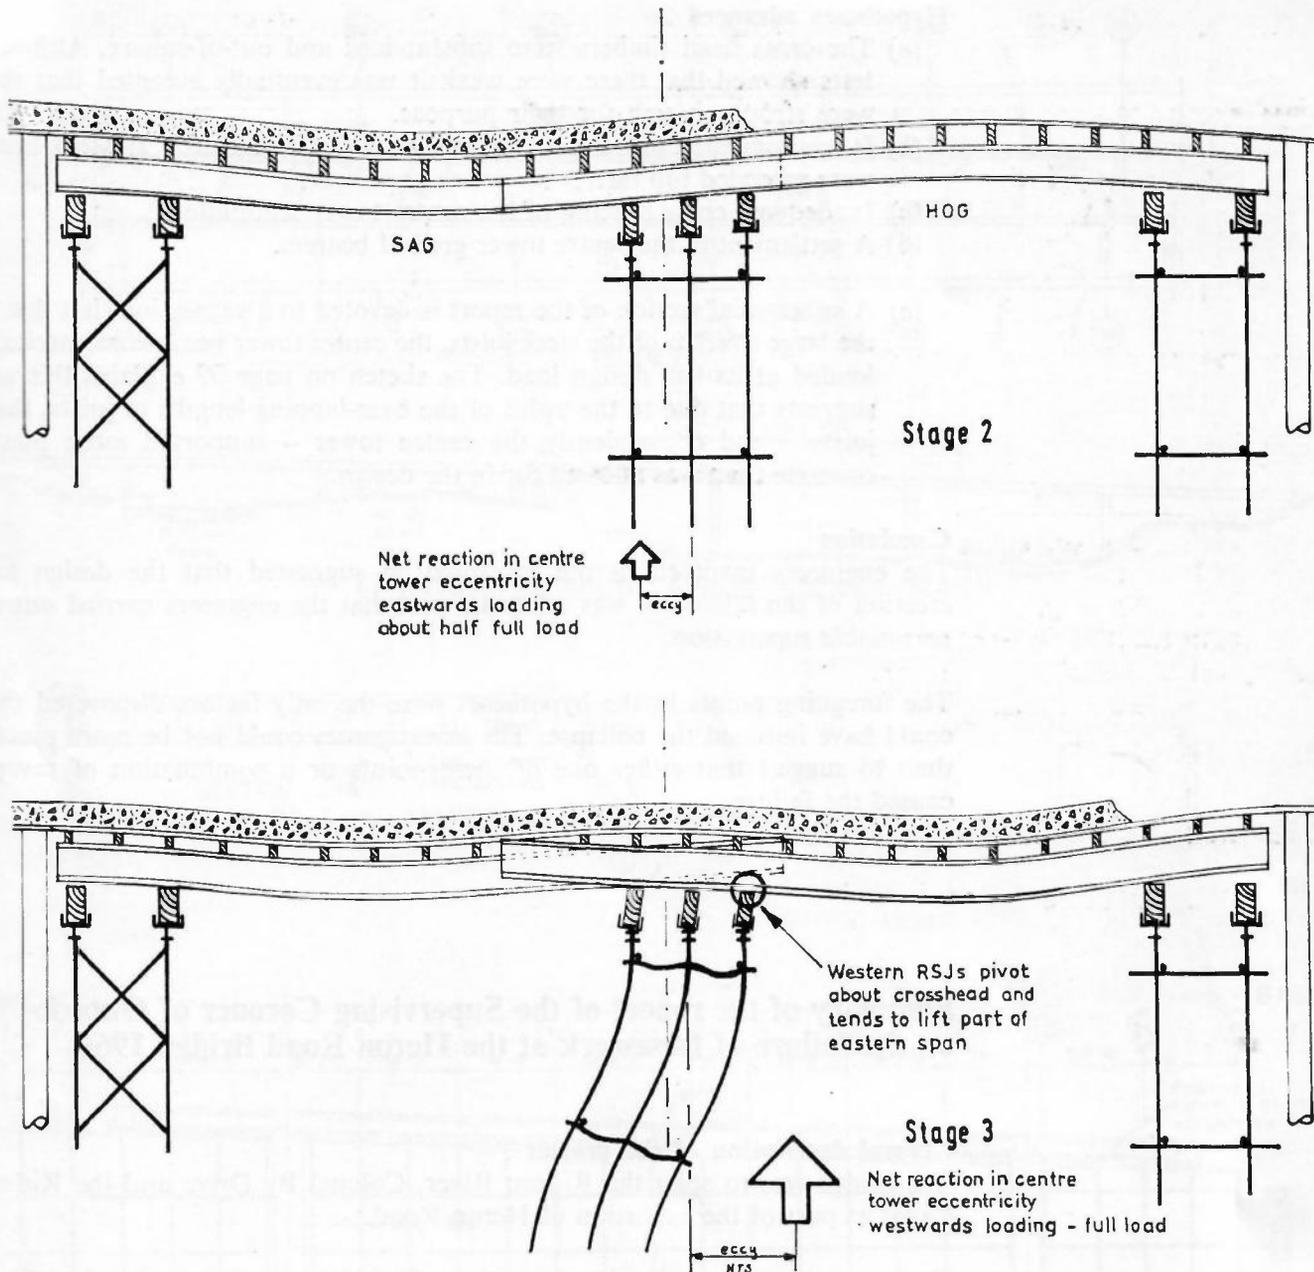
South Elevation

The second failure occurred on 8 August 1966 during concreting of the deck slab, the actual failure occurring when concrete had been placed over nearly the whole length of the central span. At the time workmen were engaged in placing the concrete and a number were injured as a result of the collapse. (It should be noted that it was the scaffolding which was test loaded that collapsed in the second failure).

- (a) In spite of all attempts the failure could not be attributed to any specific cause. (The railway onto which the falsework collapsed was cleared of debris within 7 hours). Various hypotheses were advanced by engineers associated with the investigation as to how the failure might have been caused; however no one was able to substantiate his case.

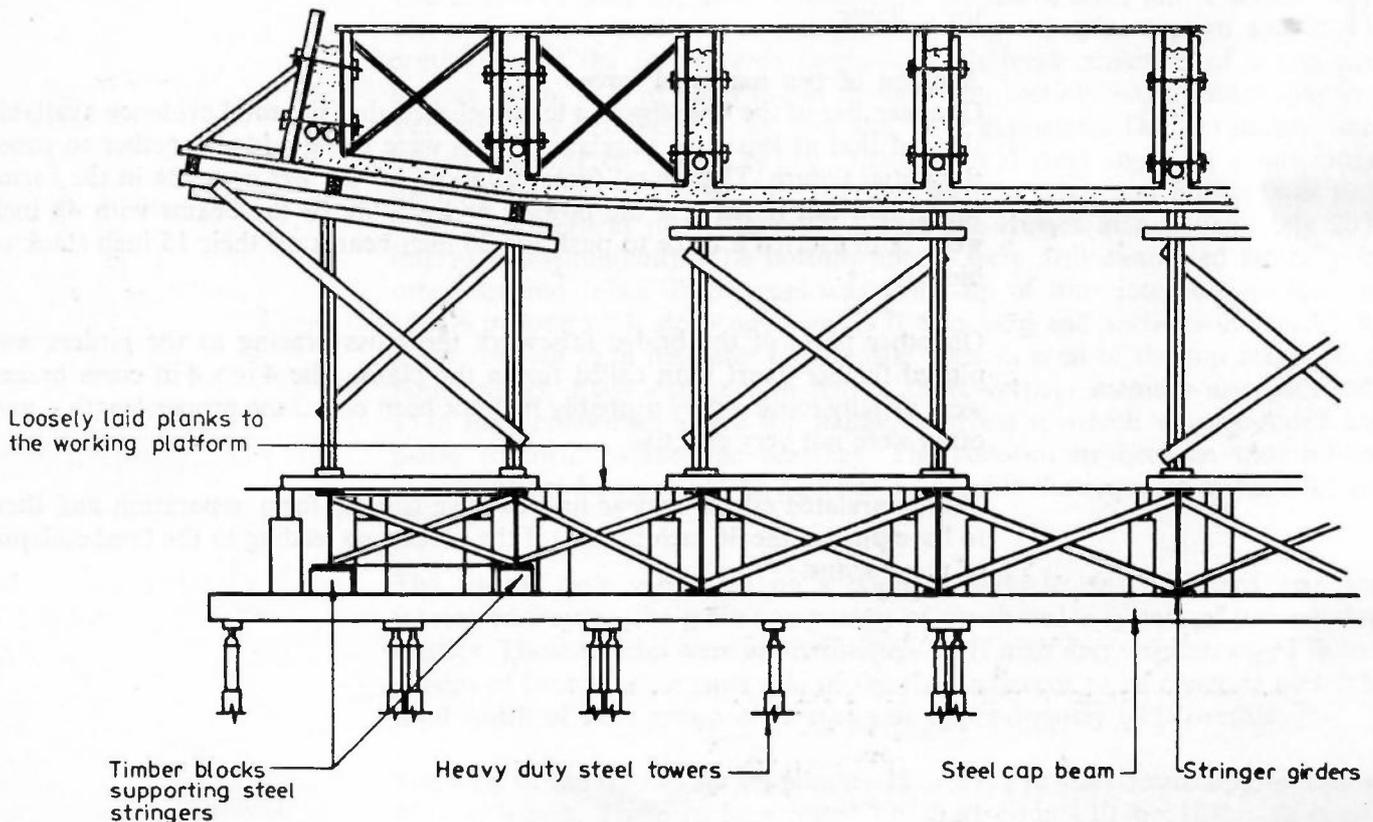
A portion of the collapsed member was removed and tested. On cutting open the member, which is a hollow rectangular tube, it was apparent that it had been

heated and straightened previously in the same location where the buckling had occurred.

The investigation team believes the weakened diagonal brace, in not preventing the tower collapse, contributed to the complete failure.

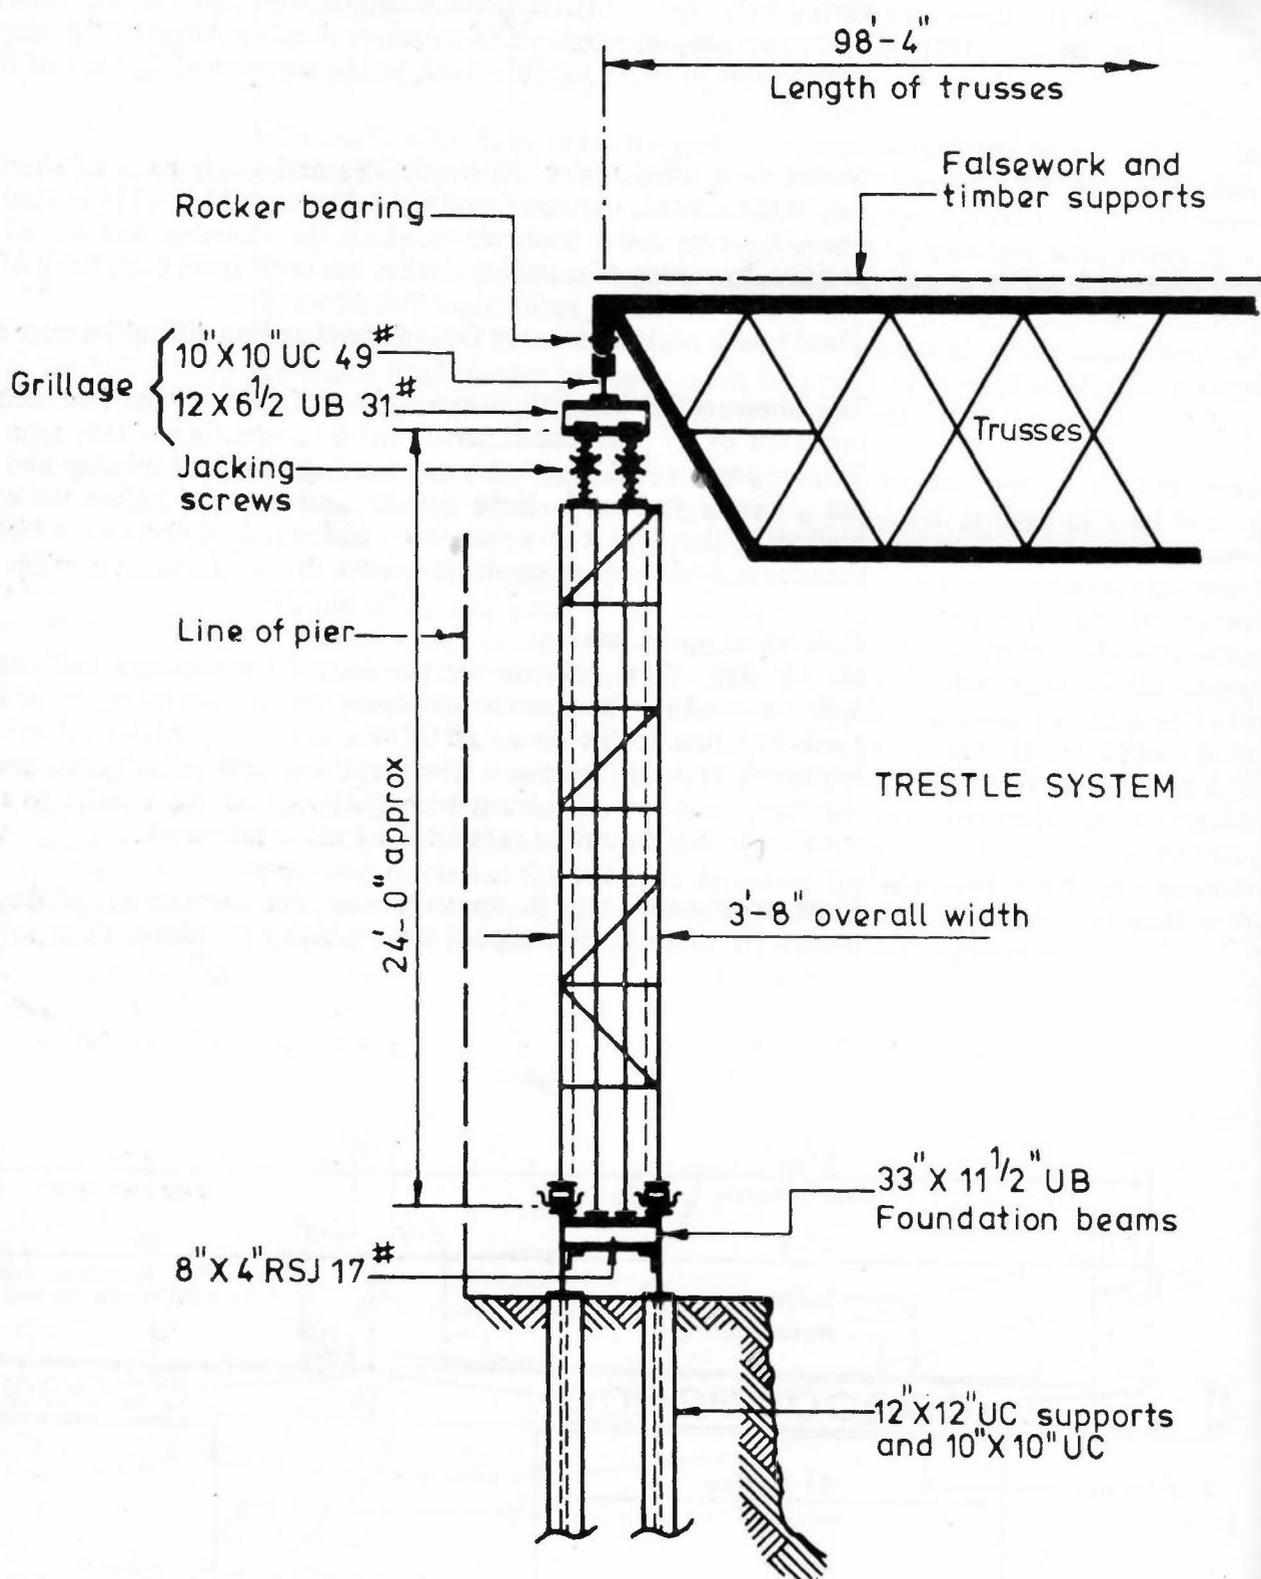
Part Side Elevation of Trestle System

In order to distribute the load carried by the 26 trusses over 16 pairs of forkheads, each end of the trusses rested on a two-layer grillage of steel beams placed on top of the trestles. (See page 114). Each upper layer of this grillage consisted of header beams of 10 in \times 10 in \times 49 lb universal column sections, with special bearing pads 12 in long \times 12 in wide on the top flanges, the upper surfaces of which mated with the rocker bearings of the trusses. These bearing pads were either tack welded, or clipped by bolted steel flats, to the upper universal column sections. The latter were supported on short lengths of 12 in \times 6 $\frac{1}{2}$ in \times 31 lb universal beams at right angles to the 10 in \times 10 in \times 49 lb header beams, and spaced generally at intervals of approximately 3 ft 6 in along the top of the trestles either side of the river and rested in the trestle forkheads at 2 ft 4 in centres. Short lengths of 5 in \times 2 $\frac{1}{2}$ in rolled steel channels were fitted inside the forkheads to centralise the 12 in \times 6 $\frac{1}{2}$ in \times 31 lb universal beams over the backing screws. Tapered timber packings were also used with the centralising RS channel pieces, to fix the beams in position.

Having eliminated the possibility of foundation movement or defective formwork as potential causes of the accident, attention was concentrated on the steel falsework. The overall stability of the falsework was suspect in that the pin-jointed type of framework was not firmly anchored. In other words, although the uprights were standing freely on the foundation beams at their bases and the trusses were merely resting on the bearer plates at the top, the uprights were not tied back to or braced against the concrete piers alongside them. In addition, the lateral stability of the connected trusses was doubtful. However, there was insufficient evidence to suggest that these two factors substantially reduced the stability of the structure.

Although the moving of the falsework was reported as a relatively smooth operation it had been necessary to weld side plates at the rocker bearings to maintain them in position. There had also been difficulties in aligning the trestles when the falsework was re-assembled. As a result of these alterations the actual support conditions for the trusses on the grillage beam assemblies bore little resemblance to those assumed in calculations, namely vertical loads applied centrally on the bearings without horizontal forces. Other effects which had not been allowed for included frictional forces in the rocker bearings, the inadequate fixing and the eccentricity of the bearing pads on the 10 in \times 10 in \times 49 lb header beams, and the poor seating of the grillage beams in the forkheads.
